COMPOSITE ANCHORING, GROUTING AND STABILIZATION OF THE BRISTOL MARITIME ARMORY

BY JOHN M. WATHNE

Bristol Maritime Armory Stabilization Bristol, Rhode Island

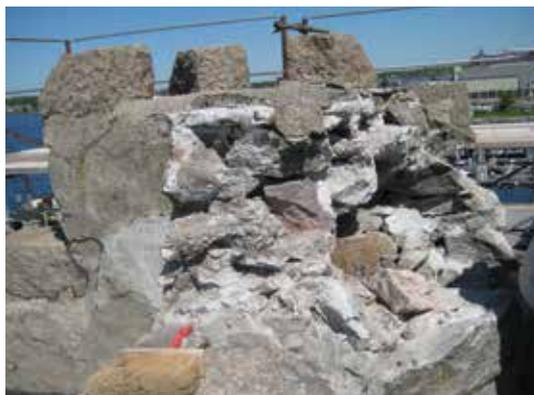
The first phase of repairs focused on the severely-cracked northeast turret and the cracked and bulging east elevation (Fig 2 and 3). Initially, the repairs were intended to consist of through-pinning the elevation and gravity-filling and packing the back-up construction with mortar and chinking stones by opening small windows at removed stone. However, the conditions encountered during construction were so severe it was determined that it would be necessary to do a comprehensive reconstruction of the middle portion of the façade and a total reconstruction of the turret.

Fig. 2: Internal turret condition

This work was done using ASTM C270¹-style Portland cement, hydrated lime and sand blends, both in standard mortar consistency and (with the addition of a shrinkage compensator) in the form of a fluid grout.

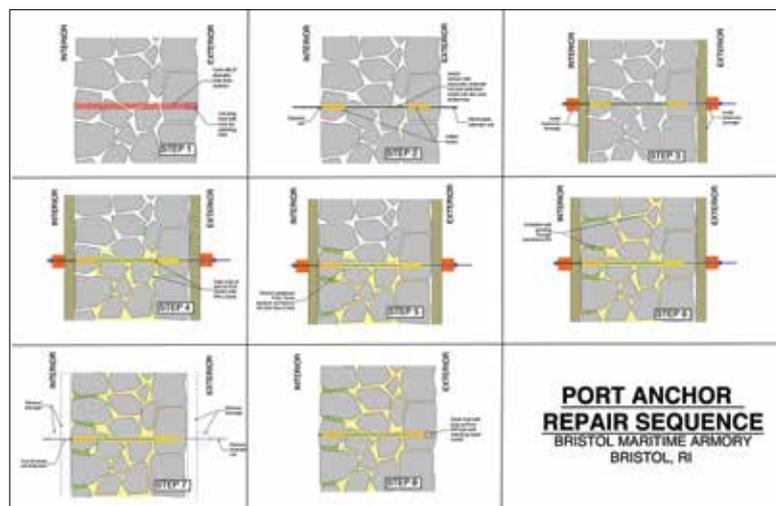
Fig. 8: Port anchor repair sequence

The first step was to perform an updated survey of the structure to lay out the anchor locations. Anchors were positioned where they could be of the greatest value, such as along cracks, at the centers of bulges, and at protruding large stones (Fig. 8). Holes were core-drilled through the wall and the outer leaf, and back-up thicknesses were determined. Interestingly, between 10 and 20 per-

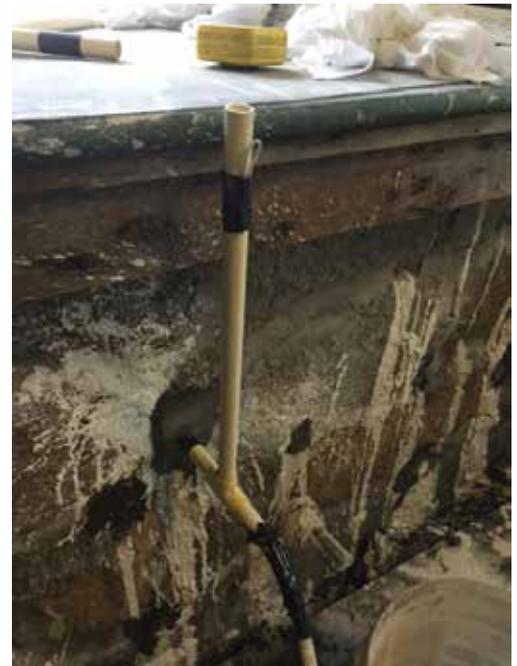
Fig. 10: In-line injection piezometer

the interior. Grout lifts were limited to 3 ft (1 m) per day, and a system of pressure-limiting in-line piezometers (Fig. 10) was devised to avoid internal grouting pressure spikes when refusal was reached.

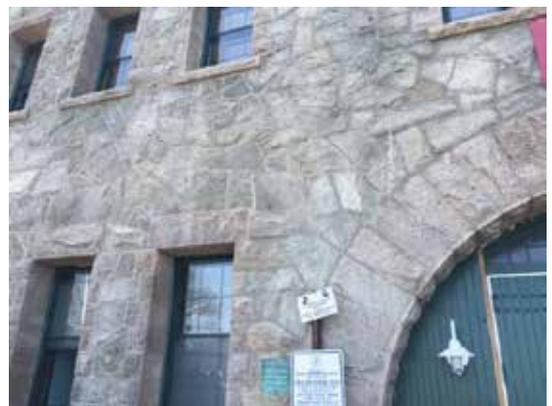
Fig. 11: Completed work before final wash-down

After the first round of grout injection was complete, several rounds of holes were drilled into the wall to confirm that it had been solidly filled. Where voids were encountered, the holes were then used for re-injection. After the walls were solidly filled, the dunnage and extension rods were removed, and the anchor holes were filled by bonding thin “biscuits” that were cut from the outer ends of the corresponding cores. A section of completed work is shown on Fig. 11.
