## **Onsite Structural Testing and Assessment of the CINTEC Anchor Reinforcement System at Basildon, Essex.**

By R J Currie  
February 1993

## Onsite Structural Testing and Assessment of a CINTEC Anchor Installation at Basildon, Essex.

## Executive Summary

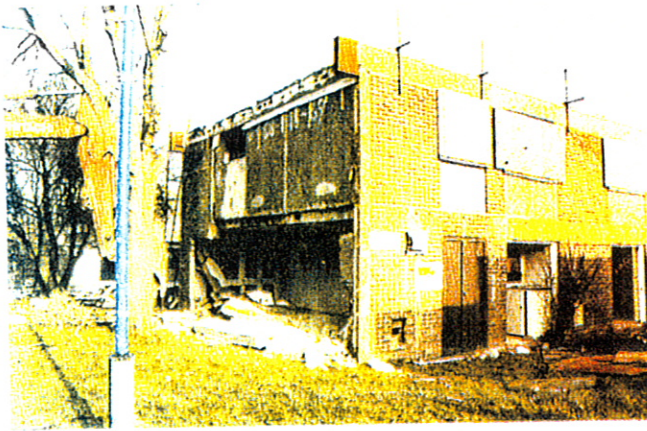
**A4**

Shows the stage where virtually all the load bearing support has been removed from the end of the structure. At this point there is no significant disruption to the structure and the first floor planks have just started to deflect under the load.

- Photograph A4 - Shows the stage where virtually all the load bearing support has been removed from the end of the structure. At this point there is no significant disruption to the structure and the first floor planks have just started to deflect under the load.

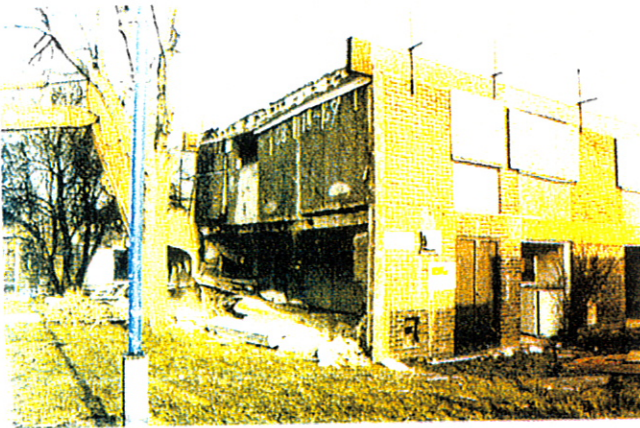
**A5**

The last remnants of the supports are removed and the first floor starts to fail slowly under the weight of the panels above.

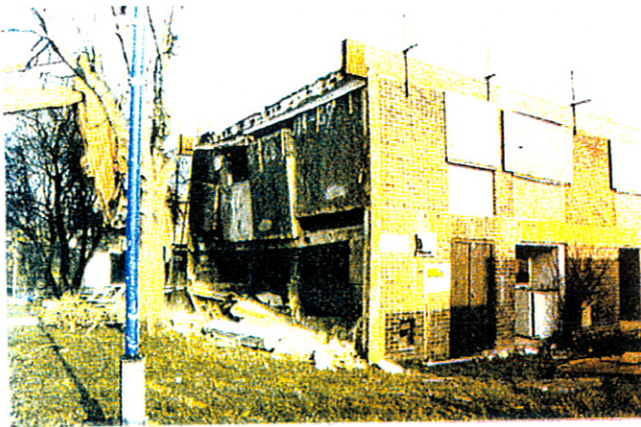
**A8**

The first floor continues to fail as a unit leaving behind the roof which is unsupported but still intact. The side walls start to buckle out at first floor level under rotational forces induced by the first floor wall panels.

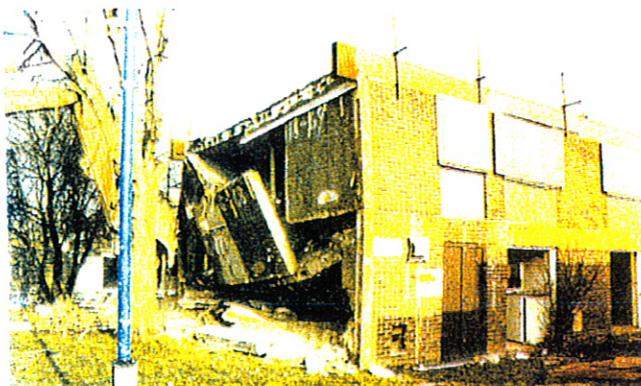
**A10**

The first floor collapse is complete, the side walls are now buckling badly but the unsupported roof remains in place and intact.

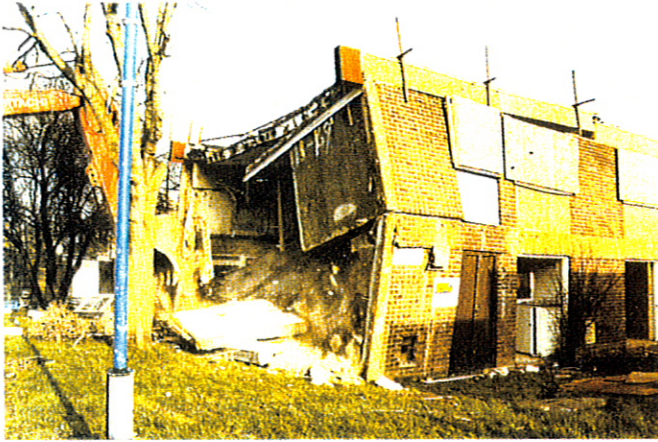
### **A12**

There is complete loss of stability of the side walls due to rotation at first floor level forcing down the roof structure as a unit.

- Photograph A10 - The first floor collapse is complete, the side walls are now buckling badly but the unsupported roof remains in place and intact.
- Photograph A12 - There is complete loss of stability of the side walls due to rotation at first floor level forcing down the roof structure as a unit.

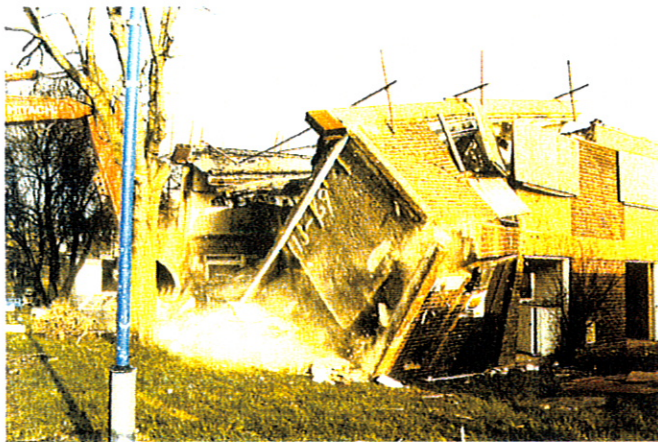
### **A14**

Collapse of the complete end of the structure. Note the upper storey side walls being pulled inwards and roof now in free fall but still continuous.

- Photograph A14 - Collapse of the complete end of the structure. Note the upper storey side walls being pulled inwards and roof now in free fall but still continuous.

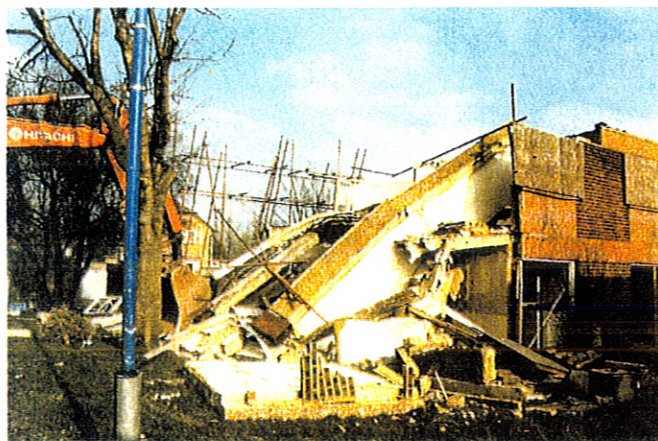
### **A35**

Final condition of collapsed structure. Note most of the debris lies within the original dimensions of the building.

- Photograph A35 - Final condition of collapsed structure. Note most of the debris lies within the original dimensions of the building.

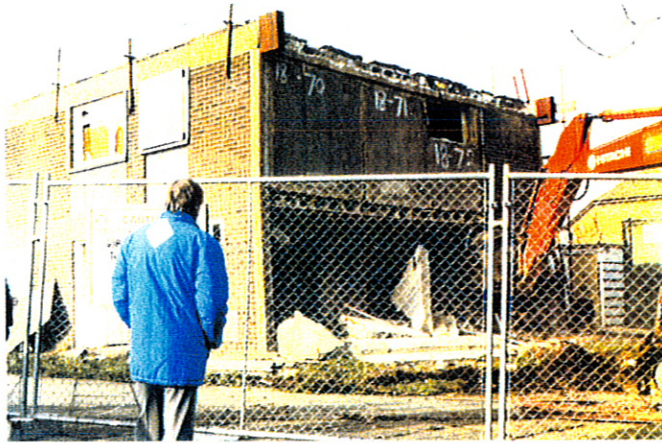
**B5**

This shows a stage where the support wall is being removed. It can be seen that the first floor has slipped down at the side nearest the camera and the end first floor wall panels and the side walls have started to rotate.

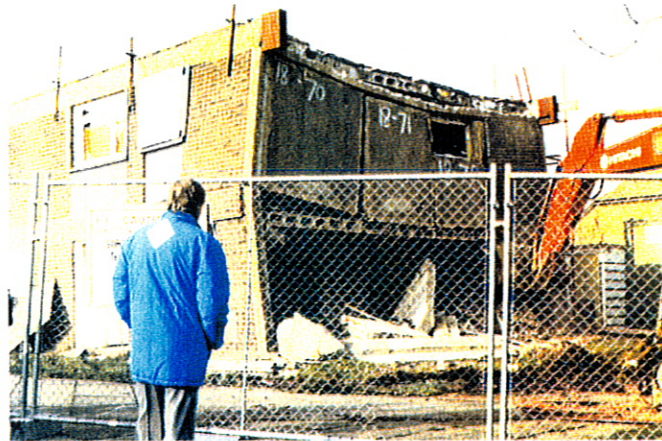
**B6**

The first floor is failing rapidly as the excavator bucket attempts to remove the remaining supports and the side walls have commenced buckling at first floor level.

At End B a similar degree of buckling to the side walls was present by the time the first floor had moved down approximately 300mm (Photo B6).

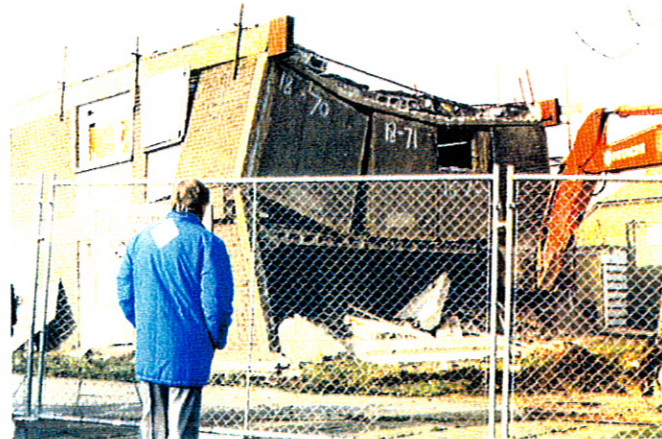
**B7**

As the failure progresses rapidly the roof breaks up and fails following the first floor down. Note the first floor centre wall panel is sandwiched between the roof and floor and the end is falling as a whole.

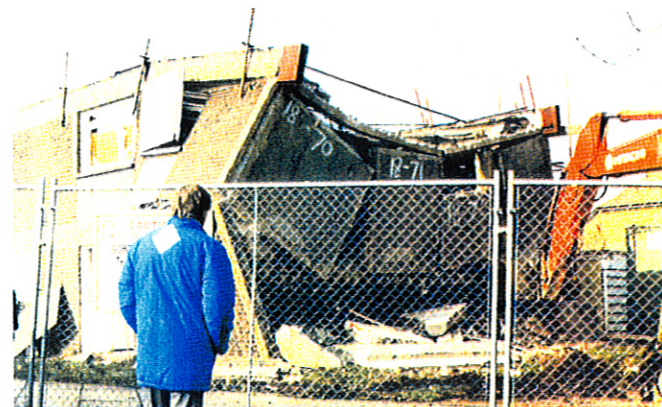
**B8**

The roof continues to follow the first floor in free fall.

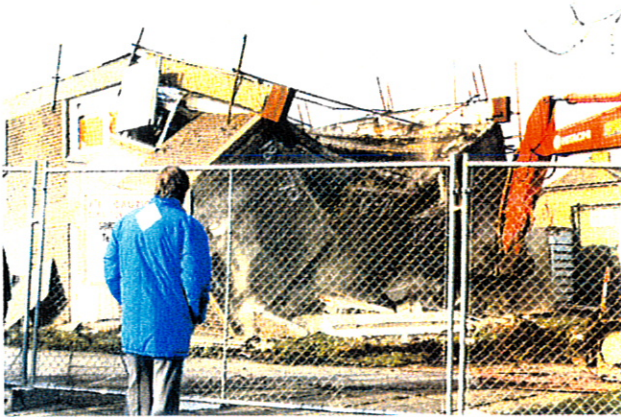
B9-11

Complete collapse of the end of the building.

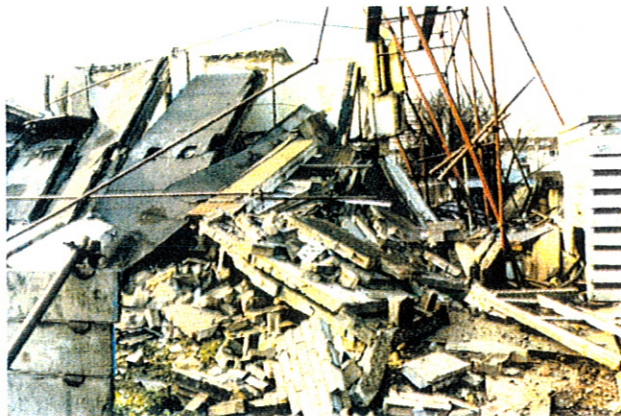
Fragmented side walls had been contained by the safety scaffolding.

Photograph B36 - Fragmented side walls had been contained by the safety scaffolding.

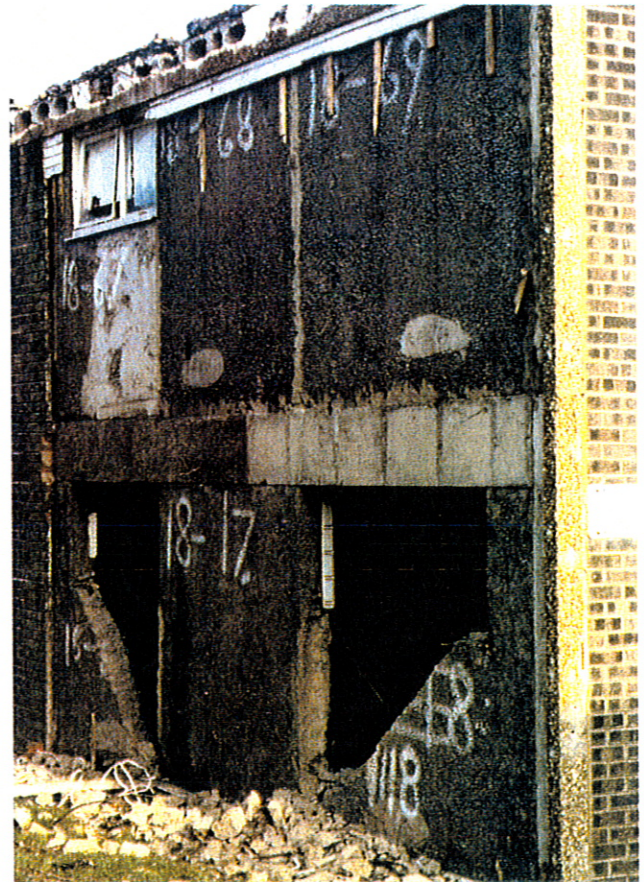
PHOTOGRAPH 1

Reduced support prior to removal of ground floor wall.

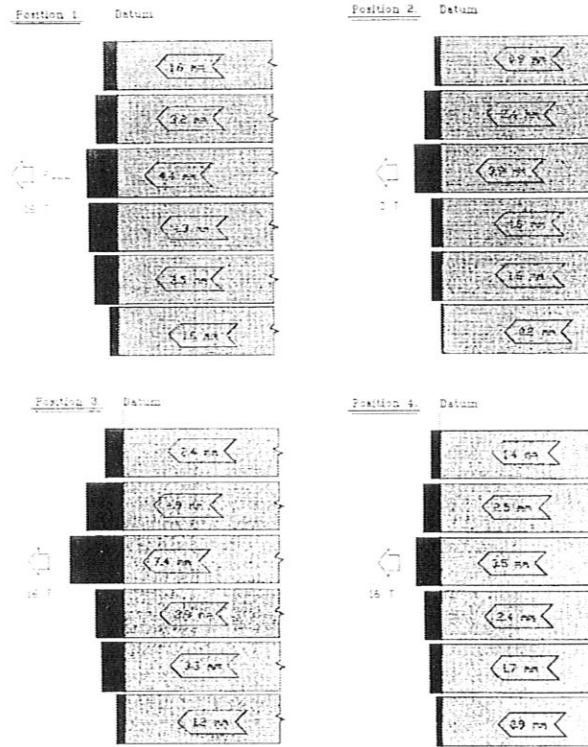
Using the edge beams as reaction points for a deep beam a tensile load was applied incrementally to one of the central planks and the movement of all the floor planks recorded. When the applied load reached approximately 16 tonnes (T) the lateral movement of the loaded plank was 4.4mm and the profile across the end of the roof was as indicated in Fig. 5 position 1.

The position in which the roof planks came to rest is given in Fig. 5 position 2 which was the new datum position of the roof for the start of the second load cycle. This shows that approximately half the deflections recorded previously were recovered when the load was removed with a permanent “set” of about 3mm between the centre and edge planks.

The load was increased up to the previously recorded maximum of 16 T and the deformation profile was recorded Fig. 5 position 3. Position 4 (Fig. 5) shows the measurements in position 3 adjusted to allow for the initial datum position at the outset of the second load test.

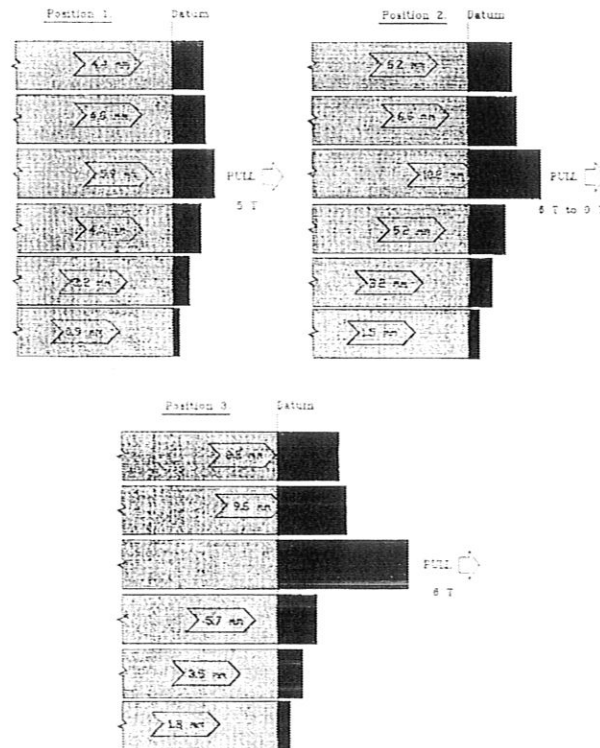
When the maximum deflection at End B was similar to the maximum deflection recorded under the 16 T load in the previous test on End A the load was held constant. At this point the load applied to End B was 5 tons and the deformed profile at this load is given in Fig. 6 position 1.

When the loading was increased to 6 T the deformation increased dramatically as indicated in Fig. 6 position 2. At this point the load was released and the structure inspected. No recovery of the deformations occurred on removal of the load, the deformed profile being maintained under zero load.

The 6 T load was reapplied and the loaded plank continued to pull out of the floor at this constant load. The test was terminated when the maximum lateral deflection reached was 18.4mm and the final deformed profile under the 6 T load is given in Fig. 6 position 3.
