## A treatment report by Conservation Solutions, Inc., on a terra-cotta cornice adorning the Capitol Building in San Juan, Puerto Rico, shows the potentially catastrophic effects of corrosion in a marine environment, and offers some innovative solutions to the problem.

Conservation Solutions, Inc., was contracted by the government of Puerto Rico to assist Pablo Quinones of OPQ & Associates in the investigation of the main terra-cotta cornice at the base of the dome of San Juan's Capitol Building.

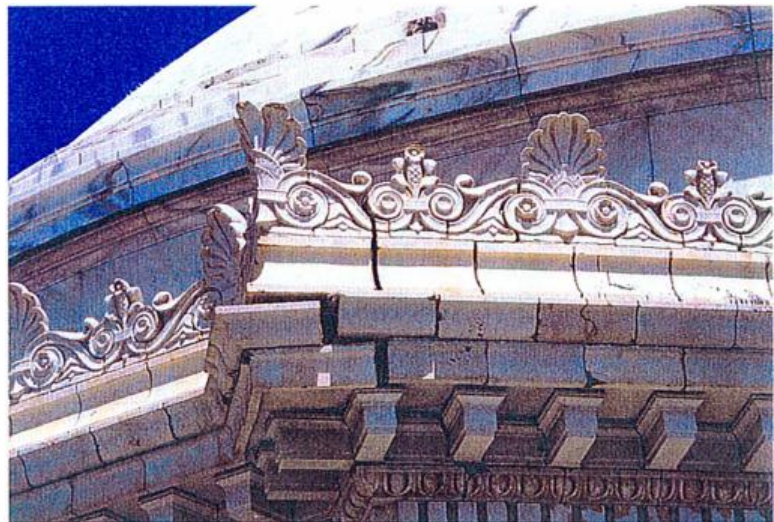
The poor condition of the terra-cotta cornice is evident in this view. The separation of the terra-cotta units is due to not only the failure of the anchoring system, but also the expansion of the corroded material.

Water had penetrated down into the cornice, and all its steel structural supports and anchors had been totally destroyed by corrosion. The total failure of the structural-support steel and anchor system had led to the structural failure of the cantilevered, and now unreinforced, terracotta cornice. The only reason that it had not collapsed was a combination of the cohesive and frictional effects of the mortar and brick fragments used as back-up to the hollow terracotta units.

Moisture had entered the open joints and cracks and, to a lesser extent, through leaks in the roof above and behind the cornice. The reason for the extreme corrosion of the steel was a combination of chlorides from sea spray and the sulfuric acid formed when saline moisture saturated and then passed through the contaminated cindercrete. The corrosion had been so severe that it was no longer possible to establish the exact dimensions of any of the former steel elements. Some had disappeared totally, leaving only rusty stains in the terracotta work.

It should be noted that any corrosion of embedded steel is associated with massive expansion of the corrosion products. In the case of the Capitol Building, this expansion had resulted, and will continue to result, in the shattering of the immediately adjacent terracotta. Thus, all stabilization, conservation, and restoration work must involve the removal of all corroding steel and/or the prevention of any further corrosion and associated expansive effects. All new steelwork must be AISI Type 316 stainless steel, which is non-corroding in the chloride-rich maritime environment present here. AISI Type 304 stainless steel is attacked by chlorides and cannot be used here under any circumstances because it will corrode.

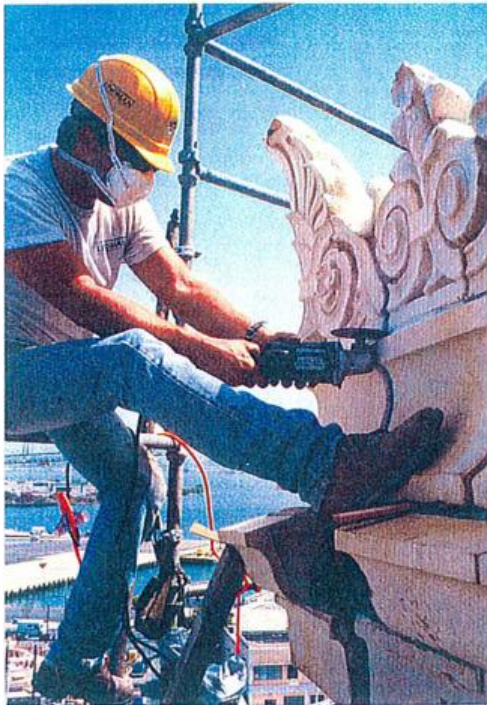
A worker is seen here cutting the mortar joints between the terra-cotta blocks in preparation for the disassembly of the cornice.

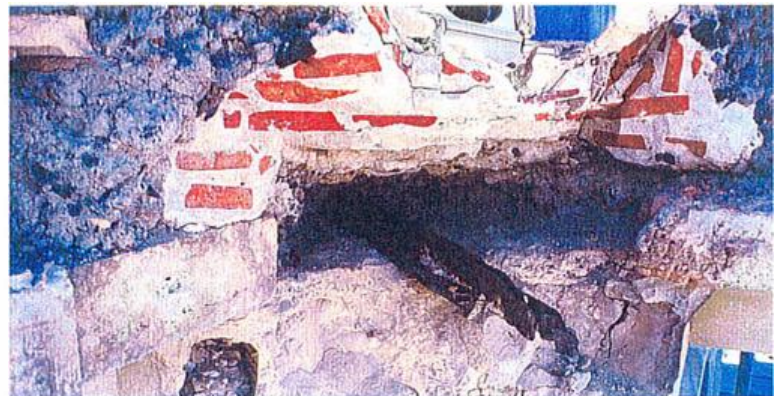
Once the cornice had been partially disassembled, the materials and techniques used in its construction could be easily identified. Note the linker concrete, or "bondcrete," between the terra-cotta blocks and the brick backup material and the cyclic deterioration of the steel supports. CSI recommended that all new rebarwork be type 316 stainless steel, a non-corroding type, which is essential in this chloride-rich maritime environment.

As the careful cutting away commenced at the cornice's upper level we found that the cornice was backed-up by a mass of "clinker concrete" or "cindercrete." This material is based on an aggregate of furnace ash and large fragments of clinker. Its use has been suspended for many years because the large quantities of sulfur compounds present in the ash and clinker have been found to cause severe corrosion of adjacent steel in the presence of moisture.
