**DON'T
TEAR IT
DOWN...
ANCHOR
IT DOWN!**

ST. ANNE CHURCH, OTTAWA, ON, CANADA

SAINTE-ANNE D'OTTAWA CHURCH, BUILT IN 1873

by John G. Cooke, Engineer

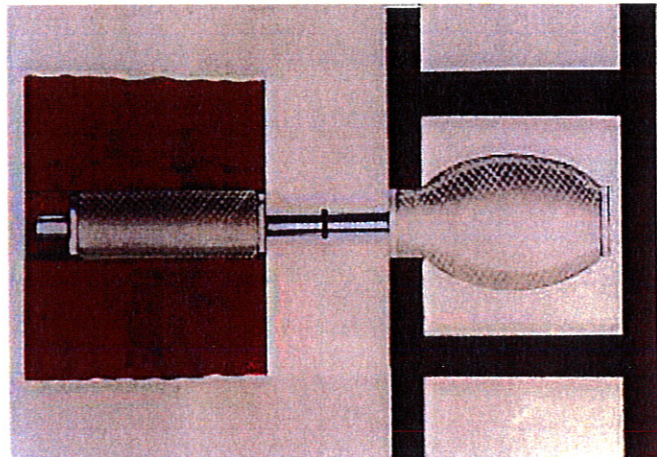
PHOTO: CINTEC
RAC FIXINGS
FOR BRICK
CAVITY WALL
