The Restoration and Stabilization of the Blists Hill Furnaces, Telford, England, U.K.

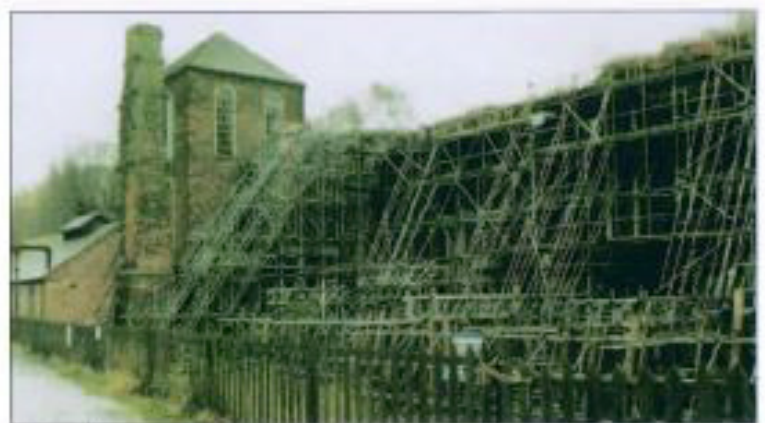
Restoration work in progress

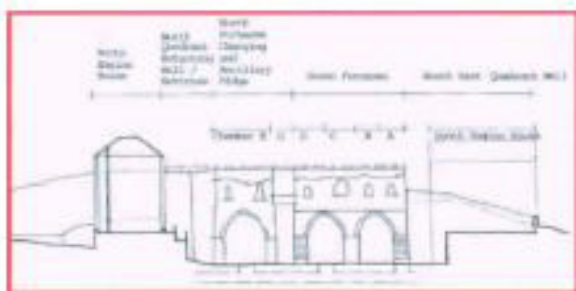
Side Elevation

- Superficial damage of the masonry and stone walls cause by the presence of vegetation and water ingress. This was most evident at the top of the structure, where significant loosening of the brick and stonework had occurred with subsequent loss of the retained material. Water penetration, in conjunction with frost action, was also causing significant deterioration to the fabric of the brickwork and stonework.
- Differential settlement in the south wall of the furnace charging building resulting in westward rotation of part of the wall and consequent vertical and diagonal cracking through the superstructure supported by it.
- Cracking and spreading movements in the superstructure, resulting in outward displacement of walls.
- Distress cracking, loss of material and localized collapse of the stone masonry retaining walls which were up to 13m high.

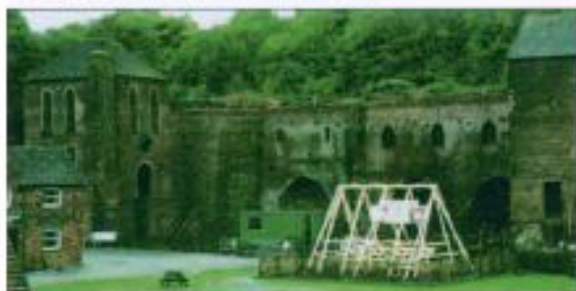
Completed renovation
