The Restoration and Stabilization of the Blists Hill Furnaces, Telford, England, U.K.

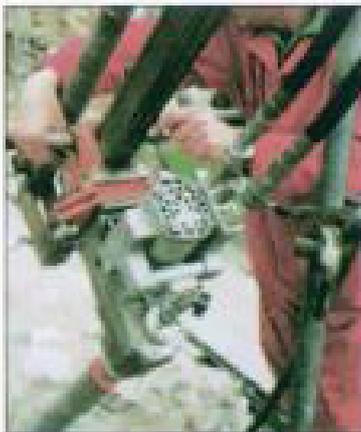
Drilling

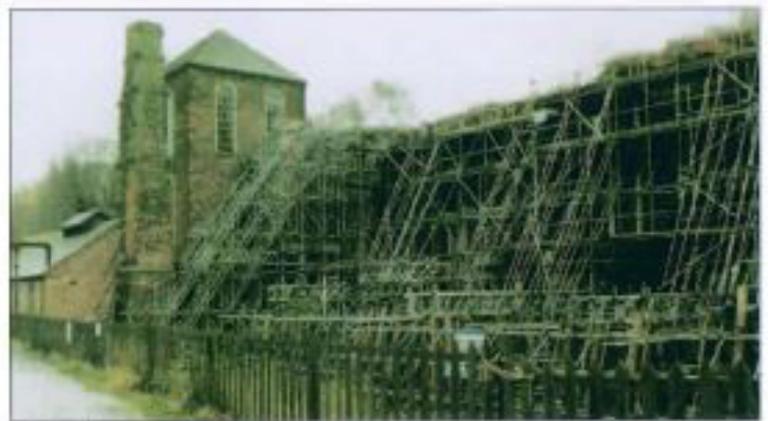
Restoration work in progress

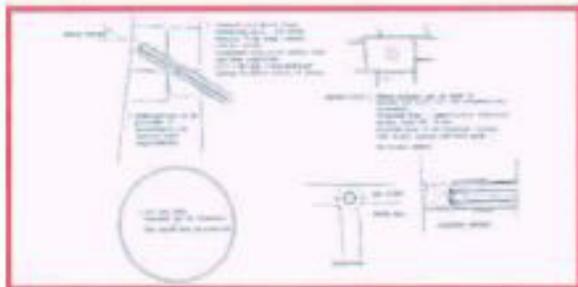
Making good anchor holes in stonework

The ground anchor installation required a 100mm diameter core to be taken out of the center of a selected stone within the retaining wall. Drilling was then undertaken with or without a steel casing, using an air flush drilling system, to a designed anchor position and length of embedment into the underlying mudstone. Even with this angular adjustment the length of the Cintec Anchors was in excess of 20m. The Cintec Anchor was then inserted in the hole with the sock positioned around the anchor. The whole anchor was then pressure grouted to within 100mm of the face of the wall. Finally the original core was refitted into the core hole and resigned into position so as to mask the end of the anchor.

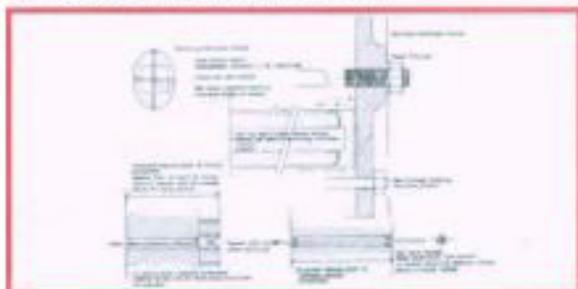
Making good anchor holes in stonework

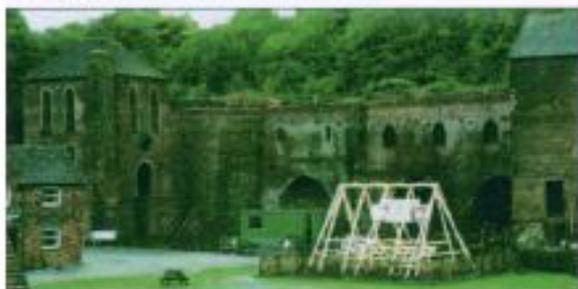
Completed renovation
