COMPOSITE ANCHORING, GROUTING AND STABILIZATION OF THE BRISTOL MARITIME ARMORY

BY JOHN M. WATHNE Structures North Consulting Engineers M.A.

Bristol Maritime Armory Stabilization Bristol, Rhode Island

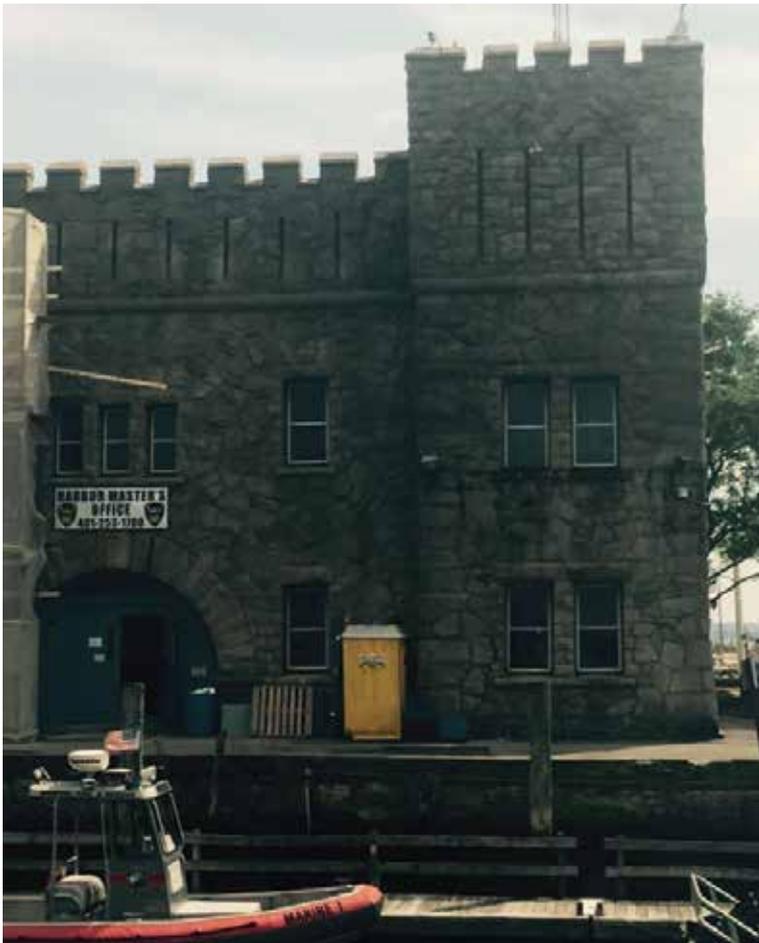
The Bristol Maritime Armory, on a wharf in Bristol, Rhode Island, is an imposing two and one-half story turreted granite edifice that appears to stand guard on the Bristol Harbor (Fig. 1). Behind its imposing façade; however, it is a poorly-constructed stack of unbonded stonework. Nineteenth century newspaper articles state that the Armory walls were cracking and bulging even in the first few years following its construction.

Fig. 1: The Bristol Maritime Armory

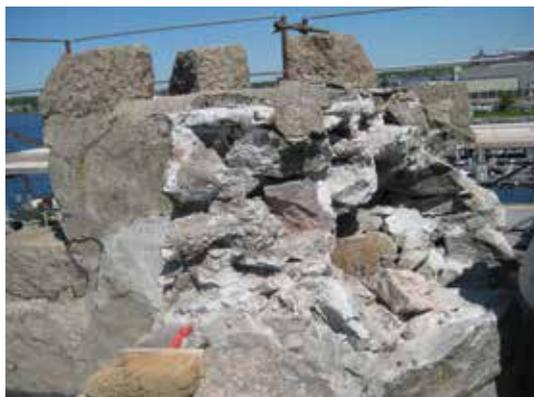
The first phase of repairs focused on the severely-cracked northeast turret and the cracked and bulging east elevation (Fig 2 and 3). Initially, the repairs were intended to consist of through-pinning the elevation and gravity-filling and packing the back-up construction with mortar and chinking stones by opening small windows at removed stone. However, the conditions encountered during construction were so severe it was determined that it would be necessary to do a comprehensive reconstruction of the middle portion of the façade and a total reconstruction of the turret.

Fig. 2: Internal turret condition

This work was done using ASTM C270¹-style Portland cement, hydrated lime and sand blends, both in standard mortar consistency and (with the addition of a shrinkage compensator) in the form of a fluid grout.

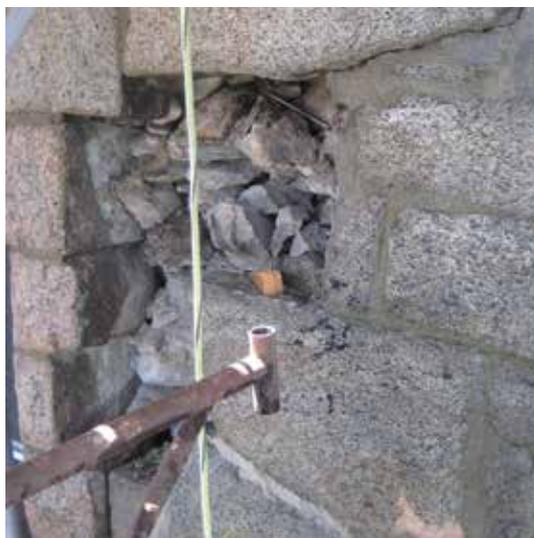
- A dangerously large bulge exists in the north half of the east wall at about mid height. By creating a hole in the window surround within the bulged area, it was apparent that the bulge was actually a separation between the exterior stone leaf and the random stone back-up construction.

Fig. 3: Internal wall condition

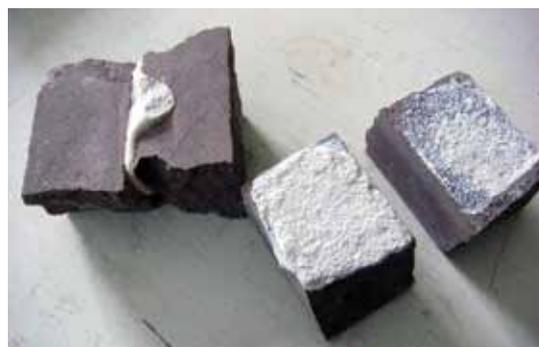
High Adhesive Strength: It is important that the grout be adhesive enough to bond surfaces together with an adhesive strength that equals or exceeds the cohesive strength of the grout (Fig. 6). This is so that any shrinkage that did occur would result in jagged microcracks within the grout rather than in debonding from the substrate surfaces.

Fig. 6: Bond test specimens

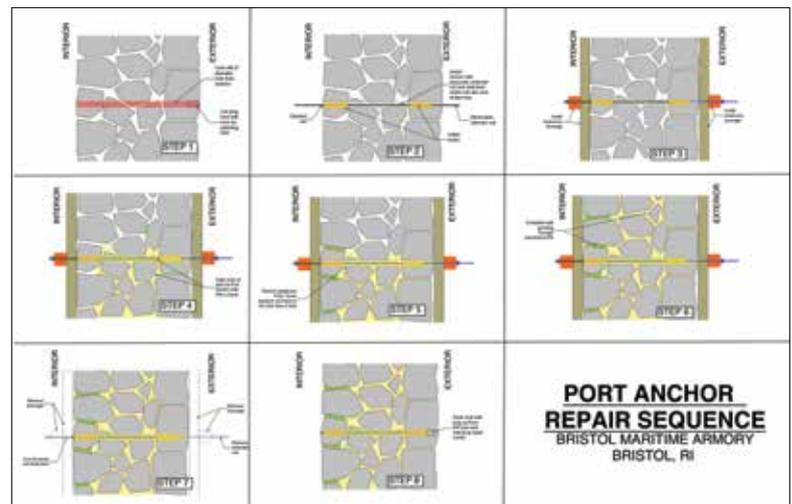
The first step was to perform an updated survey of the structure to lay out the anchor locations. Anchors were positioned where they could be of the greatest value, such as along cracks, at the centers of bulges, and at protruding large stones (Fig. 8). Holes were core-drilled through the wall and the outer leaf, and back-up thicknesses were determined. Interestingly, between 10 and 20 per-

Fig. 8: Port anchor repair sequence

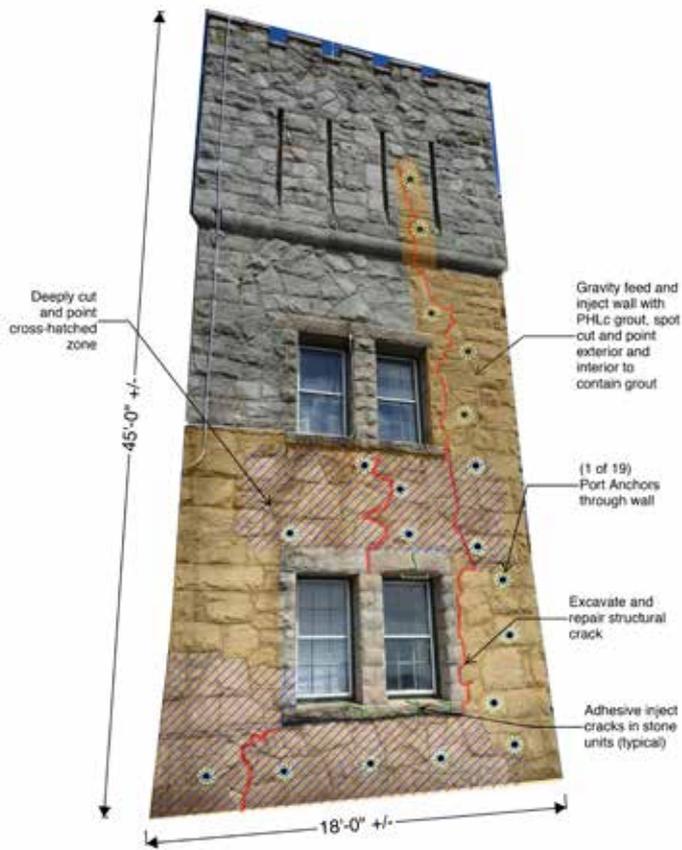
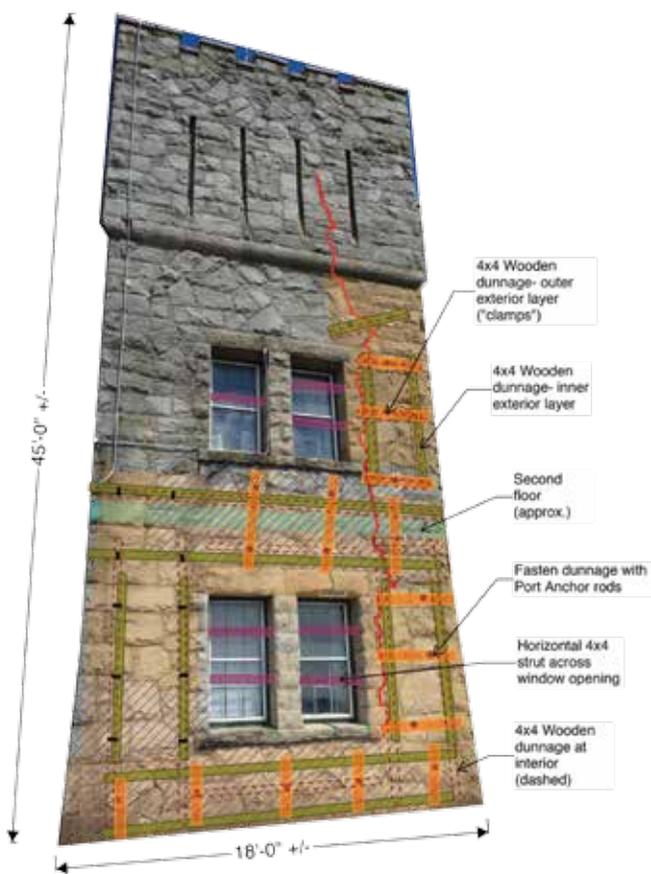
Fig. 9: Repairs and dunnage on west elevation/north half

Next, the mortar joints at the exterior were cut and repointed along with accessible, damaged mortar joints at the interior. Because of the presence of floor framing, wall returns, and in a few places interior finishes, a combination of single-ended and double-ended anchors would be used. Additionally, because of the extremely poor condition of the masonry, wooden dunnage was needed at both the exterior and interior.

Void Span Anchors were installed by inflating the fabric socks with a high strength grout, and the dunnage system was fastened to the exterior by rods that were threaded into recessed inserts in the ends of the anchors. After the anchor installation and dunnage system were complete (Fig. 9), grouting of the wall began, working from the bottom up using the port anchors as well as supplemental holes drilled into

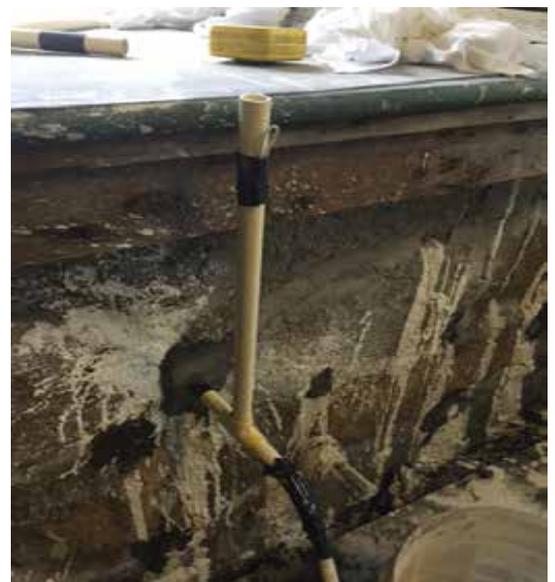
Fig. 10: In-line injection piezometer

the interior. Grout lifts were limited to 3 ft (1 m) per day, and a system of pressure-limiting in-line piezometers (Fig. 10) was devised to avoid internal grouting pressure spikes when refusal was reached.

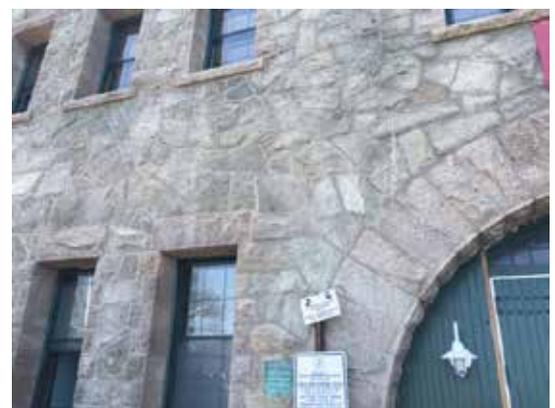
Fig. 11: Completed work before final wash-down

After the first round of grout injection was complete, several rounds of holes were drilled into the wall to confirm that it had been solidly filled. Where voids were encountered, the holes were then used for re-injection. After the walls were solidly filled, the dunnage and extension rods were removed, and the anchor holes were filled by bonding thin “biscuits” that were cut from the outer ends of the corresponding cores. A section of completed work is shown on Fig. 11.
