# CASE HISTORY

**Project:** *Fall River, Massachusetts Rt 79 Exchange*

Site Condition: Cracks in the intrados from the water line to keystone

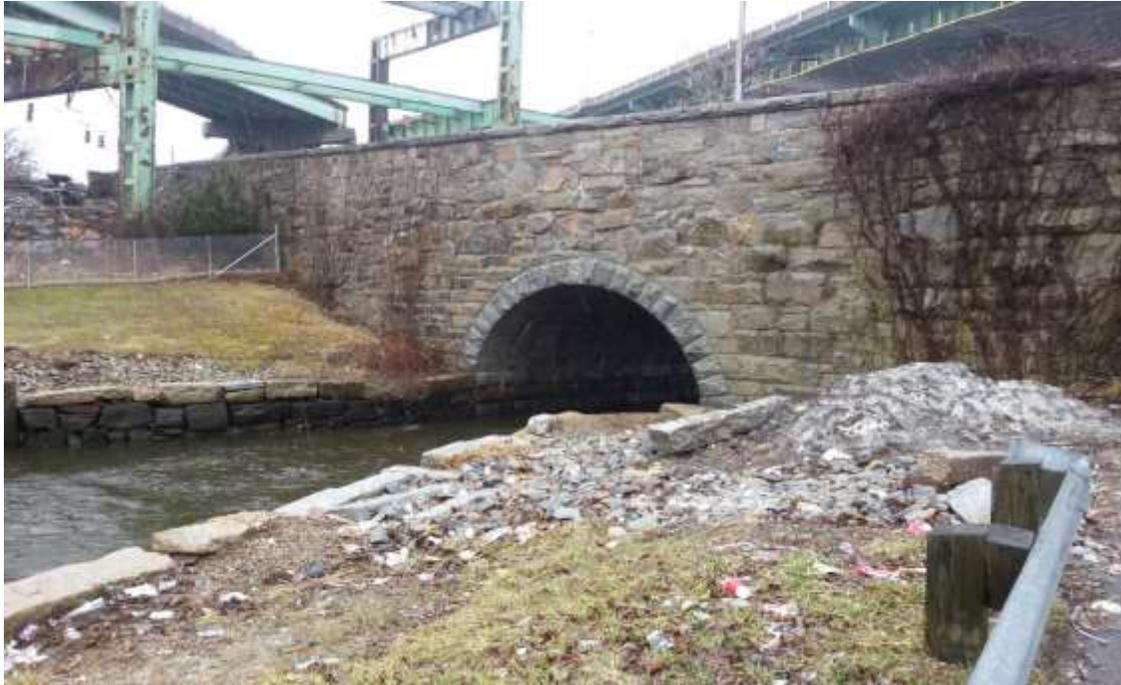
North Side Elevation

Within the barrel of the bridge seven cracks have developed over the years with crack separation from .25 inches to 3 inches in various locations. (See: Vertical Crack) The owner decided not to replace the tidal waterway but to consolidate the ring granite stones in place. Ramboll Engineers in calibration with Cintec America designed a remedial repair scheme which would allow the bridge to retain its original look and stay in service while the repairs were being done to the bridge. During the drilling and anchors inflation the bridge stayed in use with an average traffic flow of 6,000 cars a day.

The remedial repair consisted of wet core drilling 8, 2" diameter holes into the face arch ring stones from the North and South direction. The drilled 18 drilled hole lengths were 18.4", 27.4" or 16.4". The length were designed so they intersected the cracks and extended 8' last the last crack. After the holes were drilled Cintec anchors which, are number 8 stainless steel rebar grade 2205 (1") encased in a patented sock were inserted to the holes and Cintec grout pumped into the sock. The cementious grout inflates the sock and locks the stainless steel rebar in place thought the full length of the drilled hole through the arch stones.
