Castle Ward House

Castle Ward House is situated near Strangford, Northern Ireland. The property was constructed in 1756.

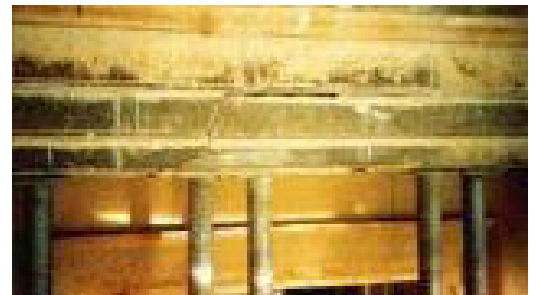
An inspection during the course of repairs revealed that one of the original timber beams in the area of the Tympanum had seriously decayed. This beam acted as a support for the upper stonework and a hanger for the lower stones. With this decay the lower stones had cracked and showed signs of falling out.

First sign of distressed beam

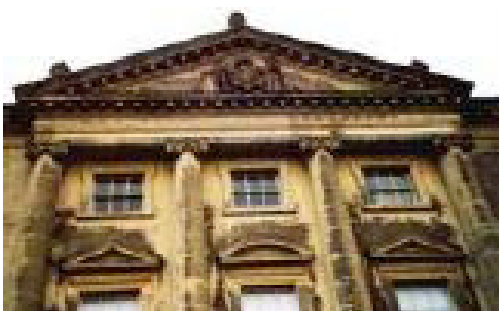
External upper beam area

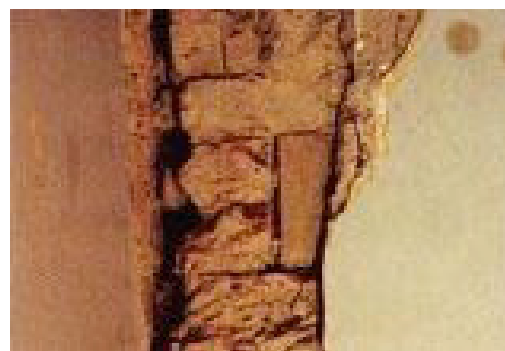
Internal damage of wooden beam

Because of the failure of the beam the immediate problem of support was solved by using 15x15x1000 mm SHS stainless steel anchors both horizontally and vertically.

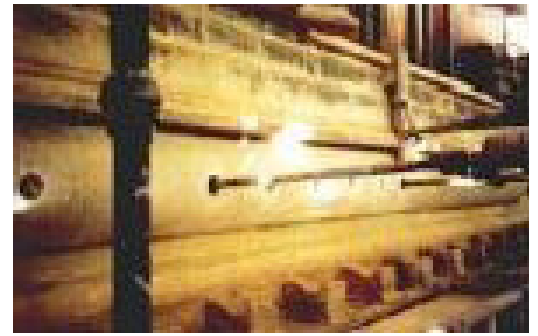
Drilling & securing stonework above beam

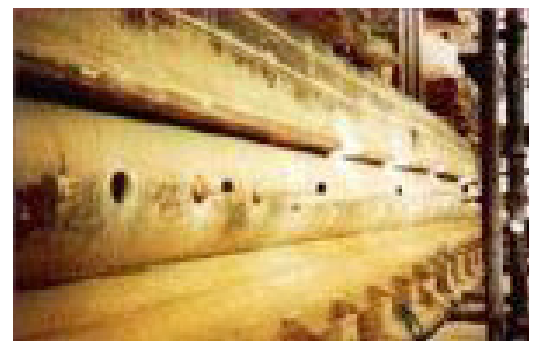
Anchor installation

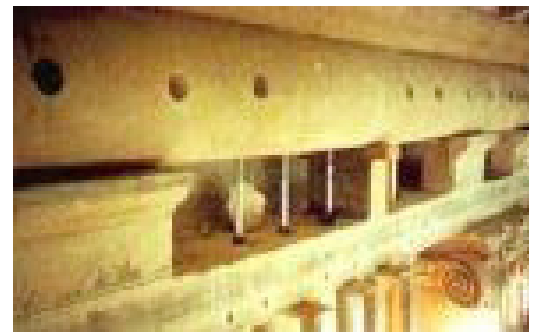
Entire length of 10 meters exposed

Drilling & securing stonework above beam The span of the original beam was 9 metres, across four vertical columns, so from the point of view of physically handling the replacement beam it was decided to construct three number three metre long beams.

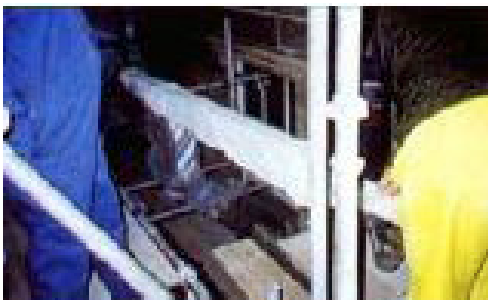
In-situ assembly of 100x100 mm stainless steel 10m anchor

These beams were constructed of 100mm x 100mm stainless steel box sections shrouded in a 300mm sock, with an outer sock for protection. These beams were slid into position and shuttering was installed to prevent grout overhang. 300 kgs of grout were pumped between the sock and the exterior of the beam to form a perfectly contoured support.

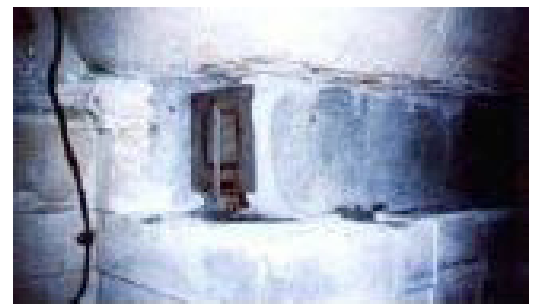
Beam after grout injection
