## **Post Earthquake Restoration**

### **Christ Church Cathedral**

#### **Newcastle, Australia**

# Earthquake damage repair and strengthening of Christ Church Cathedral, Newcastle NSW

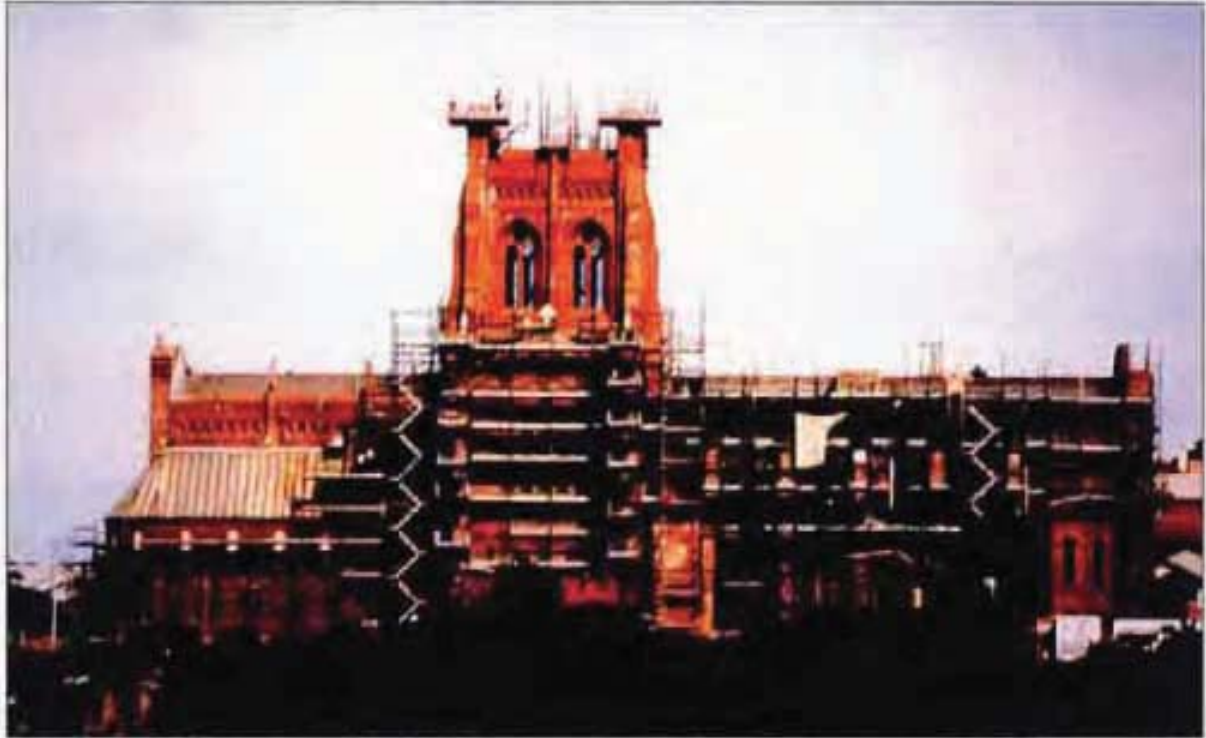
## CHRIST CHURCH CATHEDRAL – THE DAMAGE

The effect of the earthquake was largely as might be expected: high set stone crosses and other decorations fell to the ground, flying buttresses were dislodged, shear cracking occurred in the north and south walls and out-of-plane movements occurred in the east wall, dislodging windows.

(ICOMOS) principal derived from the world body's Venice Charter. To repair and strengthen the Cathedral, reinforcement of the walls was necessary, with least visual intrusion or damage to the existing fabric. Materials had to be found which were compatible with the masonry of the building and which ensure the long life for which cathedrals are noted.

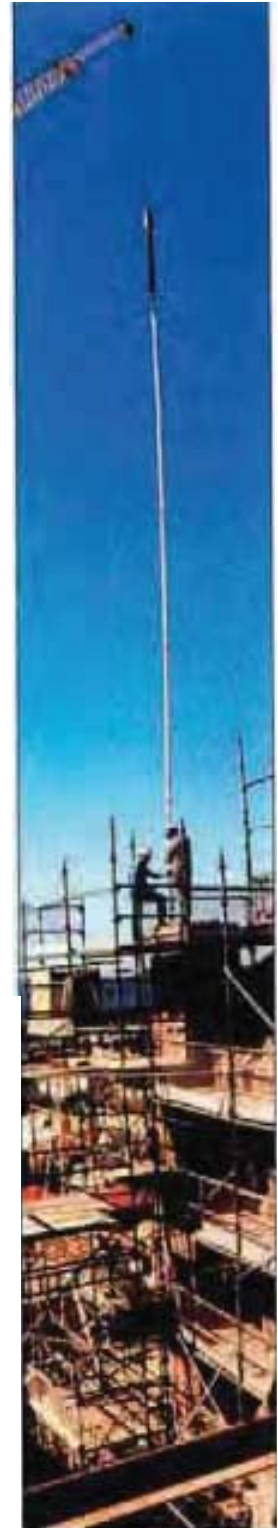
20 m vertical anchor being placed by crane in the project which saw anchors up to 32 m horizontally, Cintec's longest to date.

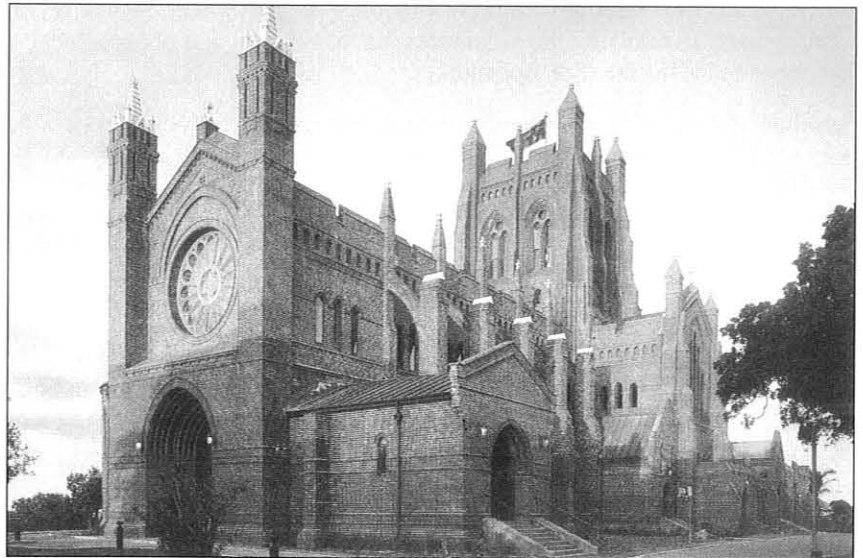
Figure 1: Christ Church Cathedral, Newcastle Australia, 1989

The effect of the earthquake on the building was largely as would be expected: high-set stone crosses and other decorations were dislodged and fell to the ground or lower roofs; flying buttresses were dislodged, but none fell completely away; shear cracking occurred in the nave walls which lie roughly parallel to the direction of the seismic wave and out-of-plane movements occurred in the east wall and dislodged windows. The degree of damage varied with the state of the brickwork with very little occurring in the tower structure, completed in 1979.

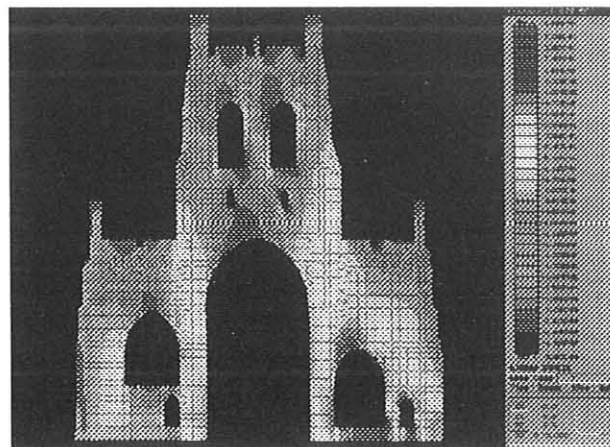
Figure 13: Typical FEA output

With the design parameters set (see Appendix) a two-dimensional finite element analysis was carried out using a readily available computer package ("Strand 6"). Different

combinations of reinforcement strength and spacing were considered and costed and, in the end, a high strength Grade 316 stainless steel deformed bar was used in sizes from 16 mm to 32 mm diameter. In order to limit the amount of drilling that had to be carried out "Hi-Proof" bar with UTS in range 790 to 920 MPa [N/mm<sup>2</sup>], depending on size, was specified. The total length of reinforcing installed was 3770 metres.

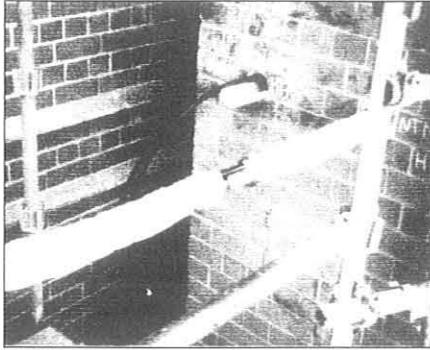
Figure 15: Horizontal anchors assembled during installation

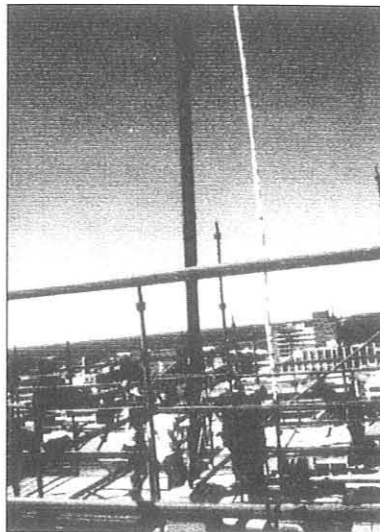
Figure 16: Vertical anchor installation by crane

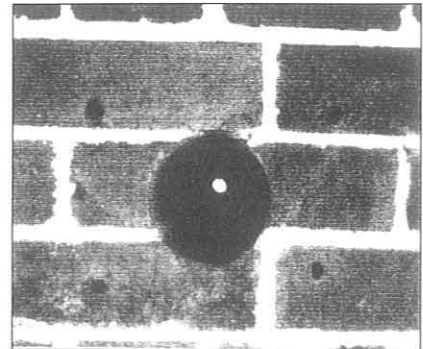
Figure 17: Finished installation prior to brickwork repair

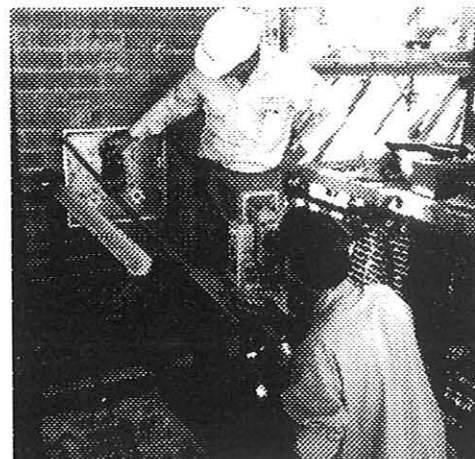
- an issue which proved to be an item of considerable dispute and cost variation, was the internal state of some brickwork — internal mortar jointing proved in some areas to be of extremely poor quality both in terms of its low strength and the non-existence of internal joint perpends resulting in internal brickwork collapse at the drill, drill blockages and difficulties in clearing of the drilling spoil — these problems were eventually overcome by down-the-hole grout injection to stabilise the masonry.

Figure 18: Drill hole survey
