Deansgate Viaduct, Manchester, U.K

"Key hole Surgery for Bridges"

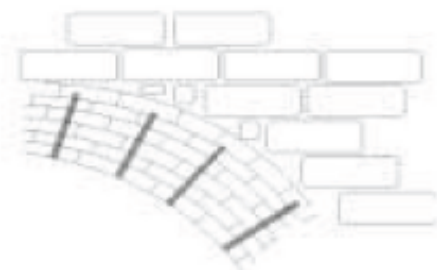
The busy Deansgate rail viaduct is situated in the heart of Manchester spanning numerous buildings, roads and canals. In 1997 the normal daily flow of railtraffic was disrupted by a destructive fire which took hold in a workshop located directly underneath. The subsequent heat generated by the blaze caused extensive damage and a weakening of the seven rings of masonry that form the arch barrels. The surface ring of brickwork completely delaminated and collapsed to the ground below.

A team of consulting engineers assessed the damage and recommended a Cintec reinforcement solution. Any remnants of the outer ring were completely removed and the remaining six rings were hammer tested to locate the extent and area of internal delamination.

Two arches were found to be in need of repair. In total

approximately 500, 24 inch long RAC Cintec anchors were installed, perpendicular to the arch and at spacings of 20 inches. The anchors were staggered to avoid the formation of sheer lines and because of their vertical aspect, each anchor was fitted with an air-vent tube to ensure full grout inflation without risk of air pockets being formed at their remote end. All anchors went no further than half way through the sixth ring so as not to puncture the original waterproof membrane that protects the arch barrel from the arch infill.

Finally the original appearance of the arches was restored by grouting an original piece from the drilled cores back into the mouth of each anchor hole. The completed work was rendered invisible to the naked eye and the viaduct was once again in operation servicing Deansgate station and the G-Mex conference centre.
