## St Bartholomew's Church, Foston, Leicestershire

On 13th June 2019, John Newton and Partners Group attended site to carry out an initial non-intrusive survey, documented in a report issued 8th July 2019.

On 24th December 2019, JNP Group attended site to inspect intrusive breaking out works by others, including trial pits and removal of plaster to internal faces of walls.

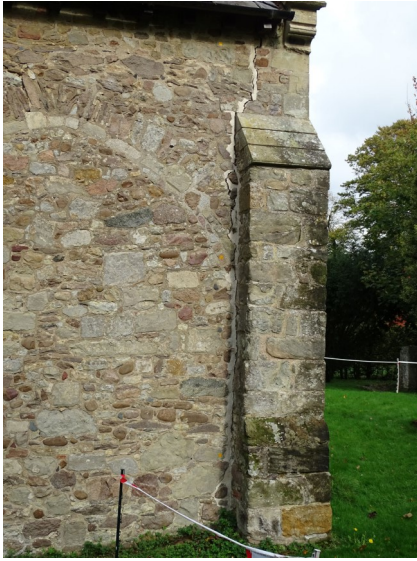
The south wall is experiencing eastwards movement as the east wall is pushed outwards by the lateral forces of the arches. The south wall is also being pushed southwards by the lateral loading from the chancel window arch. This is resulting in a general tendency for the structure to move towards the south east.

Above: South East corner.

It may be possible to provide adequate mass to resist lateral thrust of the external southern arches by tying the rubble infill within the arches to the arch structure and tying the walls together at the south eastern corner.

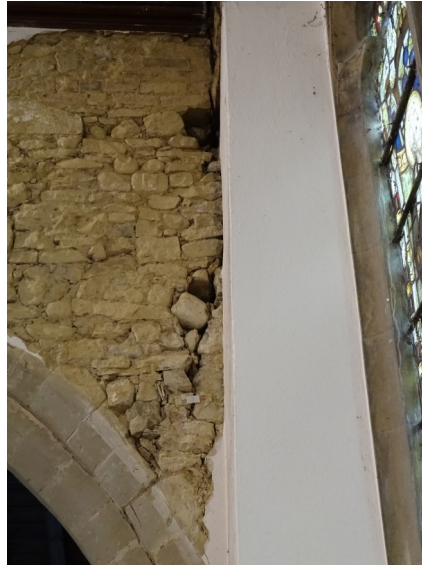
The northern row of arches is also experiencing eastern movement. The wall over the arches should be tied to the eastern wall.

North Chancel joining East Wall.

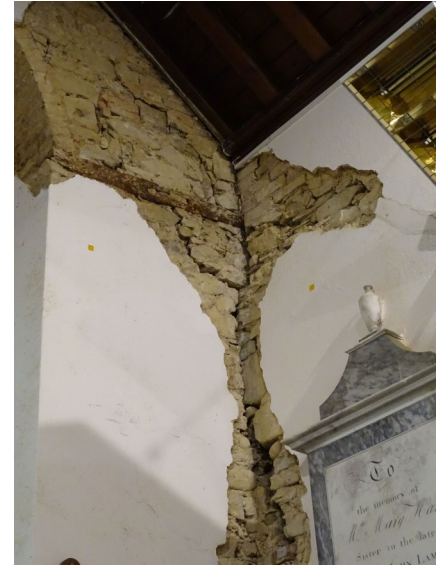
No buttressing has been provided to the eastern wall at the returns with the rows of arches. This is the only area of the church without buttressing at the ends of rows of arches

Junction of East and South walls.
