77 Howard Street, Toronto, Ontario, Canada

## Exterior wall restoration

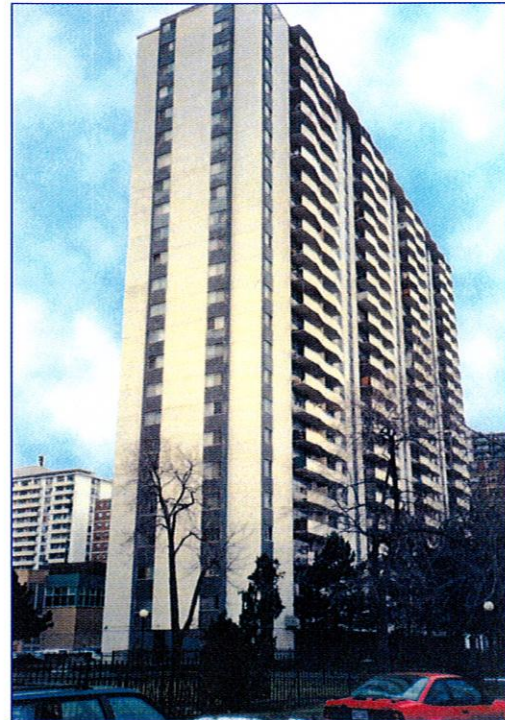
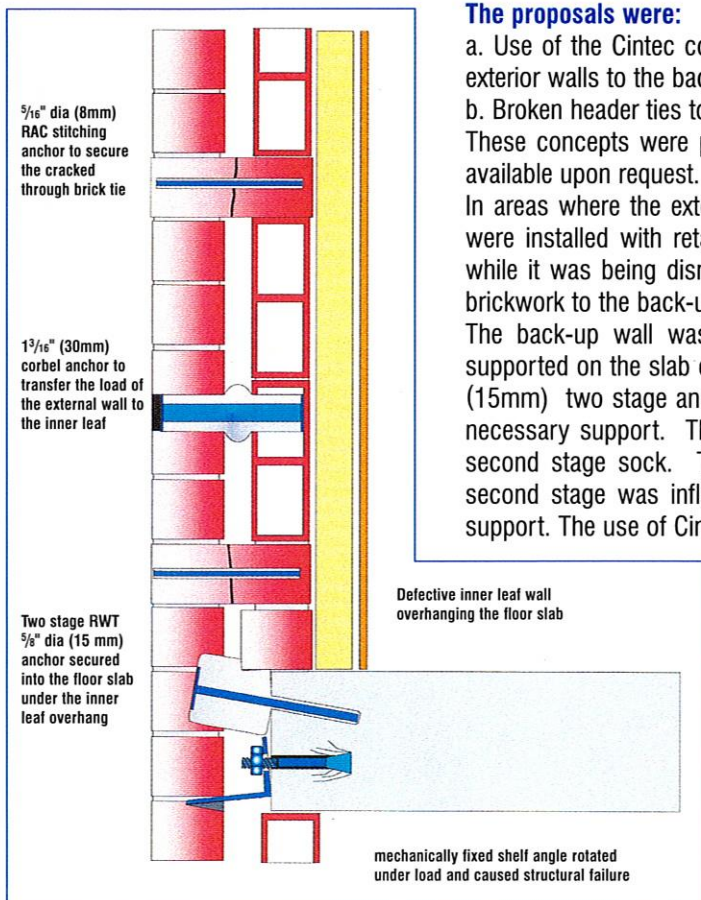
This 24-storey apartment block's exterior wall consists of two wythes tied together by courses of header bricks. The exterior wythe is a glazed clay brick and is supported by a painted steel shelf angle connected at each floor into the floor slab. The inner wythe consisted of a 4" (100mm) hollow concrete block back-up wall. Deterioration is due to vertical loads imposed by shortening of the structural frame. Lack of soft joints below the shelf angles to accommodate movement has resulted in;

1. Bowing of walls.
2. Crushing of over stressed units.
3. Shear failure of the header courses.
4. Rotation of shelf angles

Corrosion deterioration has also occurred in the shelf angles and connecting bolts. Due to occupation of the dwellings, complete replacement of the walls was impractical. Thus Halsall Associates in conjunction with Cintec Canada participated in the development of a stabilization strategy.

- a. Use of the Cintec corbel anchor to transfer vertical loads from the exterior walls to the back-up walls.
- b. Broken header ties to be restored using Cintec stitching anchors. These concepts were proven with full laboratory load tests. Results available upon request.

In areas where the exterior walls were beyond repair, Cintec anchors were installed with retaining plates to prevent collapse of the panel, while it was being dismantled. The anchor was used to tie the new brickwork to the back-up wall.

The back-up wall was found, during construction, to be not fully supported on the slab edge at some locations. A special RWT, 5/8" dia (15mm) two stage anchor was designed and supplied to provide the necessary support. This special two-stage anchor had an oversized second stage sock. This was secured into the floor slab, and the second stage was inflated under the inner leaf overhang to provide support. The use of Cintec anchors thus provided stabilization and
