## Masonry Wall Conservation

### SAINTE-ANNE D'OTTAWA CHURCH, BUILT IN 1873

*by John G. Cooke, Engineer*

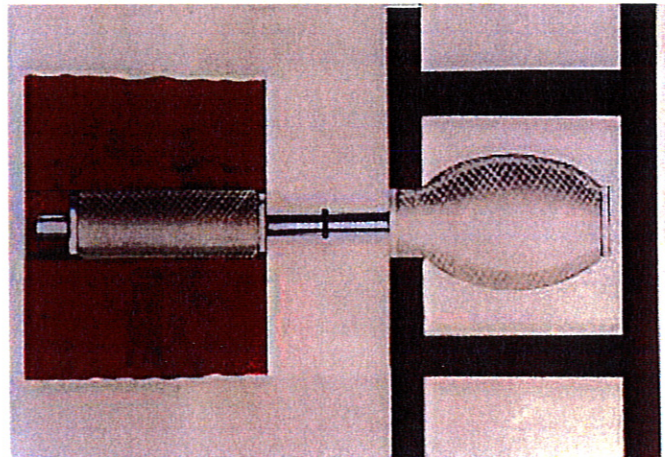
**PHOTO: CINTEC  
RAC FIXINGS  
FOR BRICK  
CAVITY WALL**
