CONSERVING A TERRA-COTTA CORNICE

A treatment report by Conservation Solutions, Inc., on a terra-cotta cornice adorning the Capitol Building in San Juan, Puerto Rico, shows the potentially catastrophic effects of corrosion in a marine environment, and offers some innovative solutions to the problem.

by Joseph Sembrat, Head Conservator and President of Conservation Solutions, Inc.

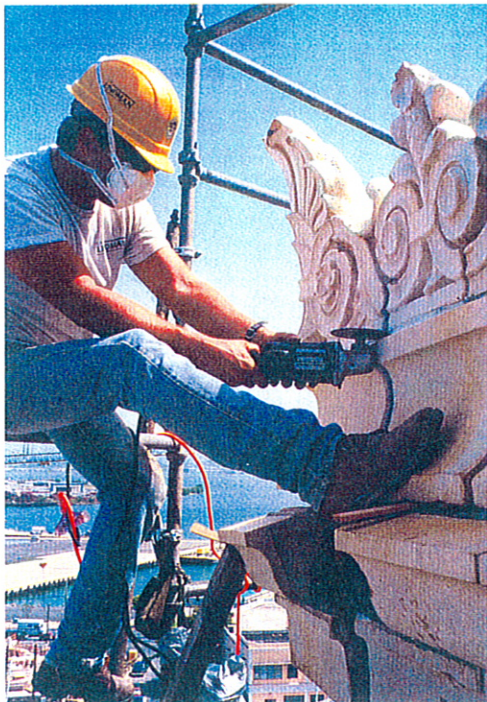
A worker is seen here cutting the mortar joints between the terra-cotta blocks in preparation for the disassembly of the cornice.

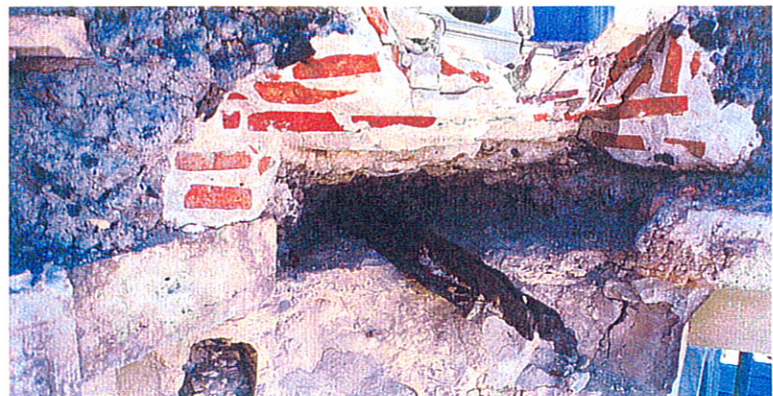
Once the cornice had been partially disassembled, the materials and techniques used in its construction could be easily identified. Note the clinker concrete, or "cindercrete," between the terra-cotta blocks and the brick backup material, and the severe deterioration of the steel supports. CSI recommended that all new steelwork be AISI Type 516 stainless steel, a non-corroding type, which is essential in this chloride-rich maritime environment.

As the careful cutting away commenced at the cornice's upper level, we found that the cornice was backed-up by a mass of "clinker concrete" or "cindercrete." This material is based on an aggregate of furnace ash and large fragments of clinker. Its use has been suspended for many years because the large quantities of sulfur compounds present in the ash and clinker have been found to cause severe corrosion of adjacent steel in the presence of moisture.
