# CONSERVING A TERRA-COTTA CORNICE

A treatment report by Conservation Solutions, Inc., on a terra-cotta cornice adorning the Capitol Building in San Juan, Puerto Rico, shows the potentially catastrophic effects of corrosion in a marine environment, and offers some innovative solutions to the problem.

by Joseph Sembrat, Head Conservator and President of Conservation Solutions, Inc.

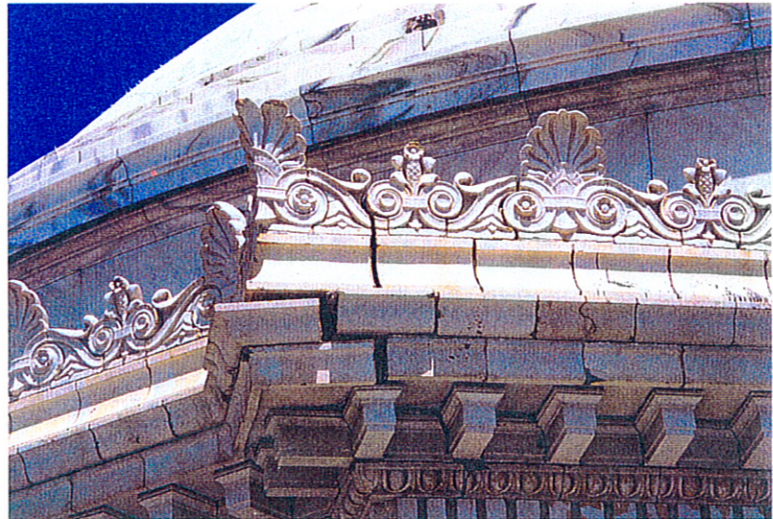
The poor condition of the terra-cotta cornice is evident in this view. The separation of the terra-cotta units is due to not only the failure of the anchoring system, but also the expansion of the corroded material.

Water had penetrated down into the cornice, and all its steel structural supports and anchors had been totally destroyed by corrosion. The total failure of the structural-support steel and anchor system had led to the structural failure of the cantilevered, and now unreinforced, terra-cotta cornice. The only reason that it had not collapsed was a combination of the cohesive and frictional effects of the mortar and brick fragments used as back-up to the hollow terra-cotta units.

Moisture had entered via open joints and cracks and, to a lesser extent, through leaks in the roof above and behind the cornice. The reason for the extreme corrosion of the steel was a combination of chlorides from sea spray and the sulfuric acid formed when saline moisture saturated and then passed through the contaminated cindercrete. The corrosion had been so severe that it was no longer possible to establish the exact dimensions of any of the former steel elements. Some had disappeared totally, leaving only rusty stains in the terra-cotta work.

It should be noted that any corrosion of embedded steel is associated with massive expansion of the corrosion products. In the case of the Capitol Building, this expansion had resulted, and will continue to result, in the shattering of the immediately adjacent terra cotta. Thus, all stabilization, conservation, and restoration work must involve the removal of all corroding steel and/or the prevention of any further corrosion and associated expansive effects. All new steelwork must be AISI Type 316 stainless steel, which is non-corroding in the chloride-rich maritime environment present here. AISI Type 304 stainless steel is attacked by chlorides and cannot be used here under any circumstances because it will corrode.

The extreme nature of the deterioration process was such that it will inevitably lead to catastrophic failure, with collapse of the terra cotta onto, and possibly through, the openings in the roof below. Accordingly, we recommended that all cracked and deformed areas of the cornice should be carefully dismantled as soon as possible. Shattered terra-cotta units should be replaced with high-quality matching new units from a well-established terra-cotta manufacturer such as Gladding, McBean of California. This firm has been in continuous practice since before the erection of the Capitol and is known for the high quality of its architectural terra cotta.
