Sainte-Anne D'Ottawa Church

EXISTING CONDITION

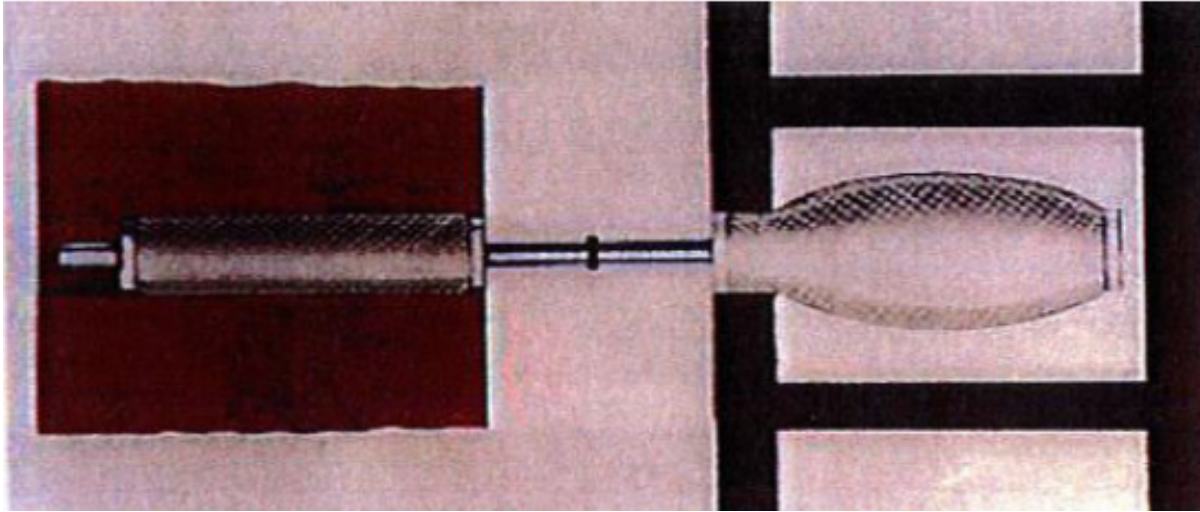
In the fall of 1990, Anrep Associates Ltd. were employed by the parish of Sainte-Anne d'Ottawa to investigate the cause of a serious bulge on the exterior face of the west transept wall. Upon investigation of the wall it was discovered that, on the inside face of the wall at the location of the bulge, there was a recess in the wall measuring 6' X 7' x 14' dp. approximately. Additional investigation revealed the same recess at the opposite end of the west transept wall and two similar recesses on the east transept wall. In one of the recesses in the east transept wall, part of the timber lintel over the opening had deteriorated due to moisture and failed. This resulted in a large amount of the rubble, between the interior and exterior stone wythes, falling into the recess.

The walls themselves consisted of two wythes of stone, with rubble and mortar in the centre. The walls were about 26" thick. Over time, the mortar in the centre had been reduced to sand. With constant weathering, freeze thaw cycles due to moisture penetration into the walls, and vibrations, the loose rubble worked its way down the wall, slowly acting like a wedge to pry the two stone wythes apart. This action eventually leads to the wall no longer acting as a single unit, but has two separate wythes acting independently. This results in a substantial weakening of the wall and eventual failure. It was our conclusion that this, in combination with the weakening effect of the recess, was the cause of the bulge. We recommended that the client shore the wall immediately until remedial work would be carried out. In addition, we were also concerned that the potential was high for the same condition to occur on the east wall.

1. Rebuild the four recesses (two in each transept wall) using a similar limestone, with a lime base mortar.
2. Anchor the two wythes of stone together using a CINTEC anchoring system.

3. Pressure grout the voids in the wall using a cementitious grout.
4. Rake out the existing joint mortar to a depth of approximately 55mm and repoint the wall using a Lime, White Non-Staining Portland Cement, sand mortar mix. At the client's request, the joints were retooled to match the profile of the mortar joints on the remainder of the structure.

5. At the corner where the bulge existed, the exterior wythe of masonry was stitched using CINTEC stitching anchors. The anchors were installed in holes drilled parallel to the exterior wall face in two directions, staggered, and spaced at 300mm on centre. These anchors were 3000mm long in one direction and 1200mm long in the other direction.

6. Below grade, where the mortar in the joints had deteriorated to sand, the joints were regouted as above grade, the face of the stone was parged, and a protective coating of a waterproof material was applied to the face of the parging.
