‘Stitching up’ the past – The strengthening of three heritage marine structures in Jersey with needling technology

The three structures are the North Pier and South Pier of St. Aubin’s Harbour and the St. Aubin’s Fort Breakwater. Both structures are exposed to waves from the south west and act as breakwaters. Both structures have suffered ongoing failures or unacceptable movements during the past decades, on the inner sheltered side of the breakwaters.

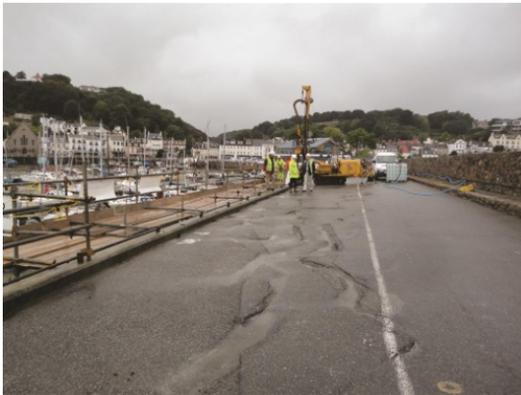
North Pier - cracks at deck level

In 2001 the North Pier was assessed as being in a state of instability due to movement of its internal wall and apparent settlement of the interior of the pier. The deck level of the North Pier is surfaced in asphalt which waterproofs the deck but also masks (to a certain extent) masonry movements. Large cracks however had developed and could be seen in the asphalt indicating a threat of impending

wedge failure of a section of the inner wall

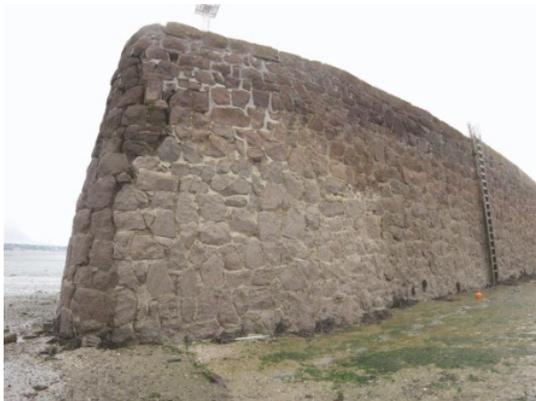
St Aubin’s Fort Breakwater has in turn suffered a re-occurrence of masonry movements and loss of pointing at its inner, lower deck wall.

In 2008 a bulge was also identified in part of this inner wall which prompted concerns about this part of the breakwater’s structural integrity.

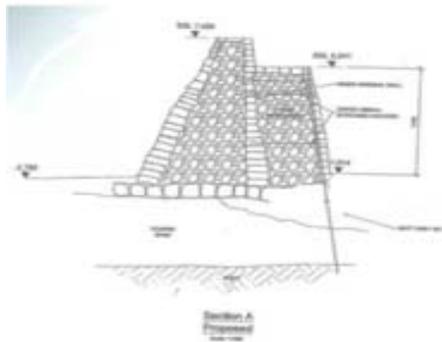
Figure 13 - St. Aubin's Fort inner wall ties and mini piles

The quality of the grout that was pumped into the end of the structure in 1972 was found (in 2009) to now be of deteriorating variable quality and consistency. However, it was not thought pragmatic or cost effective to dismantle this end of the lower deck structure and rebuild it in its original form, whilst the ‘stitching’ anchor solution provided clear benefits allowing the structure to be anchored and stitched together without changing its character and with minimal impact. In order to optimise the number of anchors, an iterative process was used, finding the optimum spacing to satisfy the onerous

load criteria imposed by the sea conditions in such an exposed location. Horizontal ties were inserted through the inner wall of the main breakwater so that the inside face wall of the lower deck was not only tied to the inner bulk of the original wall but also had additional cantilevered ‘beam’ support.
