Strengthening of the Charging Ramp Darby Furnace Coalbrookdale, UK

Synopsis

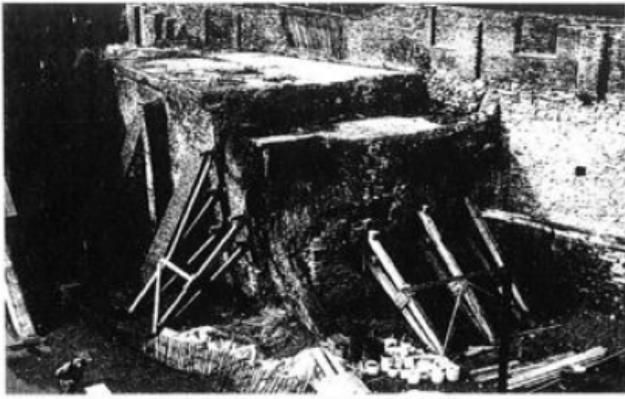
Fig 2. Condition of the charging ramp prior to restoration

The structure at this time was much as illustrated in Fig 2 - a filled masonry shell approximately 22m in length x 8m wide x 6-8m high, returning into the Darby furnace cover building, abutting and possibly buttressing the dam, with unknown internal construction and foundations. The external walls are built (or faced) with a mixture of random coursed sandstone blocks and brickwork.

The south wall consists of stone blocks up to a level 1.5-2.0m above ground where there is a clear delineation to brickwork. This entire length of the brickwork leans out at a maximum of 1 in 15 and some two-thirds of the length of the wall bulges noticeably vertically and horizontally. The reason for this characteristic deformation was to become clearer later on during the execution of the remedial work. The two large brick buttresses, 1.8m wide x 2.6m deep at the base, occur at approximately third points.

The east wall, which consists entirely of stone blocks, was reasonably plumb, though slight bulging was apparent towards the bottom. Bedding mortar had been extensively washed out from a large area at the top-left hand corner of this wall adjacent to the section that had failed. This was probably a contributory factor to the collapse, but the reason this area of masonry should have been affected in this way was not apparent at this time.

When the upper part of the southeast corner collapsed, two short lengths of wall were exposed at high level. As these were mutually buttressed and roughly vertical, they were probably in their original position. They certainly limited the extent of the collapse by continuing to retain the fill in the bulk of the structure. The rubble from the collapse had been sorted and put to one side.

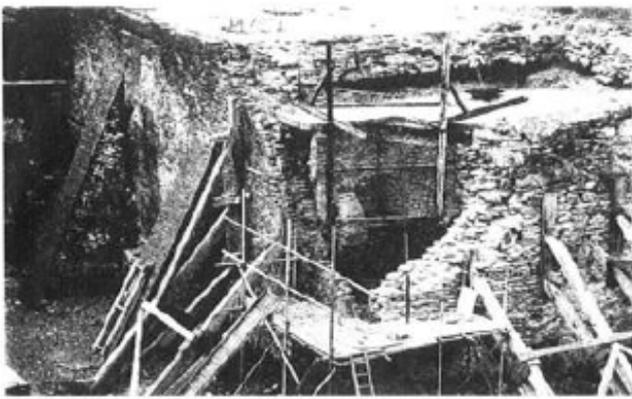
Fig 5. Southeast corner excavated prior to rebuilding

It was specified that the collapsed southeast corner had to be stabilised before ground anchors could be installed. The emptying of the remaining fill, carefully carried out by a combined team of contractors and archaeological staff, revealed the first unforeseen circumstance (Fig 5). An ill-fitting brickwork blocking low down in the eastern face of the excavation indicated a large vaulted chamber behind.

The collapsed section to be rebuilt would be stabilised by excavating the remaining fill in the corner to a suitable depth and replacing it with light-weight concrete. The new masonry would be tied to this block which would, in turn, be anchored back into the mass of fill.

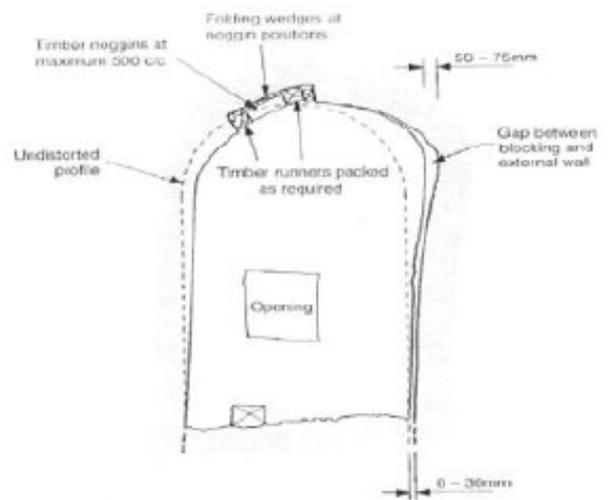
Fig 7. Typical profile of blockings and temporary stabilisation to crown within vaults

Upon inspection the vaults were found to be in a poor condition, with the inner of two rings progressively collapsing at the crown, indicating that a hinge had formed and that rotation had taken place due to spreading at the springings. Because the second vault ring was complete the vaults were relatively stable, but loss of bricks from this ring would almost certainly have initiated partial or complete collapse of the vaults.

Restoration work was undoubtedly required to the roof but, because this would be subject to a separate SMC could not be carried out before installation of the ground anchors. Temporary stabilisation was therefore achieved by replacing the missing masonry at crown with timber runners, noggins and folding wedges (Fig 7). Hand force was only specified for this work so as to minimise the effects on a delicate equilibrium.

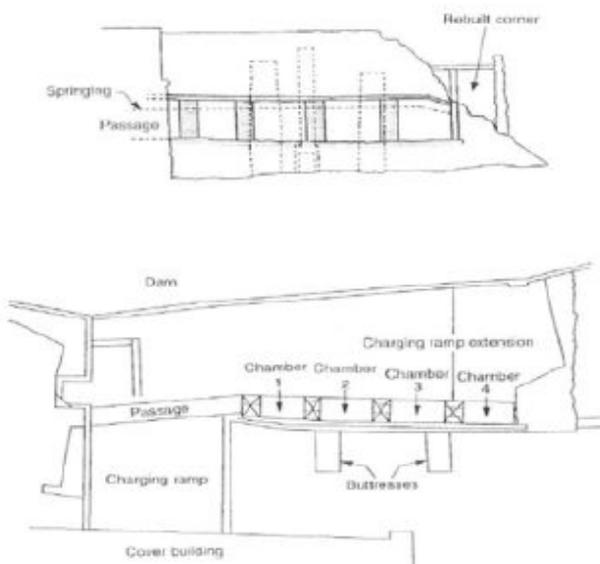
Fig 6. Vaulting, parallel to south wall

In fact a series of chambers, formally a vaulted passageway, had been discovered running along the edge of the structure, parallel to the south wall (Fig 6). The bottom of these chambers was level with the stone/brickwork delineation. They were a similar profile to the existing passageway visible in the west wall, of which they were obviously a continuation.

A small square opening was discovered in the blocking at the end of this passage which, when slightly enlarged, allowed tight access into the first of four chambers. The original passageway had three 550-850mm thick brick diaphragms, symmetrically positioned relative to the external buttresses, and therefore almost certainly added at the same time (ca 1880). The profile of these blockings (Fig 7) showed the considerable deformation that the vaults had already undergone at the time of their construction. The diaphragms had not been bonded or tied into the original walls and the horizontal and rotational movement of the structure subsequent to their installation was evident from the tapering gap between them and the external wall. A small opening in each blocking provided access to the next chamber.

The centre of the horizontal bulge apparent on the outside of the south wall approximated to the springing of the (originally) semi-circular vaulting.

A slight adjustment was all that was required to move the middle row of anchors on the south wall to the vault springing line. This seemed a sensible move since the thrust from the distorted arch could be picked up directly and general principle adopted was to reinforce the soil and masonry and tie together whilst modifying as little as possible their equilibrium.
