Strengthening of the charging ramp to the
Darby Furnace, Coalbrookdale

Paper reprinted from The Structural Engineer/Volume 74/No 4/20 February 1996

R. Dixon, BEng(Hons), CEng, MStructE
Scott Wilson Kirkpatrick

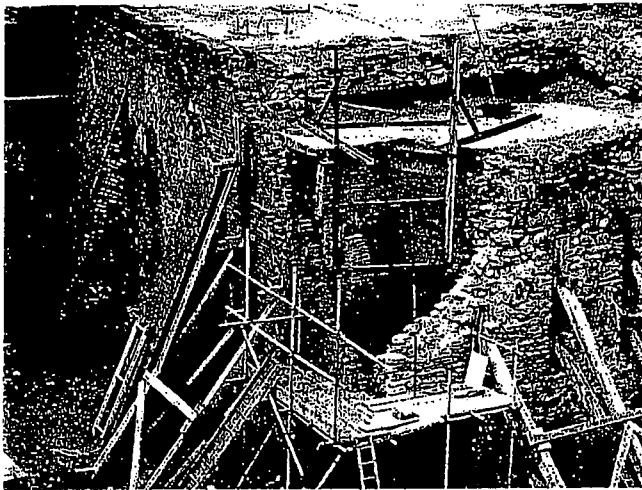
Fig 5. Southeast corner excavated prior to rebuilding

It was specified that the collapsed southeast corner had to be stabilised before ground anchors could be installed. The emptying of the remaining fill, carefully carried out by a combined team of contractors and archaeological staff, revealed the first unforeseen circumstance (Fig 5). An ill-fitting brickwork blocking low down in the eastern face of the excavation indicated a large vaulted chamber behind.

The rebuilding of the southeast corner continued uneventfully, with brickwork skilfully constructed to lean outwards and twisting in-plane to tie in with the existing. Bricks were reused to obtain as good a match as possible, and many trials carried out varying constituents, to blend new and ancient mortars.

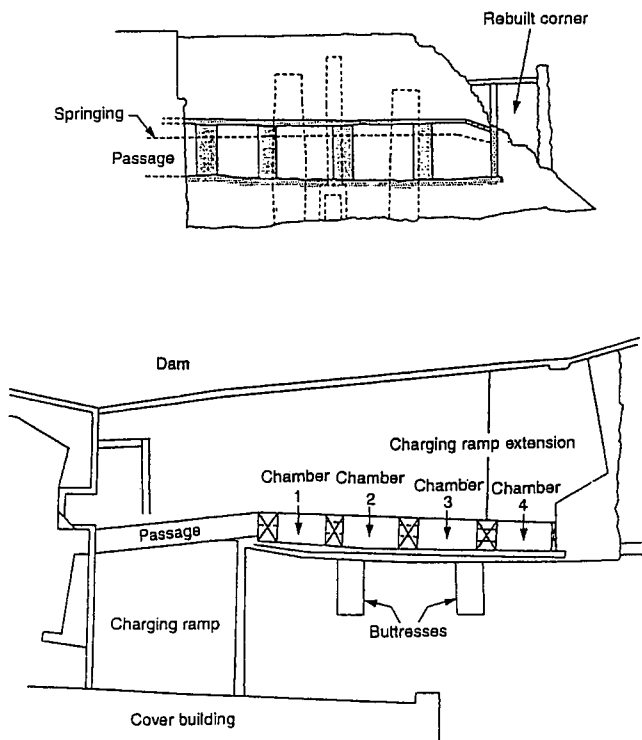
Fig 6. Vaulting, parallel to south wall

In fact a series of chambers, formally a vaulted passageway, had been discovered running along the edge of the structure, parallel to the south wall (Fig 6). The bottom of these chambers was level with the stone/brickwork delineation. They were of similar profile to the existing passageway visible in the west wall, of which they were obviously a continuation. A small square opening was discovered in the blocking at the end of this passage which, when slightly enlarged, allowed tight access into the first of four chambers. The original passageway had three 550-850mm-thick brick diaphragms, symmetrically positioned relative to the external buttresses, and therefore almost certainly added at the same time (ca 1880). The profile of these blockings (Fig 7) showed the considerable deformation that the vaults had already undergone at the time of their construction. The diaphragms had not been bonded or tied into the original walls, and the horizontal and rotational movement of the structure subsequent to their installation was evident from the tapering gap between them and the external wall. A small opening in each blocking provided access to the next chamber.

The centre of the horizontal bulge apparent on the outside of the south wall approximated to the springing of the (originally) semi-circular vaulting.

Upon inspection the vaults were found to be in a poor condition, with the inner of two rings progressively collapsing at the crown, indicating that a hinge had formed and that rotation had taken place due to spreading at the springings. Because the second vault ring was complete the vaults were relatively stable, but loss of bricks from this ring would almost certainly have initiated partial or complete collapse of the vaults.

Restoration work was undoubtedly required to the roof but, because this would be subject to a separate SMC, could not be carried out before installation of the ground anchors. Temporary stabilisation was therefore achieved by replacing the missing masonry at crown with timber runners, noggins and folding wedges (Fig 7). Hand force only was specified for this work so as to minimise the effects on a delicate equilibrium.

A slight adjustment was all that was required to move the middle row of anchors on the south wall to the vault springing line. This seemed a sensible move since the thrust from the distorted arch could be picked up directly and

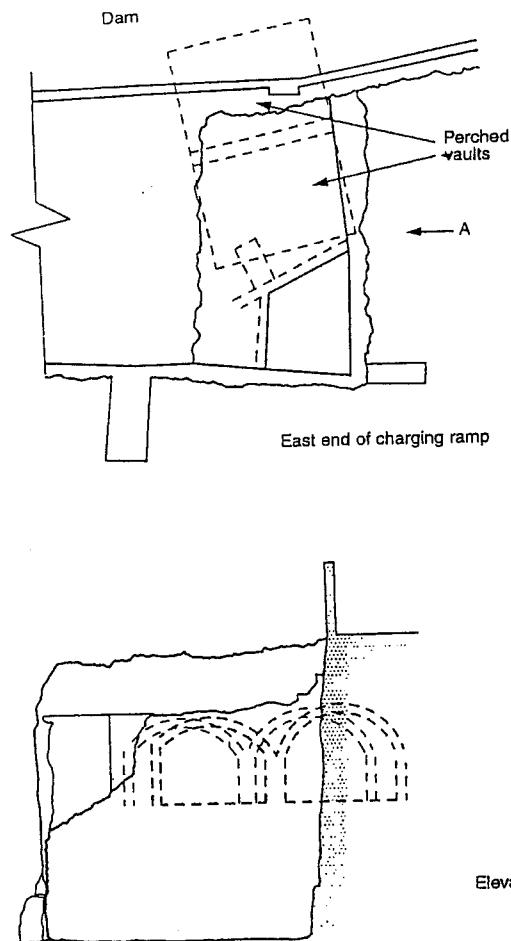
Fig 8. Vaulting, high level at east end

Two large brick vaults had been discovered perched at high level at the extreme east end of the structure (Fig 8). These were skewed, had been truncated and faced with the upper section of stonework to the east wall. Part of the north vault projected into the south face of the dam. They were clearly from an earlier, unrecorded structure.

At their southern end the springing was partly buttressed by the previously unexplained walls 'hanging' at high level in the southeast corner. This arrangement had been channelling rainwater to the top left-hand corner of the east wall, causing the area of washed-out mortar that had been observed and contributing to the collapse.

holes drilled in the mortar joints, revealed that the brickwork appeared to be complete and in good condition. Later, good visual access was obtained to the southern vault confirming this to be the case.

No remedial work was required to these vaults and, after recording by the archaeologists, they were simply left void and covered by the new slab.
