## The Madrasa & Kanqah Of Sultan Al-Ghuri, Cairo Egypt

The Madrasa and Khanqah of Sultan al-Ghuri is one of the Mohammedan monuments under the care of Egyptian Antiquities Organization. It dates back to 909-10 Ah 1503-4 AD.

# The Repair

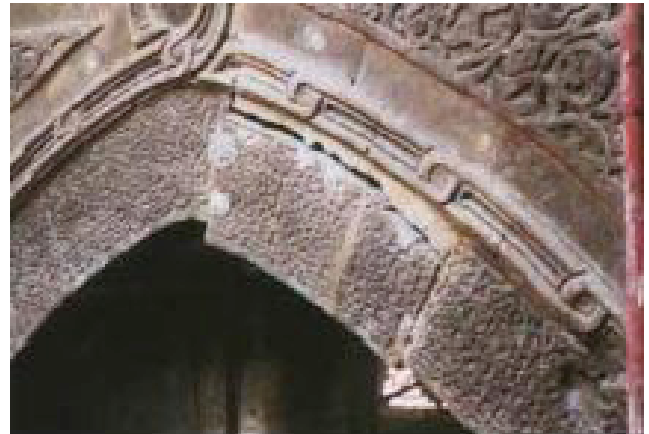
An inspection of the Madrasa reveal some very severe longstanding problems. The floor of the mosque undulated dramatically, providing evidence of very significant foundation problems of the masonry vaults supporting the floor. Attempts had been made in the past to underpin the sleeper walls supporting the vaults, these had failed. All the walls of the Mosque exhibited very severe fractures. The problems were brought about by earthquake damage in October 1992 and by the rising contaminated ground water. Further problems in the external walls had been caused by the activities of the shopkeepers trying to enlarge the space available for selling their wares.

Seismic damage to decorative arches

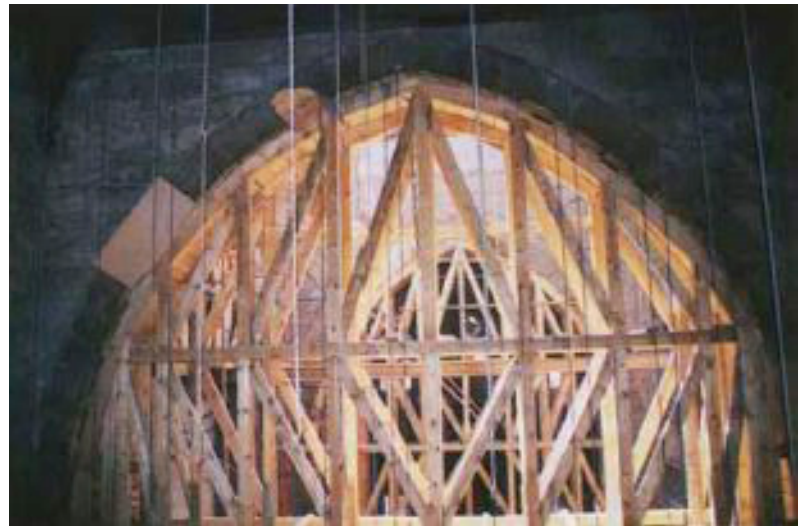
Temporary support of the Dikka arches

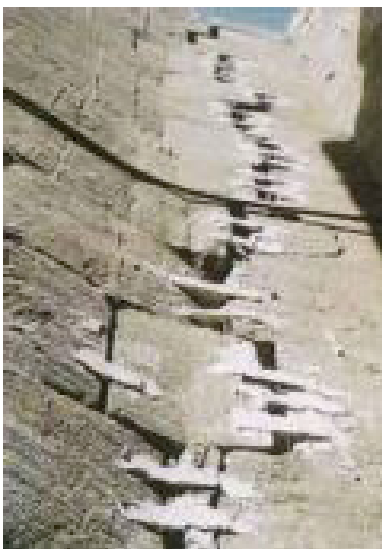
The very high walls were laterally unrestrained and very vulnerable to lateral forces such as may be produced by the next earthquake.

Vertical shear crack

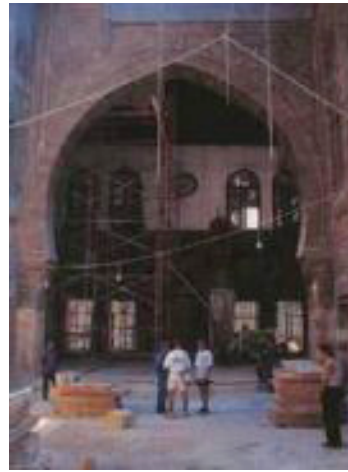
Dikka arch in the main courtyard

The Cintec stitching system was extensively used at Al-Ghuri. These reinforcement anchors, up to 12 meters long, serve to stiffen each individual wall immensely. The walls of Al-Ghuri are generally of two facing skins in-filled with a core of rubble. The large arched openings in the mosque are particular points of weakness in the structure.

Longitudinal ties in each of the stone facings of the wall above the arch would serve to resist the thrusts naturally produced by the arch as well as serving to assist the walls to resist the next earthquake. In addition to longitudinal ties, transverse ties of length equal to the thickness of the wall were introduced to increase the strength of the wall.
