Windsor Castle

Report by Richard Swift

WINDSOR CASTLE

Structural Conservation and Monumental Disasters

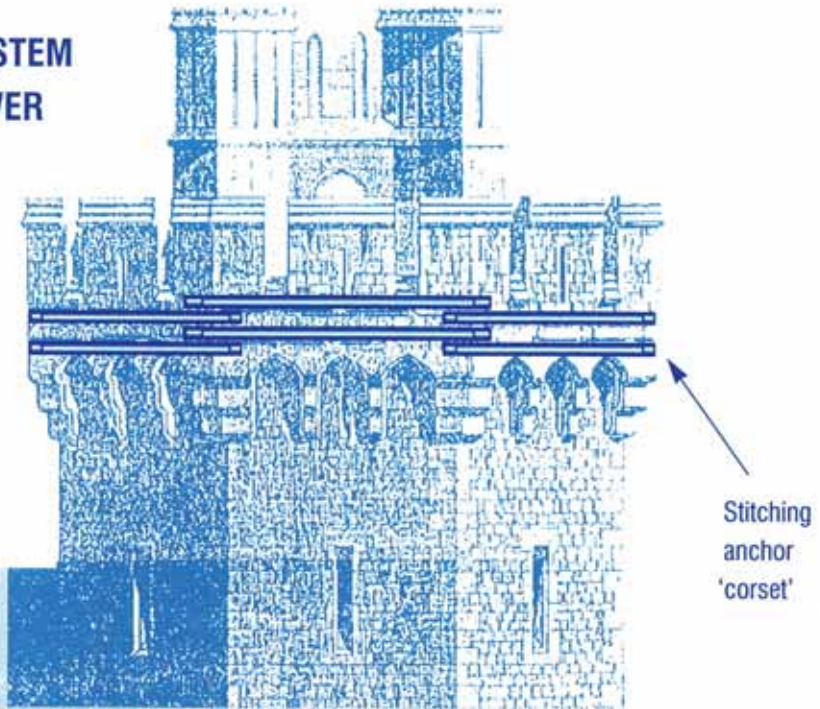
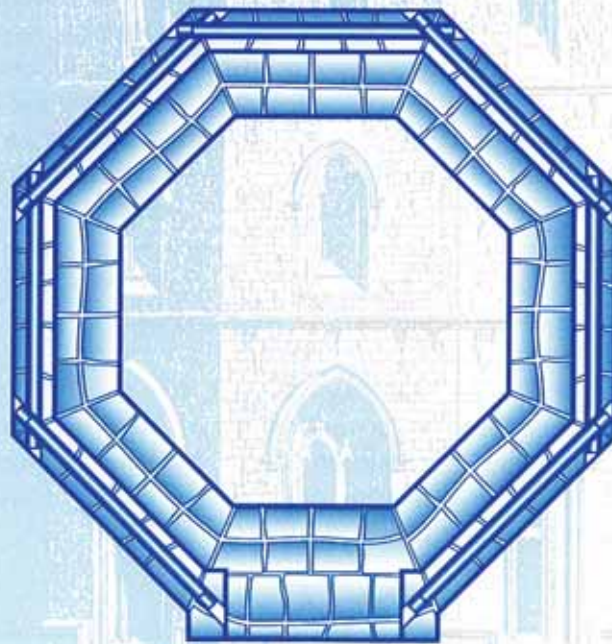
THE CINTEC ANCHOR SYSTEM AT THE BRUNSWICK TOWER WINDSOR CASTLE –

The CINTEC anchor was also used at the top of Brunswick Tower, where the fire had resulted in the movement of the crenellated parapet. The merlons had rotated outwards like opening up the segments of an orange. Initially it was considered that the only effective means of repair was the complete taking down and rebuilding of the parapet. This would involve loss of the patina of age and important architectural details of joint relationships and historic stone faces. An alternative solution was proposed, which involved the installation of CINTEC anchors like a corset around the faces of the Octagonal Tower. Holes of 40mm diameter were drilled, to accommodate the 20mm anchor body, at the centre of the thickness of the parapet. The anchor was installed and grouted and the entry hole pointed up so that there was little evidence of the remedial work. The movement cracks which had been created by the fire were monitored over a period of time to ensure that the anchors were effective in preventing any further movement.

The latest Diamond Drilling Techniques were used to create a network of holes within the stonework.

The Cintec Anchors were then installed creating a reinforcing ring, within the fabric of the stonework, maintaining the original appearance of the tower.

The illustration shows the arrangement of anchors used in the restoration of the Brunswick Tower.
