## Windsor Castle - The Brunswick Tower

Report by Richard Swift

# WINDSOR CASTLE

## Structural Conservation and Monumental Disasters

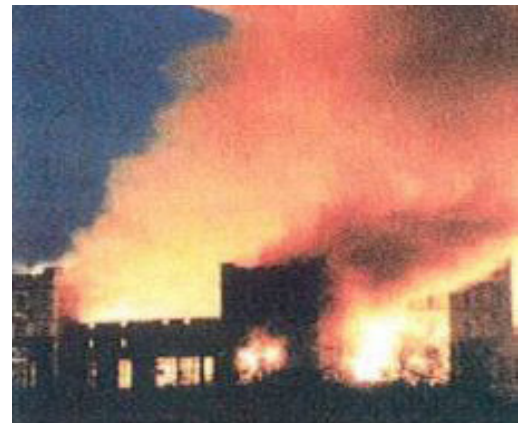
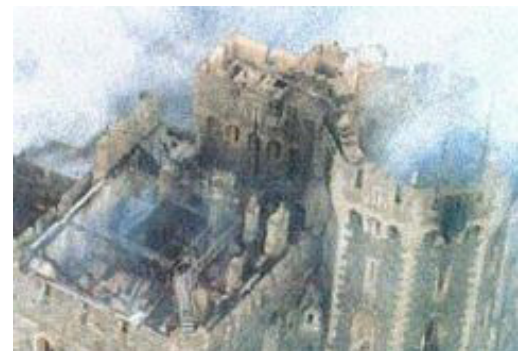
Windsor Castle - The Brunswick Tower The latest Diamond Drilling Techniques were used to create a network of holes within the stonework. The Cintec Anchors and reinforcement system were then installed creating a reinforcing ring, within the fabric of the stonework, maintaining the original appearance of the tower.

The CINTEC anchor was also used at the top of Brunswick Tower, where the fire had resulted in the movement of the crenellated parapet. The merlons had rotated outwards like opening up the segments of an orange. Initially it was considered that the only effective means of repair was the complete taking down and rebuilding of the parapet. This would involve loss of the patina of age and important architectural details of joint relationships and historic stone faces. An alternative solution was proposed, which involved the installation of CINTEC anchors like a corset around the faces of the Octagonal Tower. Holes of 40mm diameter were drilled, to accommodate the 20mm anchor body, at the centre of the thickness of the parapet. The anchor was installed and grouted and the entry hole pointed up so that there was little evidence of the remedial work. The movement cracks which had been created by the fire were monitored over a period of time to ensure that the anchors were effective in preventing any further movement.

Initially there seemed little choice but to dismantle and rebuild the top section of the tower. However the versatility of the Cintec Anchoring and Reinforcement System enabled the Engineers to design a repair solution that restored the structural integrity without further disruption to the unstable stonework.

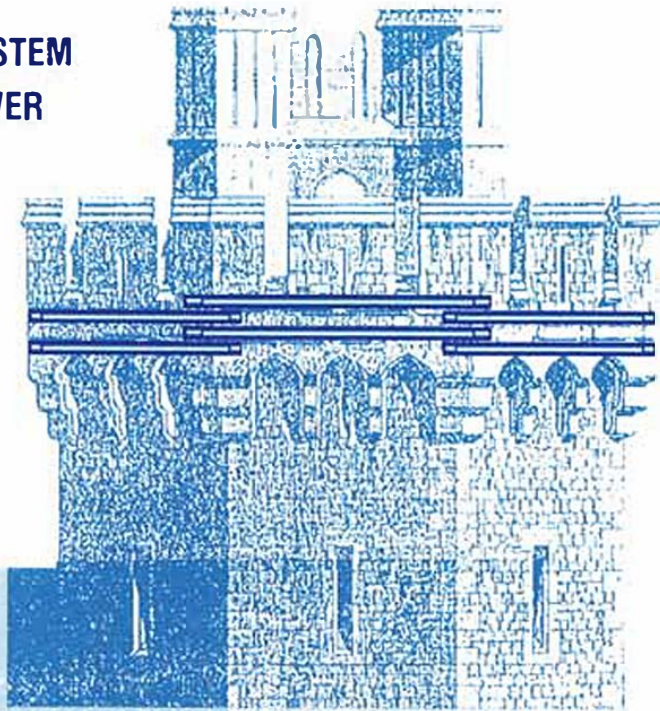
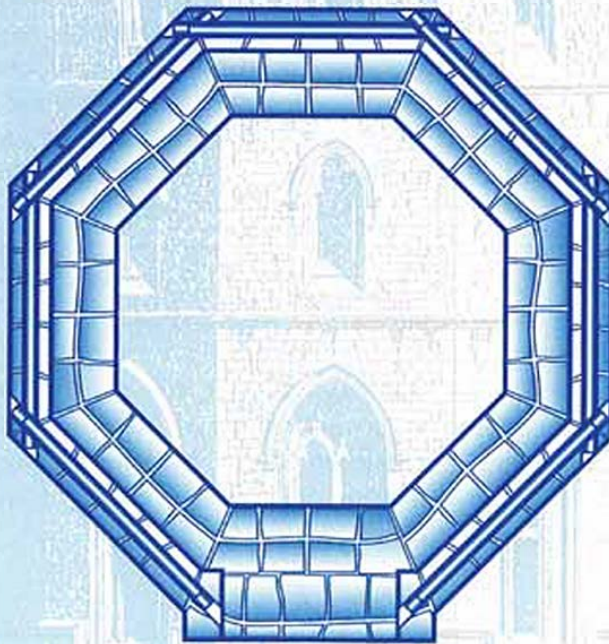
Stitching  
anchor  
'corset'

The illustration shows the arrangement of anchors used in the restoration of the Brunswick Tower.

The latest Diamond Drilling Techniques were used to create a network of holes within the stonework.

The Cintec Anchors were then installed creating a reinforcing ring, within the fabric of the stonework, maintaining the original appearance of the tower.
