# CONSERVING A TERRA-COTTA CORNICE

A treatment report by Conservation Solutions, Inc., on a terra-cotta cornice adorning the Capitol Building in San Juan, Puerto Rico, shows the potentially catastrophic effects of corrosion in a marine environment, and offers some innovative solutions to the problem.

by Joseph Sembrat, Head Conservator and President of Conservation Solutions, Inc.

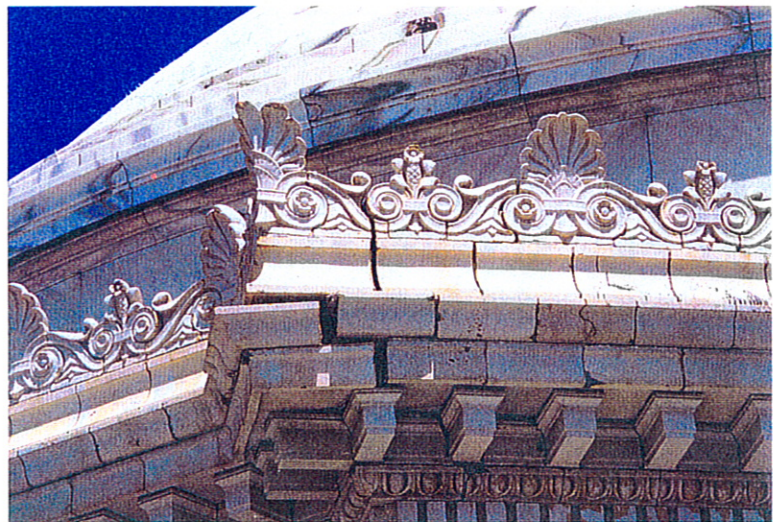
The poor condition of the terra-cotta cornice is evident in this view. The separation of the terra-cotta units is due to not only the failure of the anchoring system, but also the expansion of the corroded material.

Water had penetrated down into the cornice, and all its steel structural supports and anchors had been totally destroyed by corrosion. The total failure of the structural-support steel and anchor system had led to the structural failure of the cantilevered, and now unreinforced, terra-cotta cornice. The only reason that it had not collapsed was a combination of the cohesive and frictional effects of the mortar and brick fragments used as back-up to the hollow terra-cotta units.

Moisture had entered via open joints and cracks and, to a lesser extent, through leaks in the roof above and behind the cornice. The reason for the extreme corrosion of the steel was a combination of chlorides from sea spray and the sulfuric acid formed when saline moisture saturated and then passed through the contaminated cindercrete. The corrosion had been so severe that it was no longer possible to establish the exact dimensions of any of the former steel elements. Some had disappeared totally, leaving only rusty stains in the terra-cotta work.

It should be noted that any corrosion of embedded steel is associated with massive expansion of the corrosion products. In the case of the Capitol Building, this expansion had resulted, and will continue to result, in the shattering of the immediately adjacent terra cotta. Thus, all stabilization, conservation, and restoration work must involve the removal of all corroding steel and/or the prevention of any further corrosion and associated expansive effects. All new steelwork must be AISI Type 316 stainless steel, which is non-corroding in the chloride-rich maritime environment present here. AISI Type 304 stainless steel is attacked by chlorides and cannot be used here under any circumstances because it will corrode.

The extreme nature of the deterioration process was such that it will inevitably lead to catastrophic failure, with collapse of the terra cotta onto, and possibly through, the openings in the roof below. Accordingly, we recommended that all cracked and deformed areas of the cornice should be carefully dismantled as soon as possible. Shattered terra-cotta units should be replaced with high-quality matching new units from a well-established terra-cotta manufacturer such as Gladding, McBean of California. This firm has been in continuous practice since before the erection of the Capitol and is known for the high quality of its architectural terra cotta.

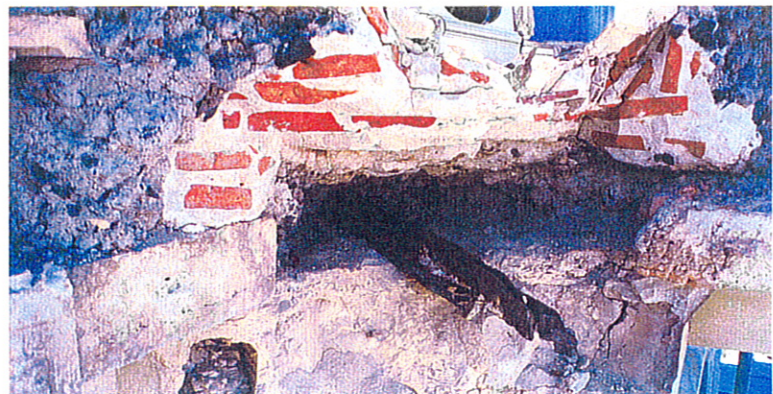
Once the cornice had been partially disassembled, the materials and techniques used in its construction could be easily identified. Note the clinker concrete, or "cindercrete," between the terra-cotta blocks and the brick backup material, and the severe deterioration of the steel supports. CSI recommended that all new steelwork be AISI Type 316 stainless steel, a non-corroding type, which is essential in this chloride-rich maritime environment.

As the careful cutting away commenced at the cornice's upper level, we found that the cornice was backed-up by a mass of "clinker concrete" or "cindercrete." This material is based on an aggregate of furnace ash and large fragments of clinker. Its use has been suspended for many years because the large quantities of sulfur compounds present in the ash and clinker have been found to cause severe corrosion of adjacent steel in the presence of moisture.
