Pont Telpyn bridge links the A525 at Rhewl with the B5429 and crosses the river Clywd. In 2008 during strengthening works the bridge suffered severe flood damage and was very near complete collapse, the only saving grace was that Cintec Archtec anchors were in the process of being installed , the installed anchors prevented the complete collapse of the bridge.

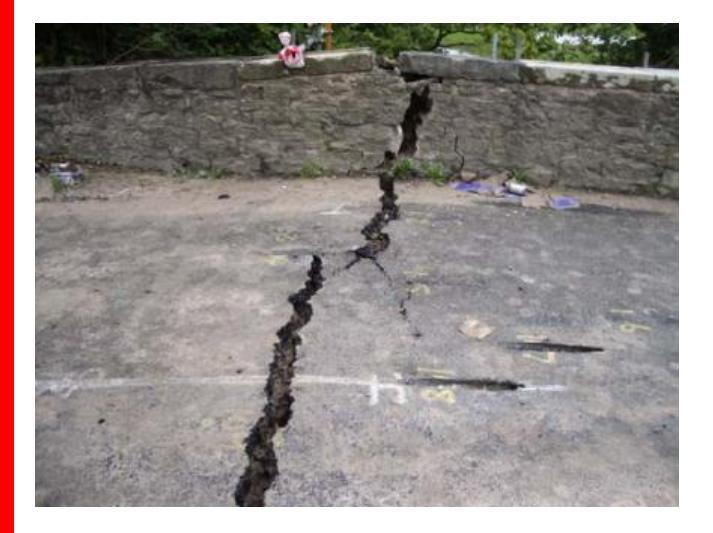
The east abutment appeared to be intact with no movement or cracking identified. The west abutment appeared to be intact at the upstream elevation. At the downstream elevation there was a large amount of dilatency of the masonry, with severe cracking and evidence of movement on both faces.

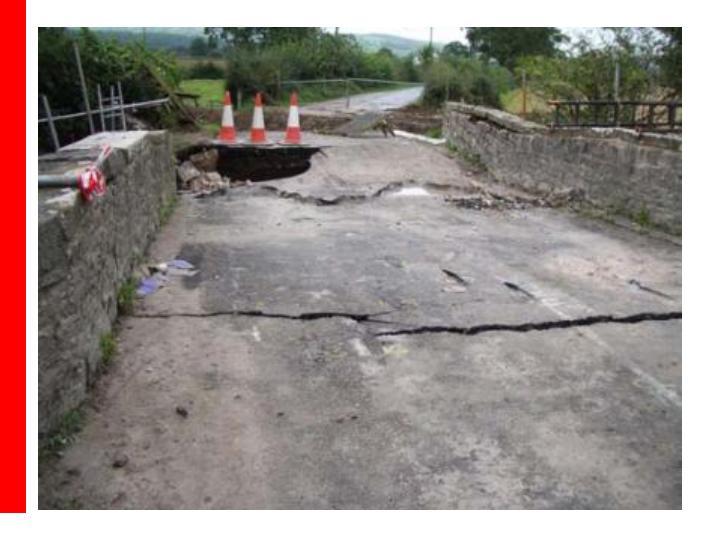
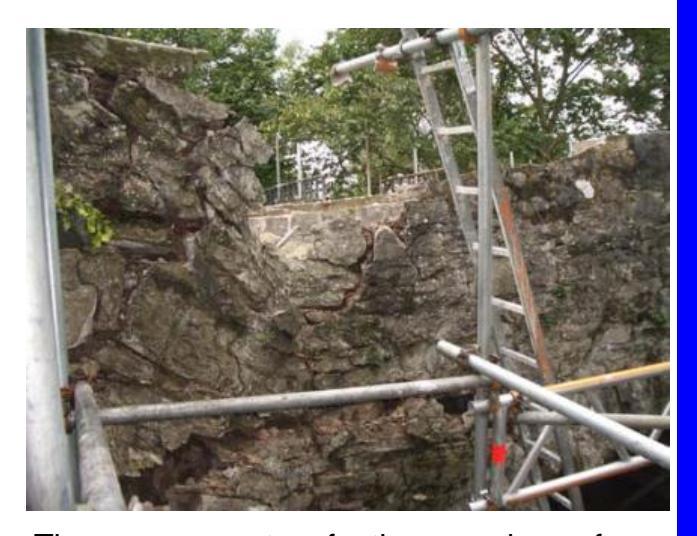
The movement of the road surface suggested that the arch barrel had rotated up to 4.5 degrees about the east springing. There was distortion of the arch barrel due to differential movement, resulting in a shear crack at the west upstream corner. The fact that this corner is lower than the adjacent arch barrel suggested that the abutment dropped vertically at this corner, followed by the adjacent arch barrel. Apart from this south west corner, the arch barrel was in reasonable condition.

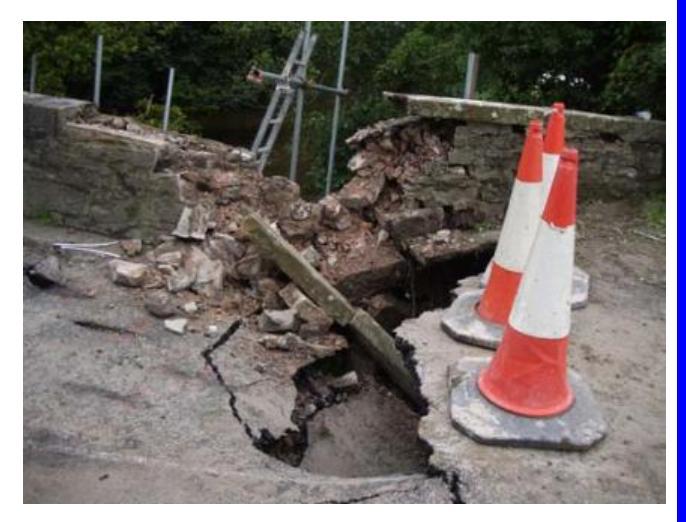
The damage to the upstream spandrel and parapet was mainly limited to the large area of damage above the west abutment and a significant crack above the east abutment. Damage to the downstream spandrel and parapet was more widespread, with cracking through mortar joints almost throughout the length of the wall.

The road surface showed three main failures, indicating tension failure above the east abutment, compression failure above the west springing and shear failure to the west of the bridge.

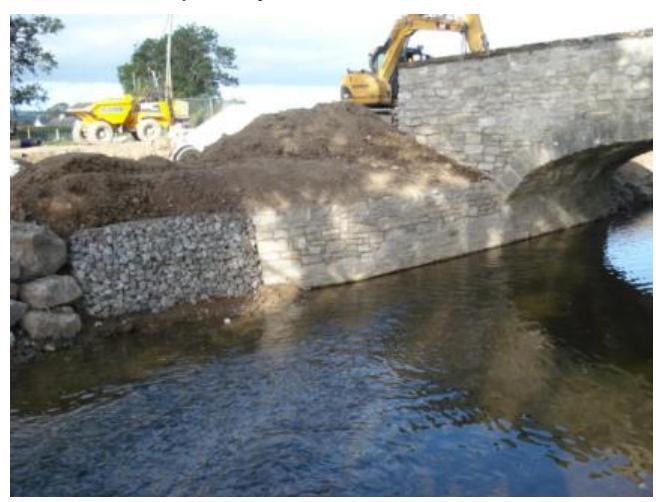
The flood had caused the abutment to move which necessitated the complete removal of the abutment and providing a new foundation and concrete abutment, which was subsequently faced with stone.
