Strengthening a stone arch bridge

New Technology helps maintain historic charm

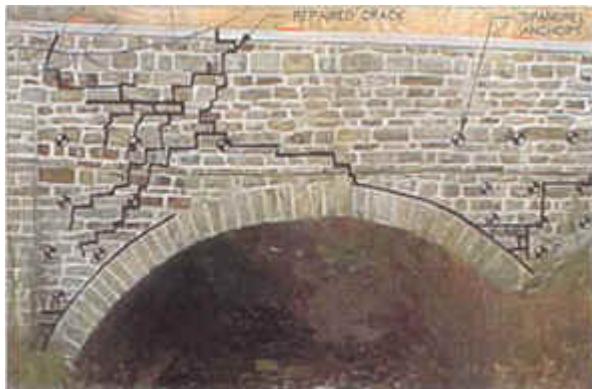
Figure 1: View of south spandrel wall showing the location of repaired cracks and remedial spandrel anchors.

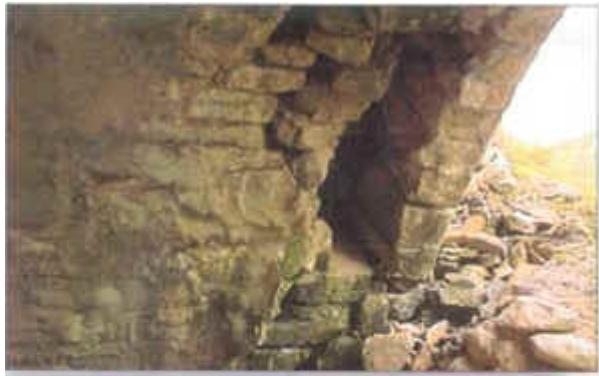
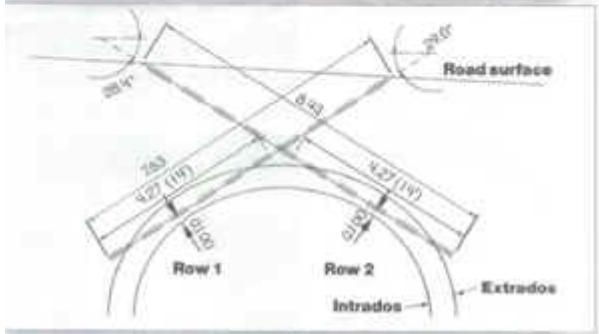
Figure 2: (top) Severe deterioration at Southwest corner showing separation of spandrel wall from arch barrel and resulting void. Figure 3: (bottom) Section through arch showing typical ARCHTEC strengthening anchors installed tangent to intrados at quarter span (dimensions shown are in meters).
