CASE HISTORY

HEMSLEY BUILDING 230 PARK AVENUE, NY, NY U.S.A.: TERRACOTTA REPAIR

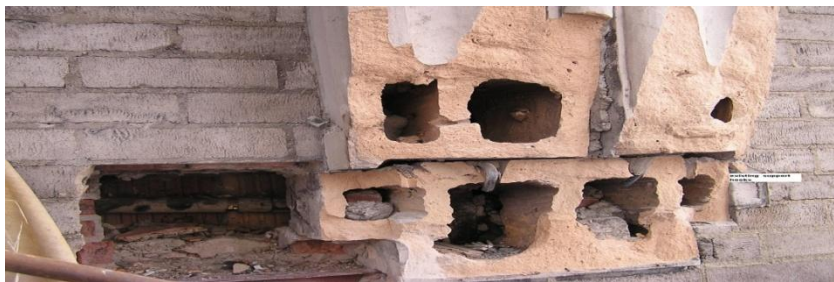
By 2009, the building had begun to show its age. At the top of the building some of the twenty-six east and south facing Terra-Cotta columns [with the base starting at the 26th floor and extending past the 34th floor] had begun to show cracking and in some areas had begun to shed large pieces of stone. The building owners/management had inquired as to replacement cost of these Terra-cotta Brackets and had been quoted prices exceeding 16 Million dollars. By employing the Cintec method of repair, the owner was able to save more than 15 million Dollars effecting by repairs for just over 1million dollars.

Cintec in North America was contacted by Thornton Tomasetti Engineering Corporation to find a solution to this issue, working together Cintec North America and Tomasetti Engineering Corporation formulated a plan. Through exploratory probes and use of a borescope it was assessed that the structure behind the columns (staked brick) was sound, given this assessment it was decided that all that would be needed would be to attach the Cintec Anchoring System to the backup and tie it to front face of stone that was sound in order not only to strengthen the attachment to face but to create additional points of contact in the stone face brackets that were sound. This was achieved by drilling oversized holes through the face of the stone and recessing the anchor 1" from face of stone to accommodate a finish patch, thus creating an invisible repair. The ability to tie the face of the original Terra-cotta panels to the back up wall saved the integrity of the landmark building.
