CASE HISTORY

NORTH OR RED PYRAMID AT DAHSHAR, CAIRO, EGYPT

NORTH OR RED PYRAMID AT DAHSHAR, CAIRO, EGYPT - THE PROBLEM

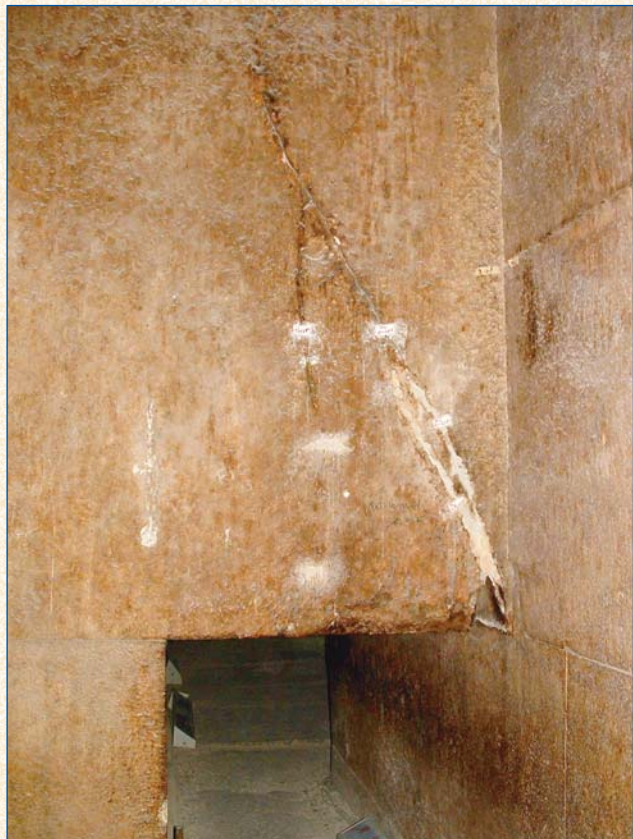
Front elevation of cracked beam

The present problem was not on the exterior of the pyramid but one on the corridor between the corbelled burial chambers. The beams spanning the low corridor opening were cracked, from the base of the stone beams, up through the centre of the beams, to a position just adjacent to the centre at the top of these stone beams. It was impossible to drill at right angles to the corridor due to the mass of the core of the pyramid. However, it was possible to drill at an angle of 43 degrees in the respective burial chambers at both the entrance and exit of the corridor and secure the beam with a row of 20mm diameter Cintec stainless steel consolidation anchors. Work was completed at night after the monument was closed to the public because the position of

the burial chamber was some 60 metres down a 45 degree slope and a dust extraction unit and breathing apparatus was required by the operatives.

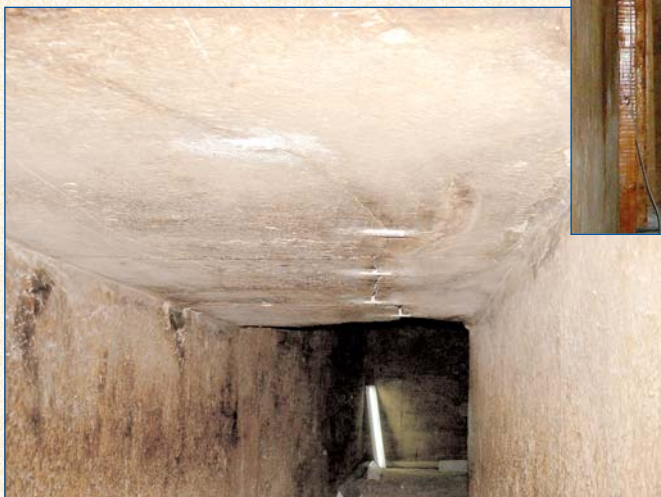
Soffit of cracked beam in the corridor between the burial chambers
