CASE HISTORY

AURTHERS COTTAGE: BALLYMENA, NORTHERN IRELAND

CINTEC HARKE ANCHOR

REPAIRS TO ARTHUR COTTAGE

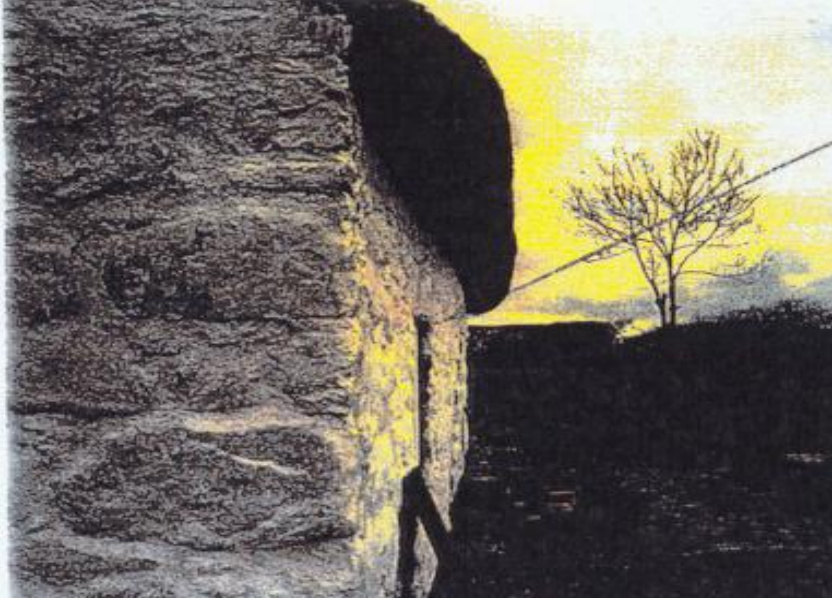
Before this, a survey had indicated that two external walls showed signs of moving outwards. (see photograph)

Before the cottage could be opened to the public it was necessary to reinforce these external walls to prevent further movement.

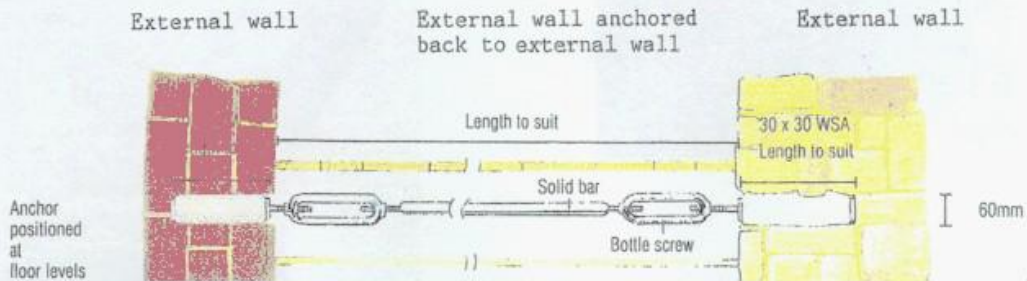
This suggestion was accepted by the Architect and two 30mm x 30mm x 450 long WSA anchors were installed tied together with 16mm rod, tensioned using two bottle screws. (See diagram below)

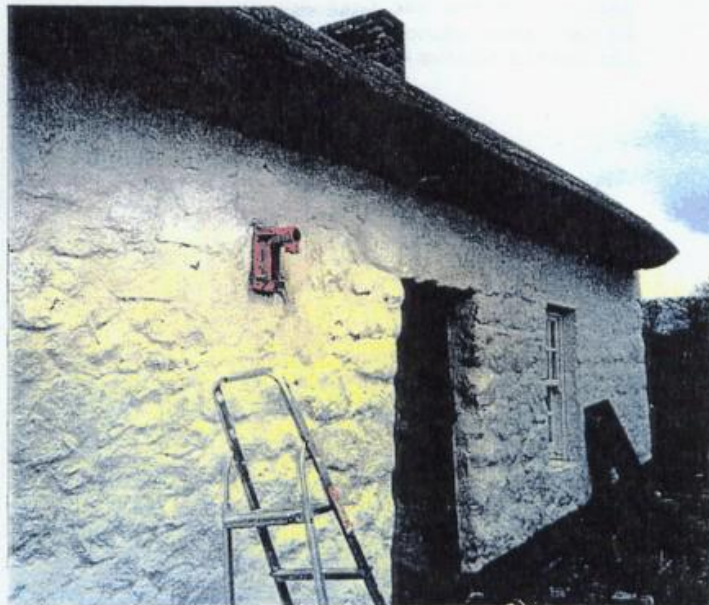
(a) Drilling Rig Base Plate fixed to wall.

The anchor is installed into a 60mm diameter hole drilled with a Diamond Drilling Rig.

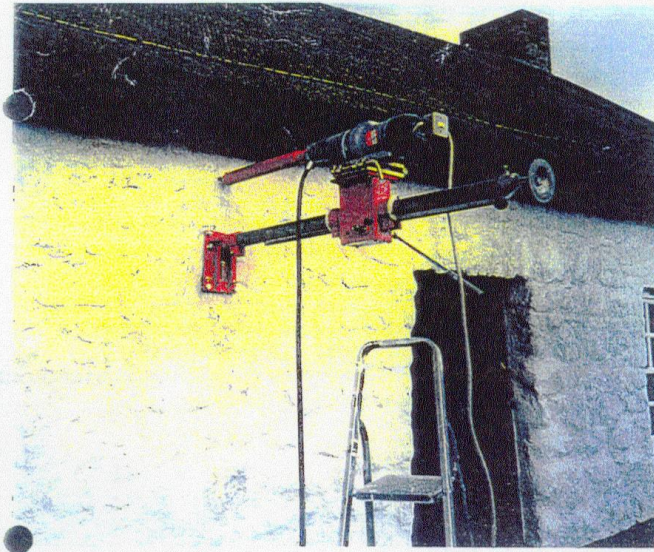
(b) Drilling Rig in place.

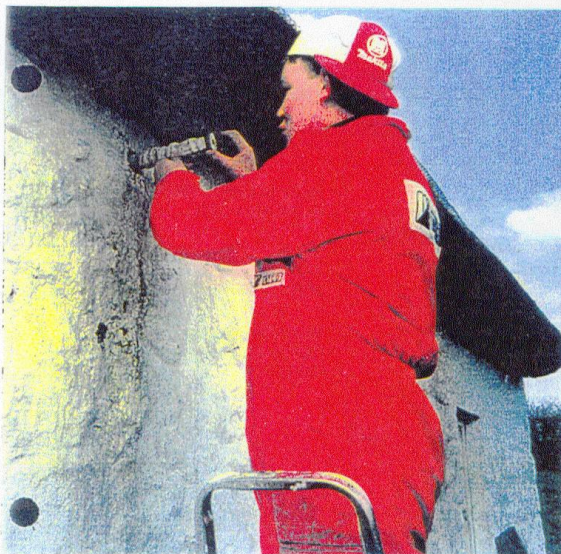
(c) Drilling one of two 60mm holes.

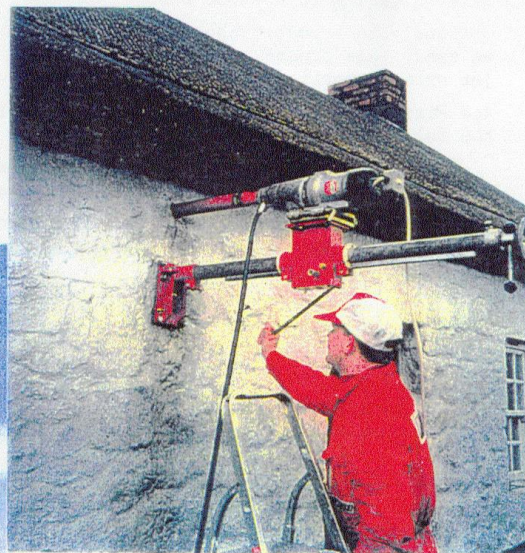
(d) Installing the anchor.

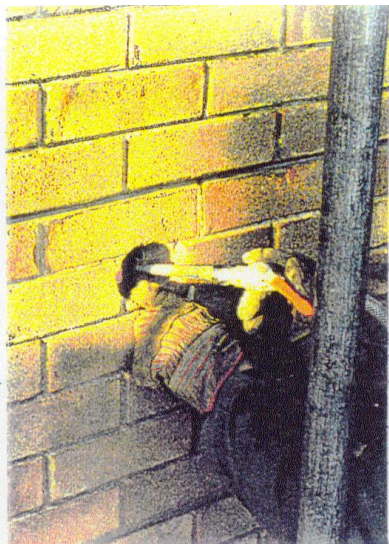
(e) Inflating the anchor with grout. (Note the photograph taken of the actual operation did not come out).

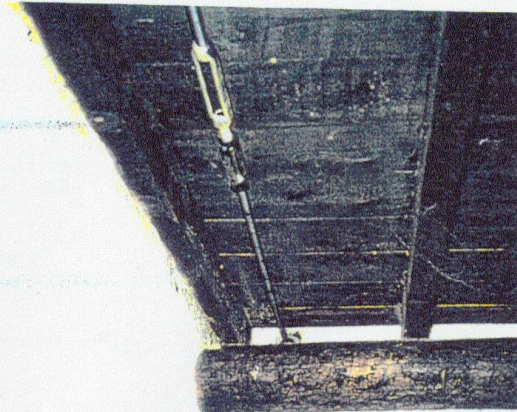
(f) Internal view of one installed anchor with the bar (connecting to the other anchor) and showing the bottle screws.

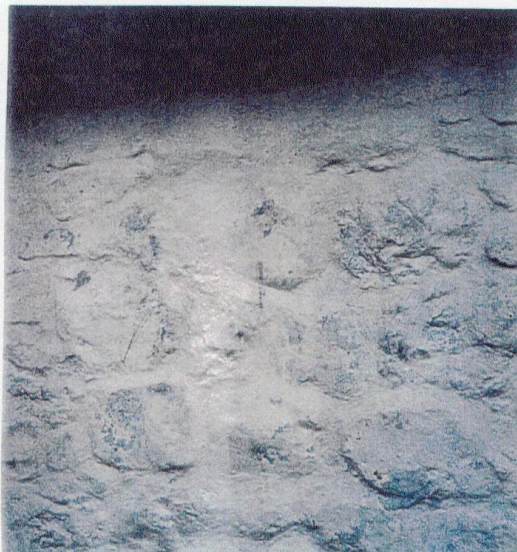
(g) The finished wall after installation of anchor and before white washing.
