CINTEC ANCHORS FOR HISTORIC  
BODIAM BRIDGE

**Tim Bilson**

Scoll Wilson Kirkpatrick

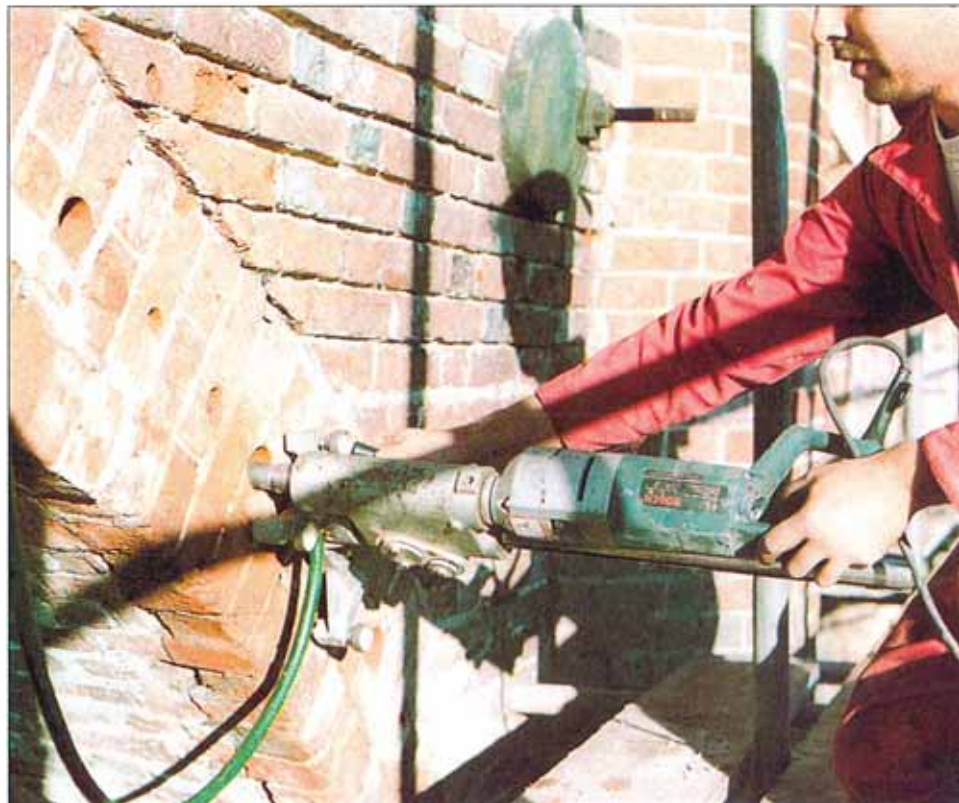
*Core drilling holes for the anchors*

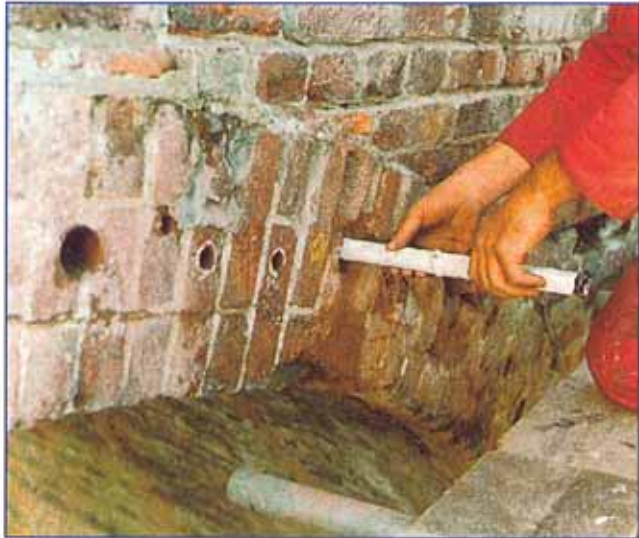
*Placing the anchor in the prepared hole*

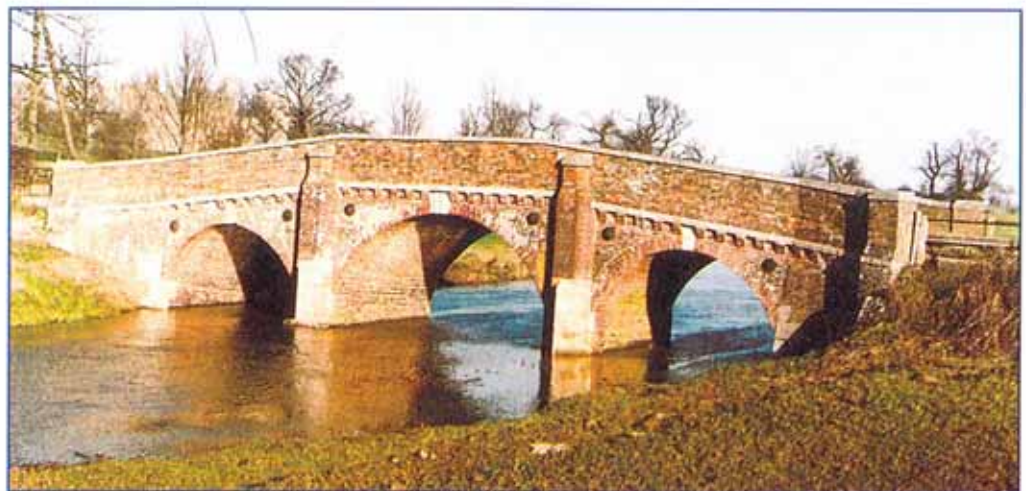
*Bodiam bridge after completion with the castle behind the trees in the background.*
