THE SALVATION OF HIBIS TEMPLE

EL-KHARGA – EGYPT

A UNIQUE ANGLO EGYPTIAN COOPERATION IN THE FIELD
OF STRUCTURAL ENGINEERING

the strengthening solution

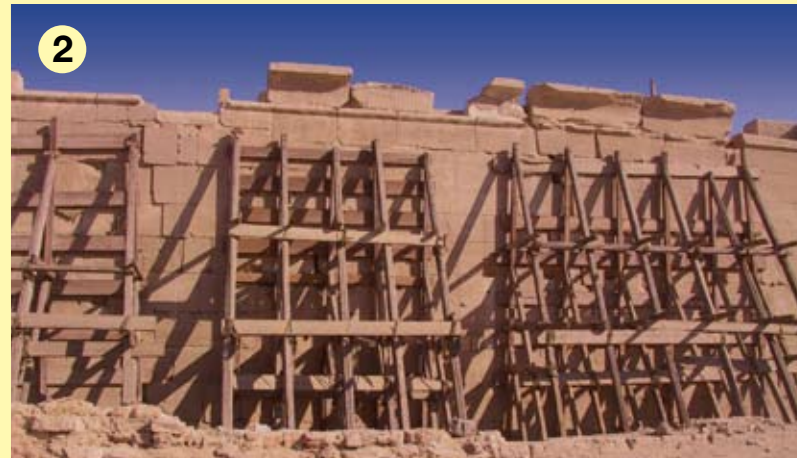
(2) The South Wall support

The condition of the temple was that the external south, west and north walls were temporarily shored with timber raking shores. There was significant rotation of the foundations because cultivation and irrigation of the soil adjacent to the footings had resulted in heave and shrinkage of the clay soils.

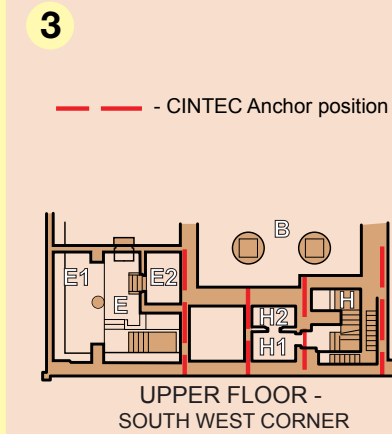
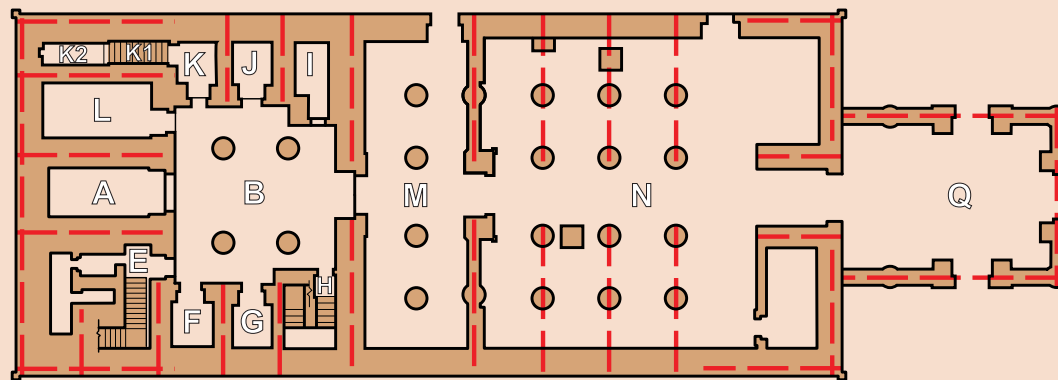
(3) The Position of the CINTEC Anchors

It was decided to stitch all the elements of the temple to stabilise the walls and enable the timber raking shores to be removed. The large open spaces in the temple made it difficult to tie laterally across the temple so most of the internal walls were used to tie the external walls horizontally to the internal structure. The wealth of hieroglyphs on the walls contributed to the difficult location of the Cintec anchors.

All the walls were surveyed and the anchors were installed in damaged or missing areas of hieroglyphs.

The large areas of walls without internal walls were strengthened using inclined Cintec anchors 9m long from the top of the walls to the foundations, bridging the vertical cracks. Each corner of the structure was strengthened in this way in addition to horizontal anchors up to 10m long.

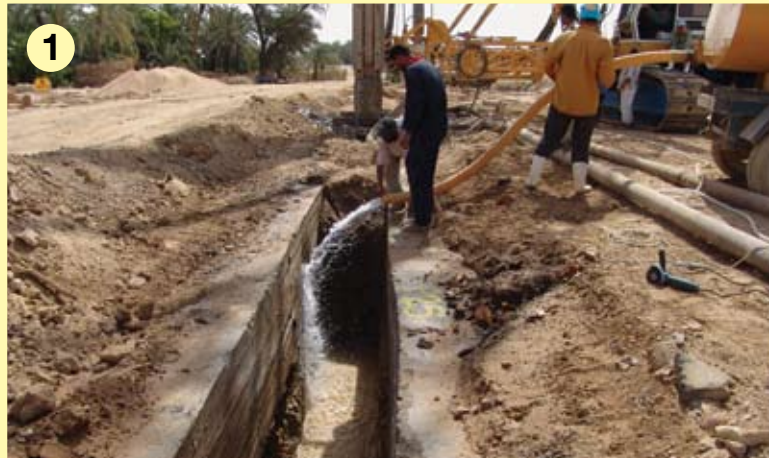
(1) Securing the Ground
(3) The finished hole ready for the anchor

However, the main task was to isolate the main structure from the subsurface water by using a trench one metre wide and up to seventeen metres deep to completely surround the monument and make it a dry island in an oasis.

To overcome any water that might enter under this barrier a series of lime piles at four metre centres some up to seventeen meters deep were formed through the entire temple at ground level to absorb any other water penetration.

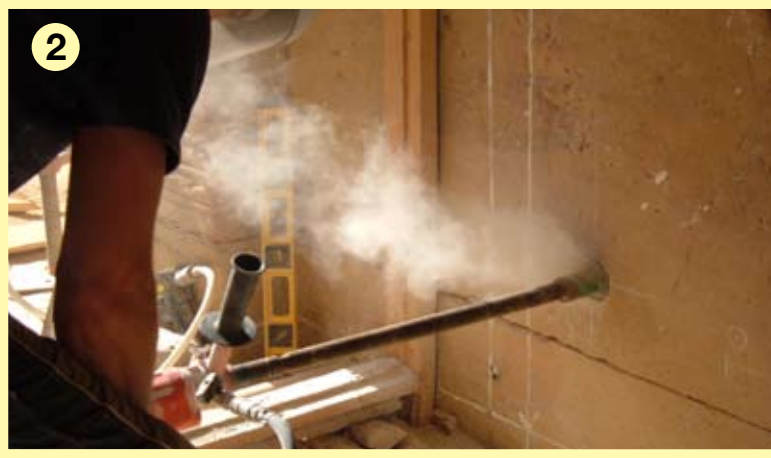
(2) Drilling for the Anchor
(4) Inserting the CINTEC Anchor

The installed drainage trench around the monument will prevent further disturbances in the soil around temple. Due to the nature and condition of this temple no vibration could be introduced in the drilling stage so dry diamond drilling techniques were used using compressed air to cool the drill bits and flush the dust from the holes.

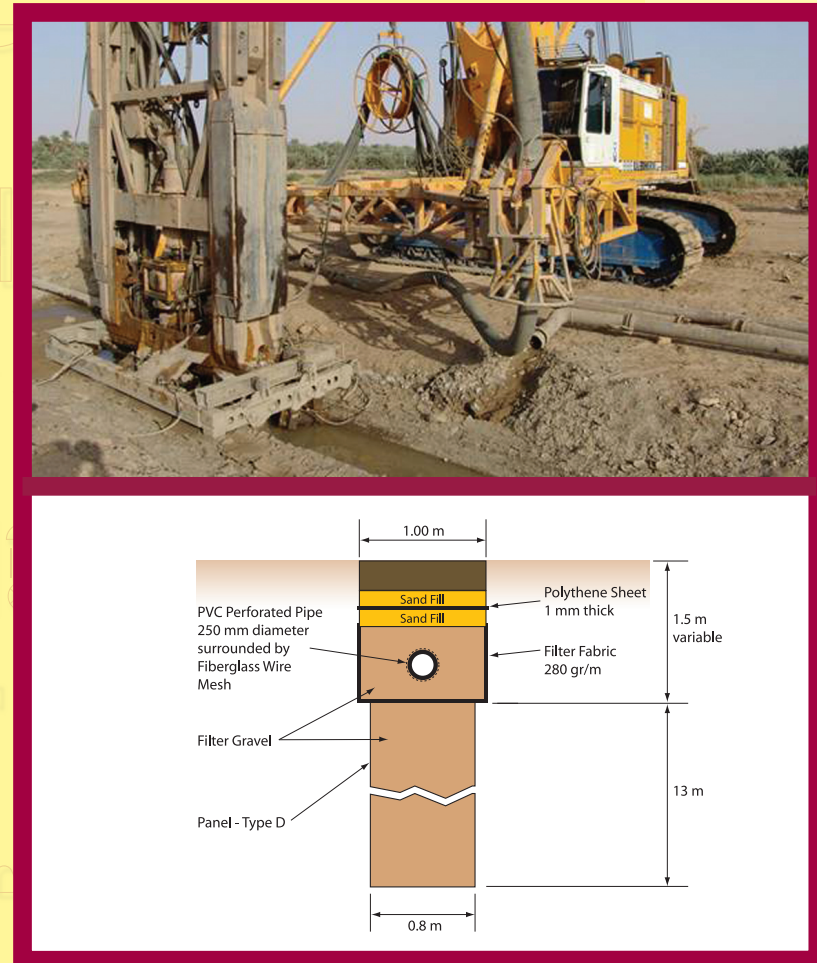
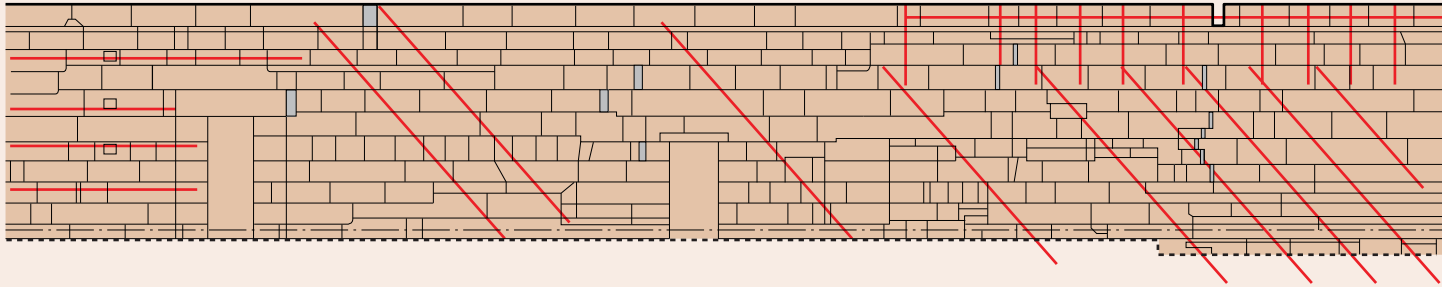
NORTH ELEVATION

(1) View of typical anchor arrangement to stabilise the outer walls of the temple. Each anchor position was carefully designed to satisfy the engineering requirements, but also were extremely sensitive to the delicate hieroglyphs adorning the temple walls.

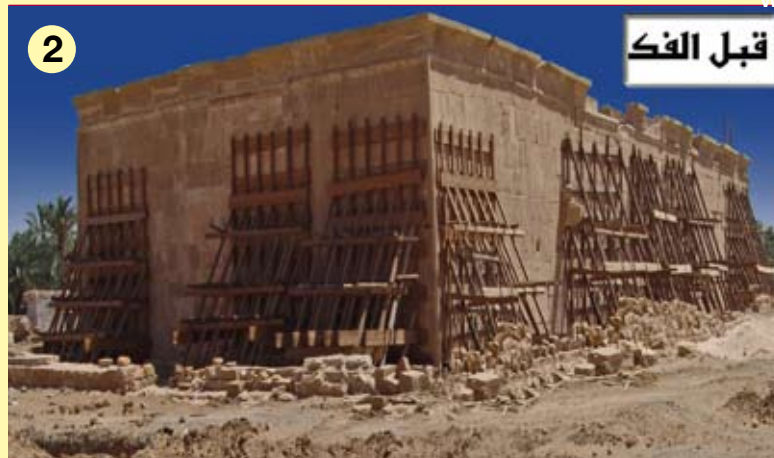
(2) The original, supported corner

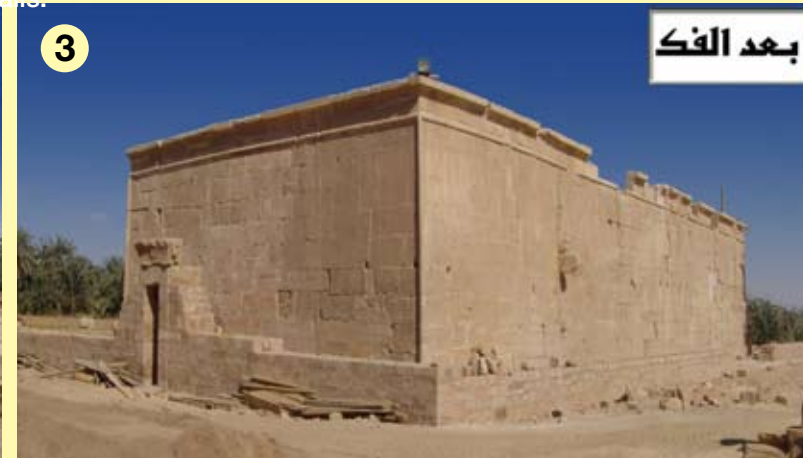
(3) The finished, secured corner

Upon completion the external raking shores were removed allowing the structure to be viewed unsupported for the first time in many years.
