# CASE HISTORY

## Malmesbury Church Street Rotation, U.K

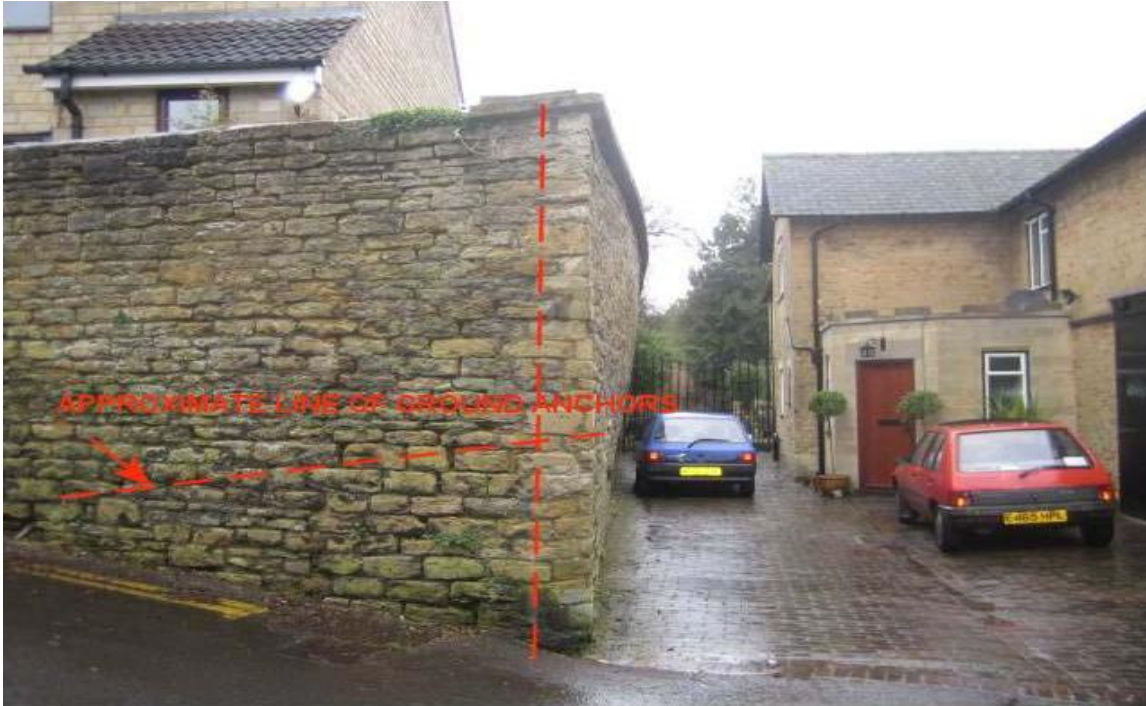
AS can be seen from above photograph this retaining wall has seriously rotated towards the next property. Understandably the neighbors were becoming extremely concerned about its safety. The wall retained the garden and some imposed load from the house foundations.
