# The Structural Engineer

What happened to the cladding  
of Egypt's ancient pyramids?

## Missing cladding of Cairo's pyramids

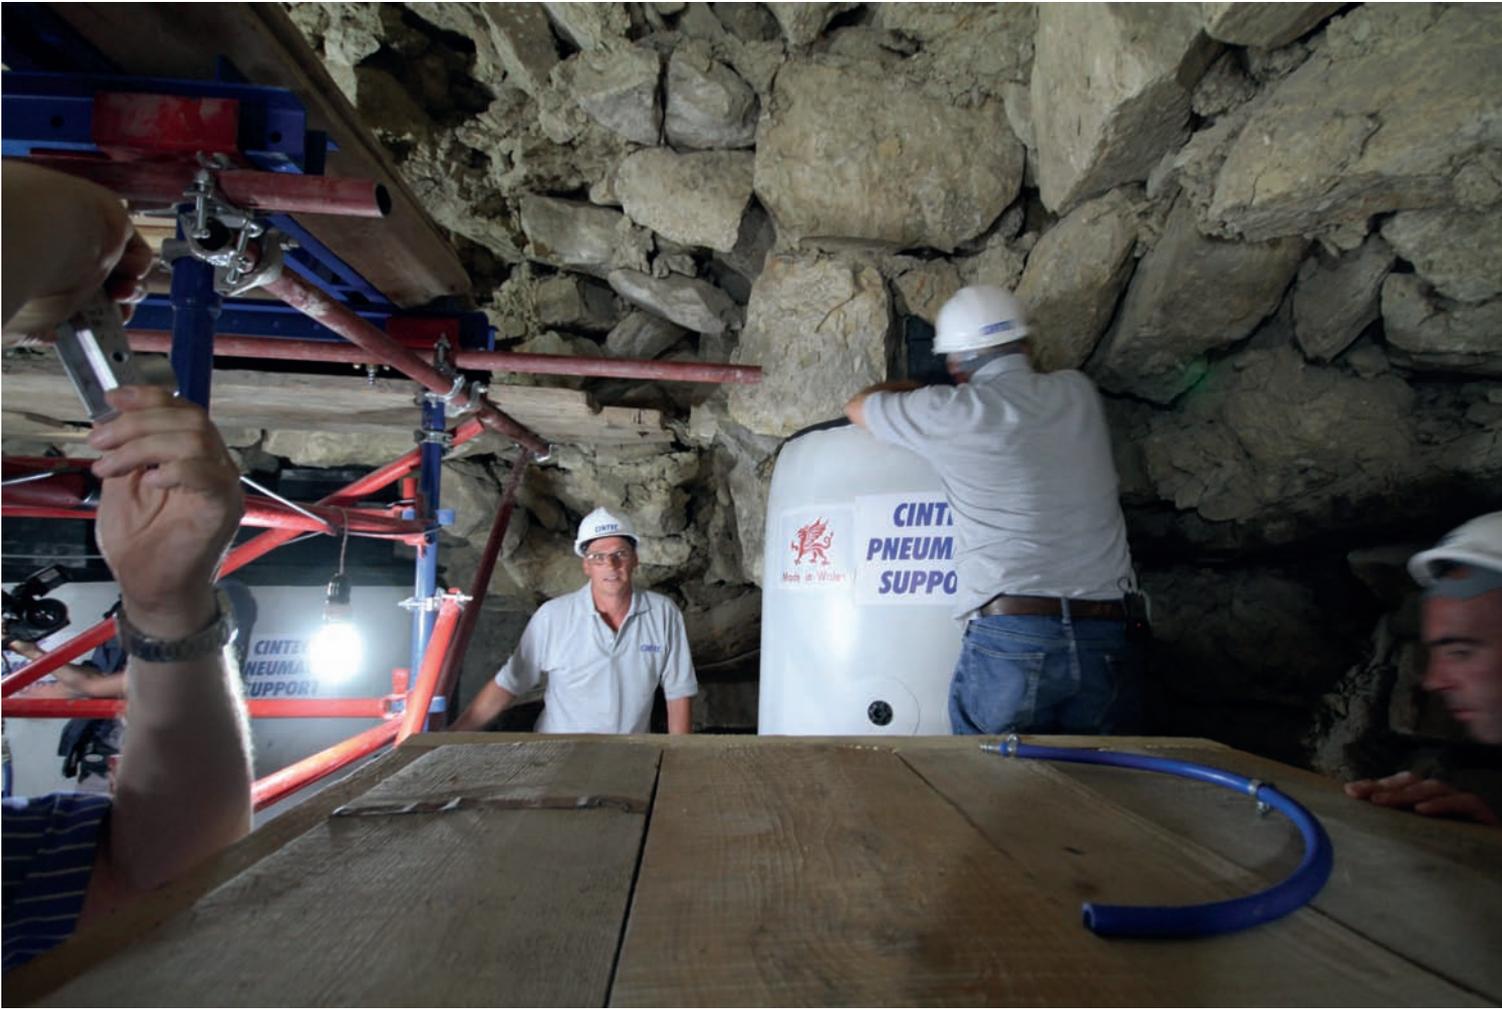
↑ Installation of WaterWall in burial chamber

← 1992 earthquake causes the Step Pyramid's burial chamber to collapse

As the WaterWall air bags are made to expand to specific dimensions, Cintec were able to design and fit the units in strategic positions around the chamber, to merely kiss the hanging stones without any upward thrust. The temporary support of the ceiling has now been finished, with the final pointing, grouting and anchoring processes approximately 50% complete.

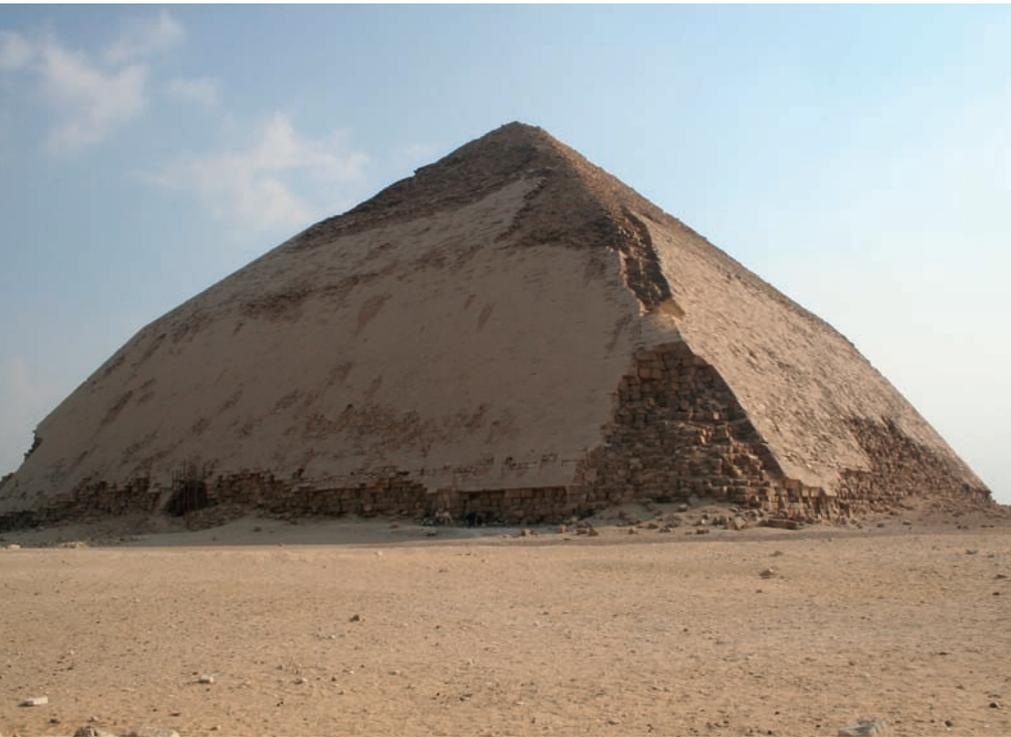
↑ An 11 degree change in angle gives the pyramid its bent appearance

It was on one of my visits to the Step Pyramid that I was asked my opinion on securing the remaining outer cladding of the Bent Pyramid, another construction by Pharaoh Sneferu, located 40 kilometres south of Cairo. The pyramid's top section sits at a slightly different angle to the main body, giving the structure its "bent" appearance.

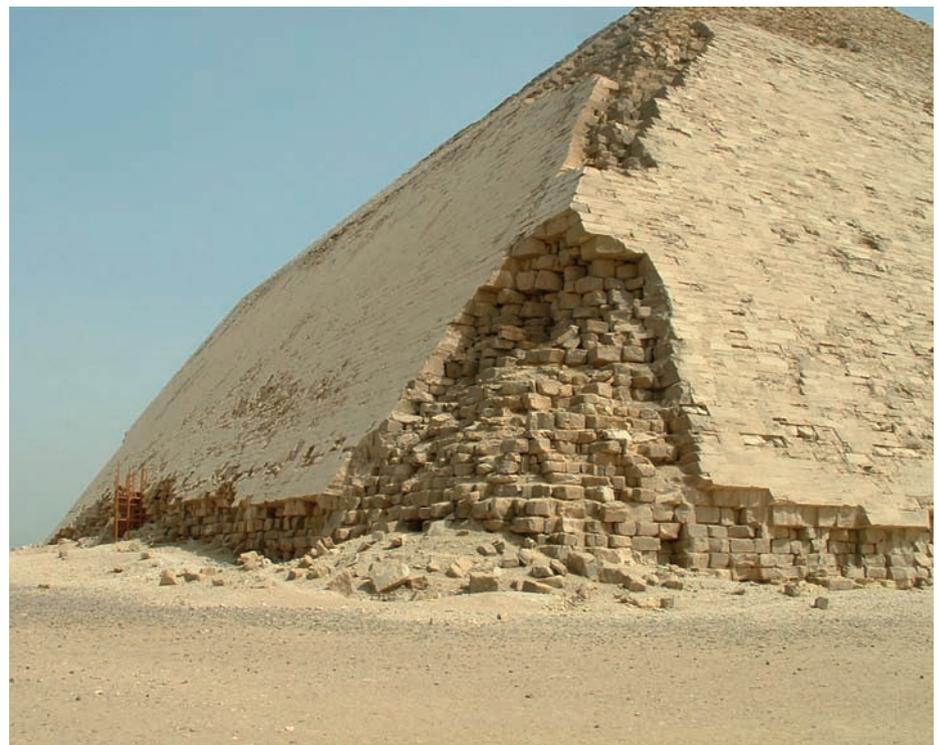
↑ Crumbling casing on the Bent Pyramid's outer corner

Fortunately, the Bent Pyramid is the only pyramid with any degree of stone casing still attached, making the mechanism of failure apparent. The failure of all the perimeter edges show that the outer casing has expanded from the centre outwards, and movement has taken place on all of the extremities.

directions. However, this is also dependant on the size of the gaps between each stone. All movement from the thermal expansion of the casing would be taken up initially in the joints, but significantly the limestone does not go back to its original position. The expansion would create dust and stone particles that would detach from the stones, filling the voids and gaps between them. This would reduce the amount of contraction possible at night, in addition to the stones' natural propensity not to return to their original dimensions and position, and so the cycle would start again. Multiply this endless movement by the number of days the pyramid has been erected and you have the reason why all the outer casing has moved to the extremities, where it has buckled or displaced against blocks moving in the opposite direction, and then fallen off. It may then have been picked up by opportunists and removed from the site. I believe that this process is the mechanism of failure on this and all the other pyramids.
