# Castle Ward House

Castle Ward House is situated near Strangford, Northern Ireland. The property was constructed in 1756.

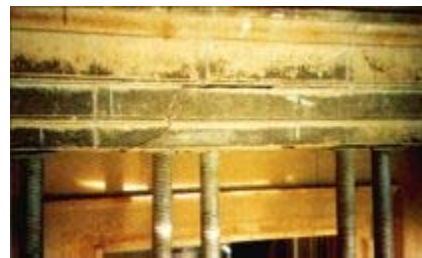
An inspection during the course of repairs revealed that one of the original timber beams in the area of the Tympanum had seriously decayed. This beam acted as a support for the upper stonework and a hanger for the lower stones. With this decay the lower stones had cracked and showed signs of falling out.

First sign of distressed beam

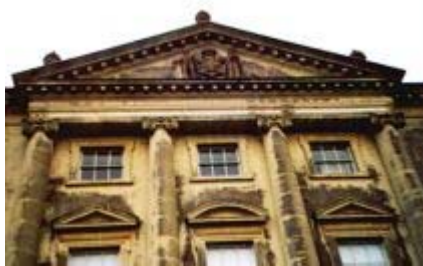
External upper beam area

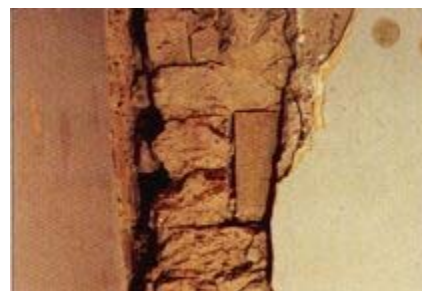
Internal damage of wooden beam

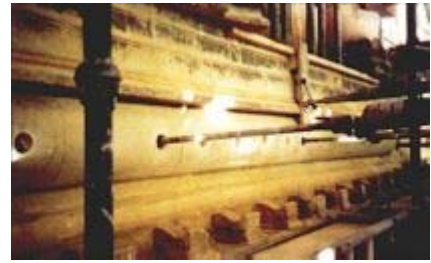
Drilling & securing stonework above beam

Because of the failure of the beam the immediate problem of support was solved by using 15x15x1000 mm SHS stainless steel anchors both horizontally and vertically.

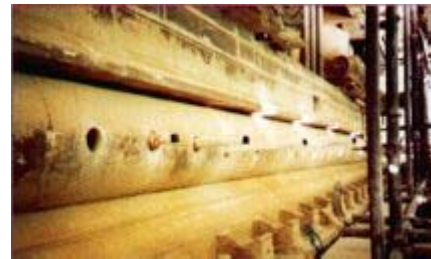
Anchor installation

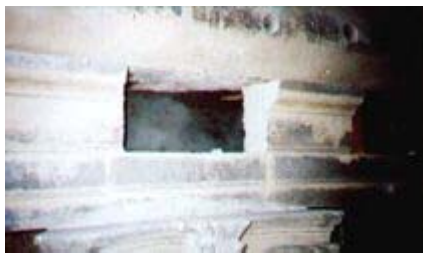
Openings cut in masonry to expose defective wooden beam prior to its removal

Once these anchors were installed the remains of the beam were removed and the problem of replacing it was addressed.

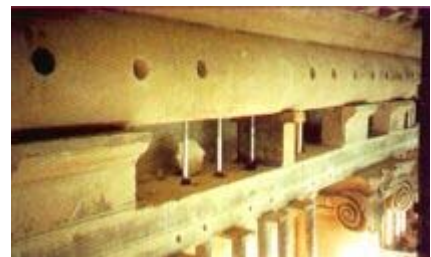
Entire length of 10 metres exposed

The span of the original beam was 9 metres, across four vertical columns, so from the point of view of physically handling the replacement beam it was decided to construct three number three metre long beams.

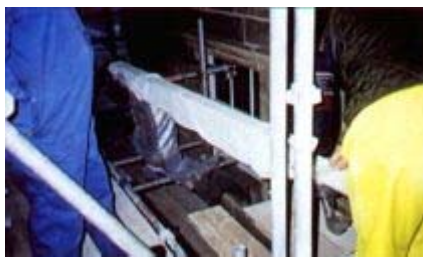
Insitu assembly of 100x100 mm stainless steel 10 m anchor

These beams were constructed of 100mm x 100mm stainless steel box sections shrouded in a 300mm sock, with an outer sock for protection. These beams were slid into position and shuttering was installed to prevent grout overhang. 300 kgs of grout were pumped between the sock and the exterior of the beam to form a perfectly contoured support.

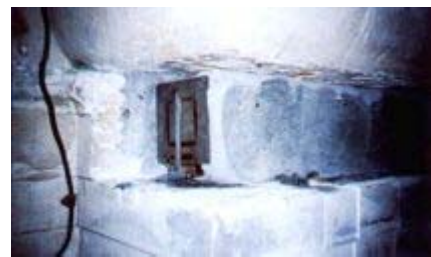
Beam after grout injection
