# HOLDING IT ALL TOGETHER

a venerable Mosque gets a new lease on life thanks to an in

by James R. Marshall

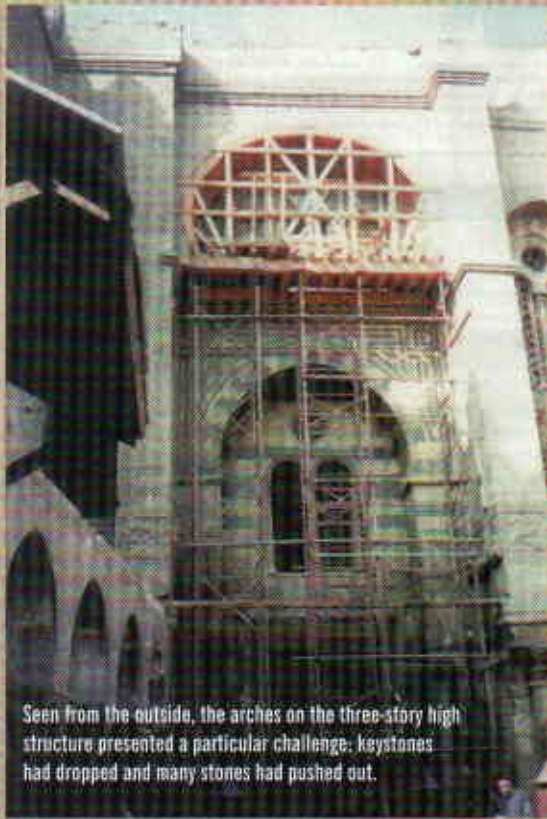
Seen from the outside, the arches on the three-story high structure presented a particular challenge: keystones had dropped and many stones had pushed out.

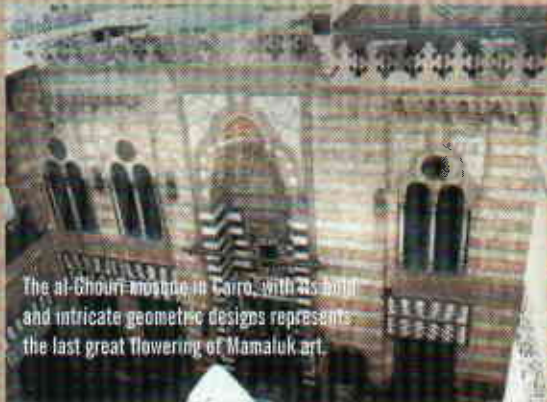
The al-Ghuri mosque in Cairo, with its bold and intricate geometric designs represents the last great flowering of Mameluk art.

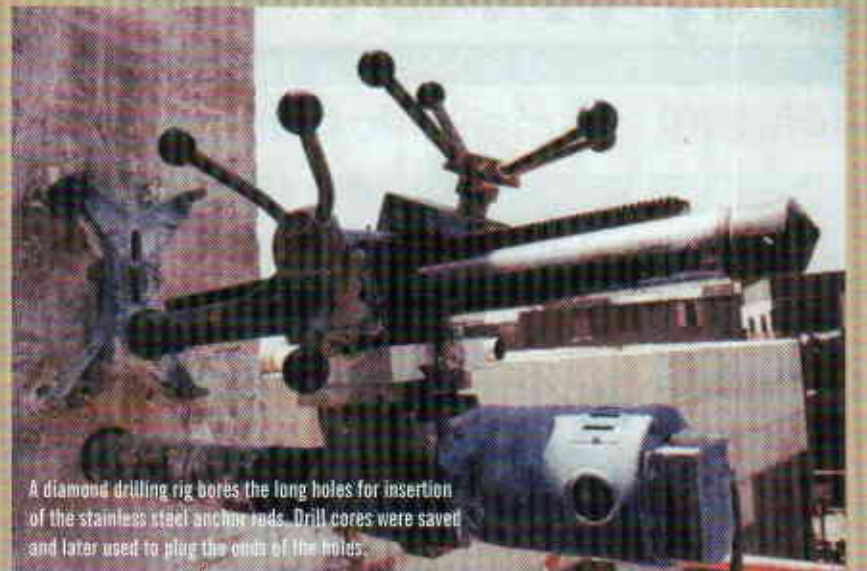
A diamond drilling rig bores the long holes for insertion of the stainless steel anchor rods. Drill cores were saved and later used to plug the ends of the holes.

To deal with the heat, the Cintec team had to devise a system for cooling the water used to mix the grout. To preserve the sandstone, the team employed dry drilling with diamond bits, a technique that required full-face helmets and dust control measures. And because the aim was to make long lasting repair, the team selected 316 stainless steel rods (the highest non-magnetic grade) for the mosque project. The job required more than 1200 metres (3.937ft) of rods, many as long as 12 metres (39ft). For some of the roof arches, eleven 37mm (1 1/2in) rods were inserted in holes drilled to a diameter of 100 mm (4in). Over-all socks were used in diameters ranging from 20 mm (3/4in) to 300 mm (12in). To ensure invisibility of the repairs, the team preserved the diamond drill cores and used them to plug the anchor holes, sealed with a carefully color-matched grout.

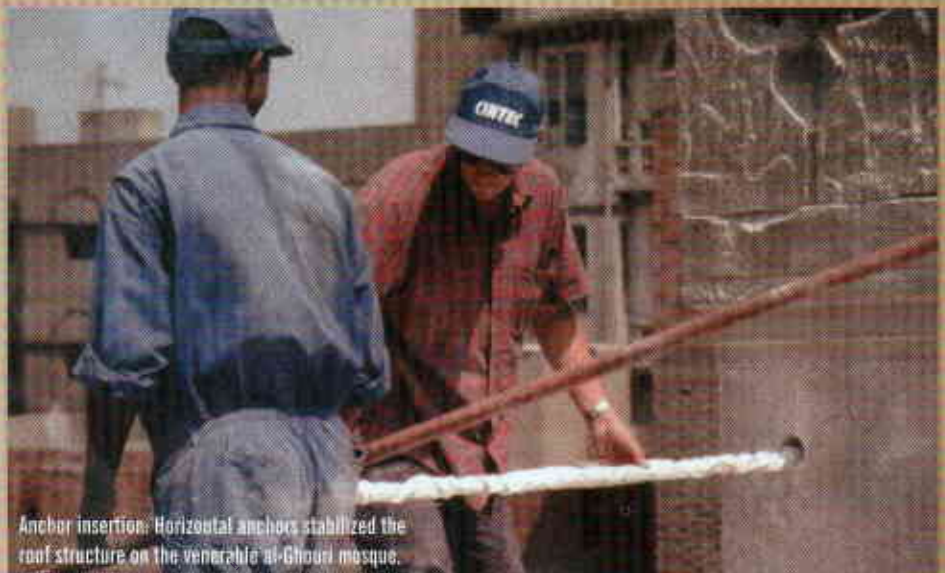
Anchor insertion: Horizontal anchors stabilized the roof structure on the venerable al-Ghouri mosque.

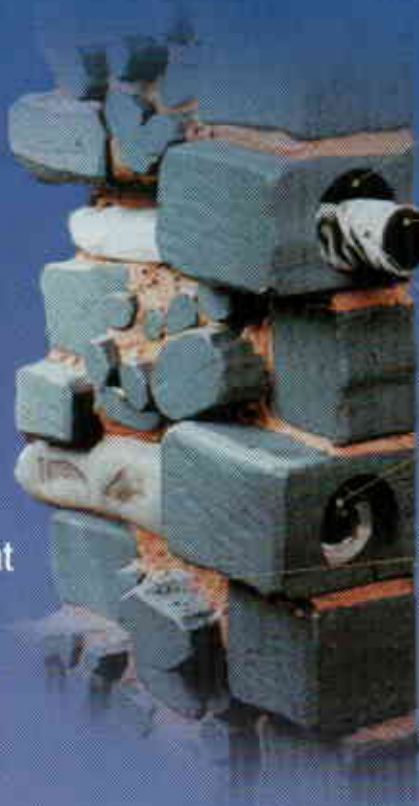
- **Drilled hole**  
usually double anchor body size
- **Main anchor body**  
available as square or circular hollow section or solid bar profile
- **Fabric containing anchor**
- **Grout injection**  
moulds anchor to the shape and spaces within the wall
- **Inner wall substrate**

invisibility but also because its walls, two meters (6 1/2ft) thick, are made up of two facing sandstone skins with a loose rubble fill. To use the Cintec System, holes are drilled into the hollow space, and the anchor rods are inserted; the rods have a polyester sock into which grout is pumped through a filler tube. The sock inflates, and the grout milk passes through its mesh, bonding to the stonework and moulding itself to the contours of the hole. Upon completion the anchor is not visible from the outside. Because the back of the anchor sock is the first filled, air is displaced toward the front, ensuring a void-free solid anchor. This system provides great strength without having to fill in the whole interior wall space — the system is strong only where it is needed most, according to Lee.
