CASE HISTORY

THE JEALOUS WALL FOLLY

Now owned by Westmeath County Council and due to be part of a new Visitors' Centre, this remarkable folly was built in 1760 and originally constructed to look as though it was a 200 year old ruin.

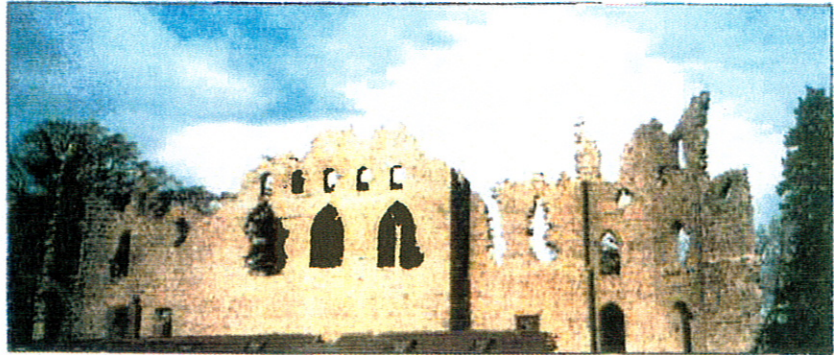
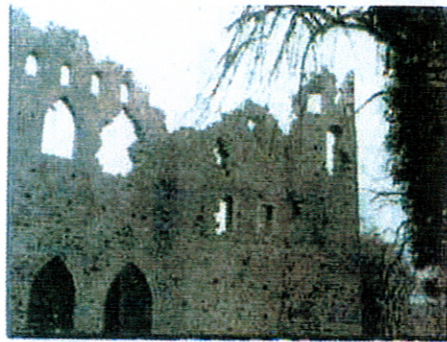
Despite appearing seriously unstable, with an erratic and uneven top line of pinnacles listing off plumb and various openings looking ready to collapse, the bulk of the structure was in fairly good condition. However, spreading ivy had shifted large sections of stonework and weathering had greatly affected much of the original lime mortar, to the point of failure in some areas. Full structural integrity had to be sympathetically restored without disruption to the original fabric.

A programme of concealed repairs was devised by WT's structural engineer. Initially all ivy and other vegetation was removed and the wall jet washed before temporary repairs were carried out.

Precision diamond core drilling was undertaken horizontally, vertically and at various angles to allow the installation of Cintec grouted stainless steel anchors up to 14m long. The accuracy of this drilling was crucial. In several instances two 65mm diameter core holes, which had to be a minimum 50mm from the wall face, were drilled through the 300mm thick wall while allowing a horizontal anchor to pass unhindered between them.

All voids were then grouted, pinning stones refixed and extensive lime mortar repointing carried out to fully restore and secure the Jealous Wall while retaining its original 'unstable' form.
