CHRIST CATHEDRAL NEWCASTLE NEW SOUTH WALES, AUSTRALIA

CHRIST CHURCH CATHEDRAL — DAMAGE

CHRIST CHURCH CATHEDRAL, NEWCASTLE, NEW SOUTH WALES, AUSTRALIA — THE REPAIR

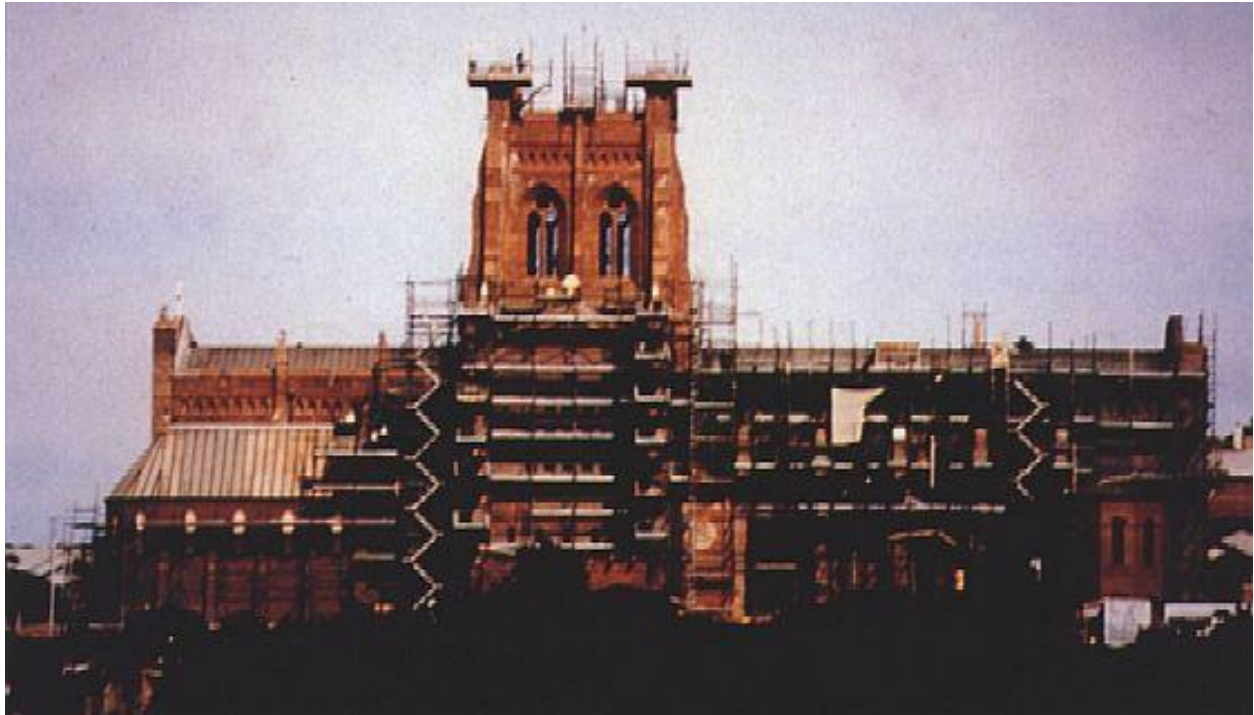
Earthquakes had previously occurred in Australia only in sparsely populated areas, and most practicing structural engineers and building authorities knew little, if anything, about earthquake design requirements. The effect of the earthquake was largely as might be expected: high set stone crosses and other decorations fell to the ground, flying buttresses were dislodged, shear cracking occurred in the north and south walls and out-of-plane movements occurred in the east wall, dislodging windows. Work on a building such as Christ Church Cathedral is governed by State heritage legislation which invokes the International Council on Monuments and Sites (ICOMOS) principles derived from the world body's Venice Charter. To repair and strengthen the Cathedral, reinforcement of the walls was necessary, with least visual intrusion or damage to the existing fabric. Material had to be found which were compatible with the masonry of the building and which ensured the long life for which cathedrals are noted.

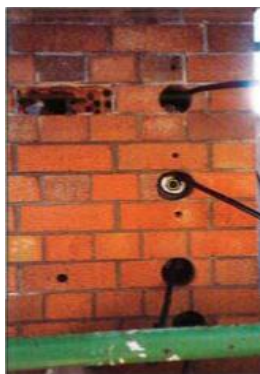
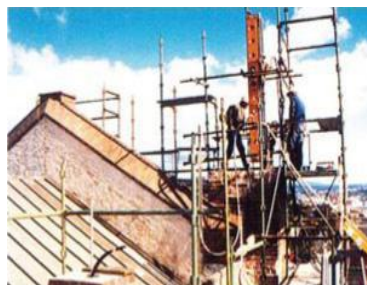
Down-the-hole video was used to verify the integrity of all drill holes and each hole was surveyed for its full length using techniques specially developed on site by the surveyors.

20 m vertical anchor being placed by crane in the project which saw anchors up to 32 m horizontally, Cintec's longest to date

The aim of the repair and reinforcement work was to turn the building from a brittle to a ductile structure, able to resist future earthquakes. Cintec anchors were used to reinforce walls and piers, horizontally and vertically. Some steel frames were used where they could not be seen, behind parapets and in the tower. Cintec anchors used on the project ranged from 215 mm long RAC cavity ties to 32 meter long anchors in the nave walls which were manufactured from 32 mm diameter "Hi-proof" grade 316 deformed stainless steel bar. All the long anchors had to be manufactured on site, with long vertical anchors being installed by crane.

The 32 meter anchors were the longest ever installed by Cintec and amongst the longest in the world. Water could not be used for drilling because of the damage it could do to the building, so all drilling was carried out with non-coring, polycrystalline diamond bits using air for cooling and cuttings removal.
