JOHN SOPINKA COURTHOUSE

Hamilton, Ontario, Canada

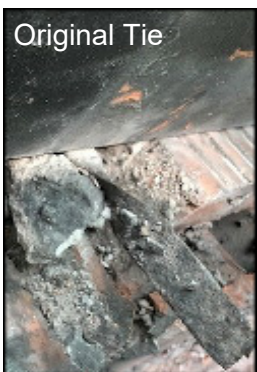
Original Tie

a+LiNK Architecture was retained and provided specialized knowledge to preserve the cultural heritage of the John Sopinka Courthouse by Infrastructure Ontario. They provided an investigation, analysis and a proposed solution for the stone façade restoration of this historic courthouse. The restoration included repairs and re-attachment to five storeys of stone on the building envelope, original masonry components and the metal canopy. With this analysis it was determined that the original ties were loose, deteriorated and failing.

The Cintec Reinforcement System was used to re-attach the stone to the diverse brick and/or speed tile (structural terra cotta) back-up wall. The fact that the Cintec anchors attached both adhesively and mechanically, which provided progressive failure as opposed to brittle fracture, as well as the inherent fireproof capability were a strong consideration. However the back up wall capacity was still of concern. To this end, extensive and successful, testing was conducted. Because the bulbing action (mechanical attachment) of the Cintec system distributed required loads over much larger areas, than other systems, the fragile back up walls were able to withstand required loads - including wind load. A 3/8" threaded rod with 1 1/4" sock, 7 1/2" long, socked 6" in a 1 1/4" hole was used.
