## Deansgate Viaduct - Manchester

*"Key hole Surgery for Bridges"*

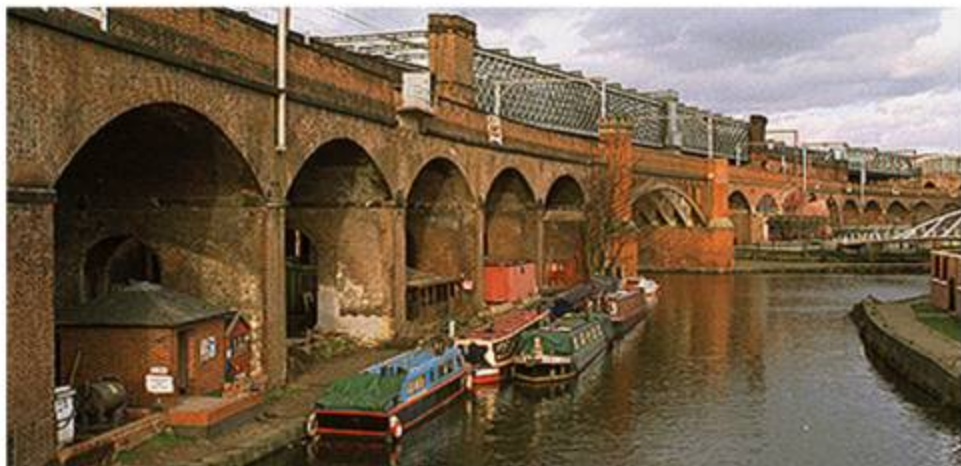
The busy Deansgate rail viaduct is situated in the heart of Manchester spanning numerous buildings, roads and canals. In 1997 the normal daily flow of railtraffic was disrupted by a destructive fire which took hold in a workshop located directly underneath. The subsequent heat generated by the blaze caused extensive damage and a weakening of the seven rings of masonry that form the arch barrels. The surface ring of brickwork completely delaminated and collapsed to the ground below.

A team of consulting engineers assessed the damage and recommended a Cintec reinforcement solution. Any remnants of the outer ring were completely removed and the remaining six rings were hammer

tested to locate the extent and area of internal delamination. Two arches were found to be in need of repair. In total approximately 500, 24 inch long RAC Cintec anchors were installed, perpendicular to the arch and at spacings of 20 inches. The anchors were staggered to avoid the formation of sheer lines and because of their vertical aspect, each anchor was fitted with an air-vent tube to ensure full grout inflation without risk of air pockets being formed at their remote end. All anchors went no further than half way through the sixth ring so as not to puncture the original waterproof membrane that protects the arch barrel from the arch infill.

Finally the original appearance of the arches was restored by grouting an original piece from the drilled cores back into the mouth of each anchor hole. The completed work was rendered invisible to the naked eye and the viaduct was once again in operation servicing Deansgate station and the G-Mex conference centre.
