Leaderfoot Viaduct - Scottish Borders

"Key hole Surgery for Bridges"

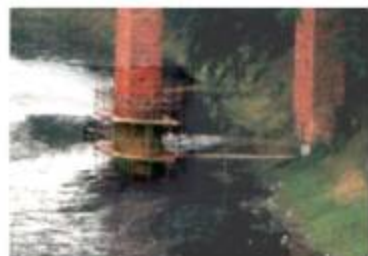
View of drilling platform

Under the supervision of the local river authority, holes were drilled at a downward angle through the boots and into the piers. These instantly filled with river water, however due to the unique nature of the Cintec anchor - filling a mesh fabric sleeve from the rear to the front, all water was fully displaced upon grout injection. The visible cracks were sealed manually by inserting lengths of sock into the fissures and expanding them. The subsequent watertight seal allowed conventional grouting to be injected into any remaining internal voids without danger of release into the water system.
