CINTEC

DESIGNED ANCHOR SYSTEMS

Structural repair solutions
for stabilisation & conservation

**Structural Repair,
Stabilisation &
Conservation System**

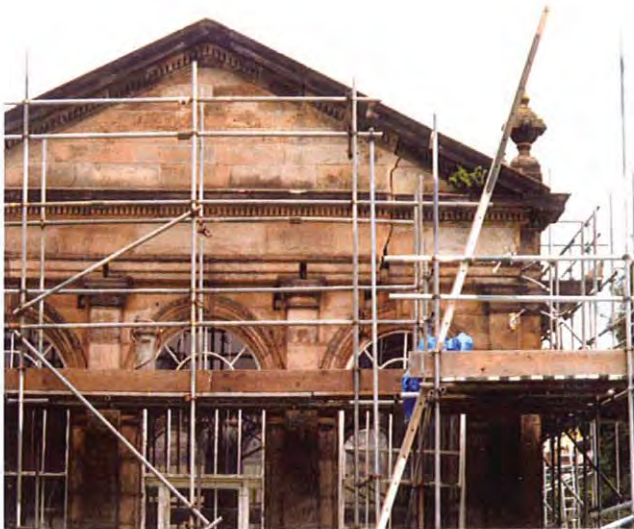
End elevation of Stoneleigh Abbey with the typical signs of differential movement due to foundation problems. A large crack is seen at the top right hand side of the gable wall running almost vertically onto the top of the circular window. The first solution was to underpin and stabilise the foundation movement. The next step was to stitch and hold the distressed walls where there was maximum movement.

The diamond drilling rig is being prepared and secured to the scaffolding prior to drilling for the anchors at foundation level.

End and front elevations of Stoneleigh Abbey after all the Cintec stitching and reinforcing anchors have been installed to the external walls on four elevations. The extensive cracking was made good using matching stonework.

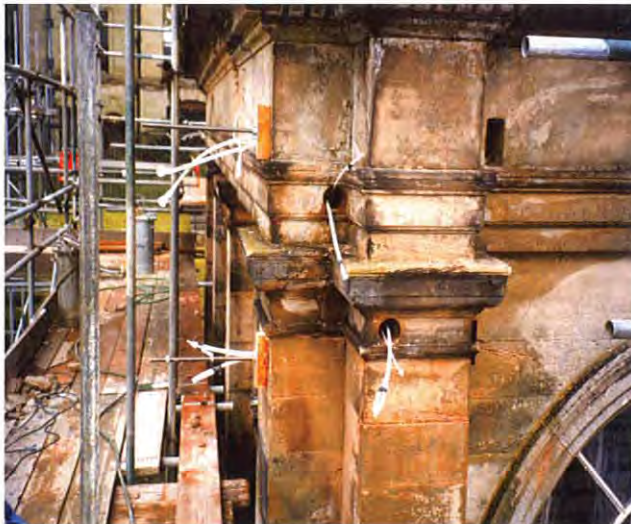
Work in progress showing the anchors positioned and inflated prior to making good and cleaning

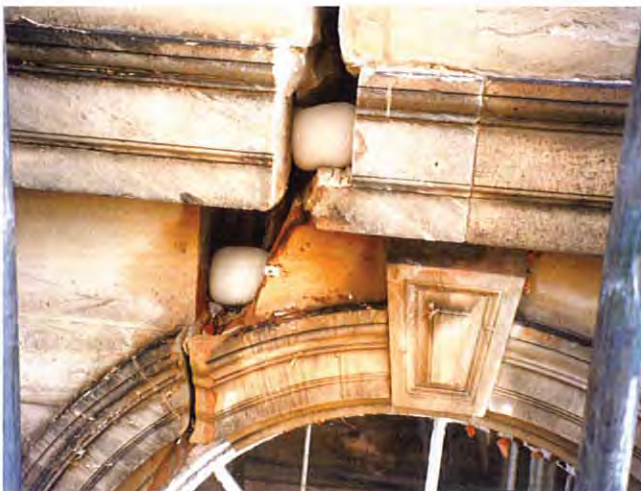
The simple expedient of putting a fabric sock around a steel anchor body appears on the surface to be relatively easy. However, our research and experience over many years has shown that the issues involved are very complex. Consider that the operative can only see the front portion of the anchor assembly when the assembly is positioned in the drill hole and is working blind and has to judge when the whole anchor assembly is fully inflated.

The fabric outer sock that surrounds the stainless steel anchor body must be strong enough to withstand mechanical handling damage both during manufacture, storage and handling of the assembly on site during installation. Yet, the fabric sock must be thin enough to conform to the shape and profile of the drilled hole when whole assembly is installed in the drilled hole.

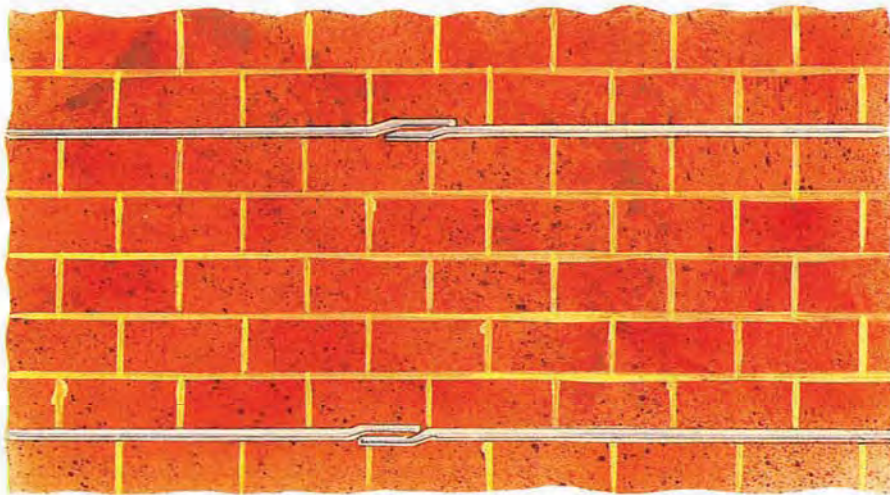
Everything 6th course but dependent upon mortar strength

Raked out joint to 50mm

3mm stainless steel wire with crimped indentations

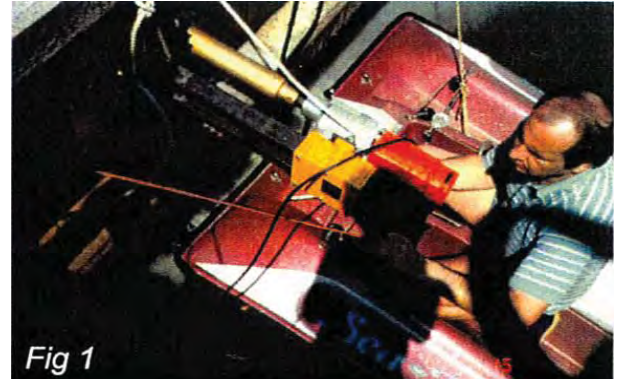
In the case of Marco Island, an additional wide section of expandable sleeve, or sock as it is often called, was attached to the far end of the anchor. When the grout was injected, the additional section expanded to a diameter greater than the rest of the anchor. This created a bulb deep within the soil and ensured a truly secure point of anchorage.

Consisting of a steel rod enclosed in a mesh fabric sleeve, the principle of the system is to inject a specially developed cementitious grout into the restraining sleeve of the anchor and so inflate it along its entire length. As well as providing an extremely strong mechanical bond, some liquid or 'grout milk' passes through the material membrane and bonds with the original substrate beyond.

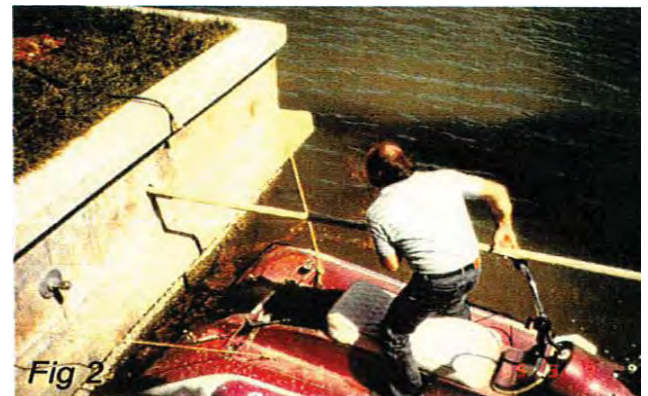
As can be seen in the images (right) the individual boreholes were produced by diamond core drilling, in this case with a core diameter of 65mm (2 ½") and to the length of the anchor : 3.2 meters (15ft) – Fig 1. The anchors were then installed with a plastic half pipe to facilitate their insertion – Fig 2. Finally the anchors were injected with 'presstec' cementitious grout expanding them from their far end to the front. Although not essential, a flange – plate was also screwed to the exposed anchor end for additional securement – Fig 3.

As can be seen in the images (right) the individual boreholes were produced by diamond core drilling, in this case with a core diameter of 65mm (2 1/2") and to the length of the anchor; 3.2 metres (15ft) - Fig 1. The anchors were then installed with a plastic half pipe to facilitate their insertion - Fig 2. Finally the anchors were injected with 'Presstec' cementitious grout expanding them from their far end to the front. Although not essential, a flange-plate was also screwed to the exposed anchor end for additional securement - Fig 3.

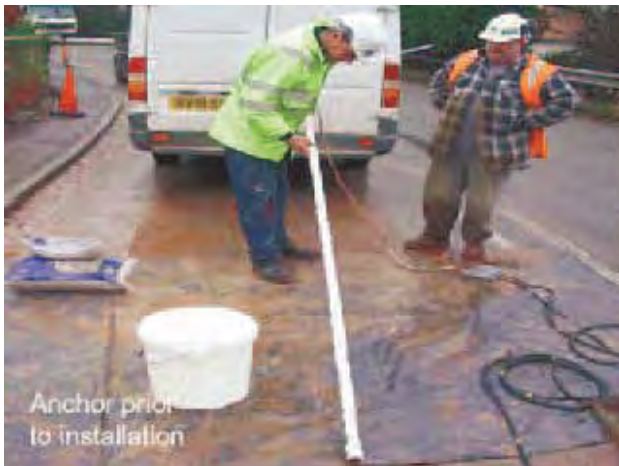
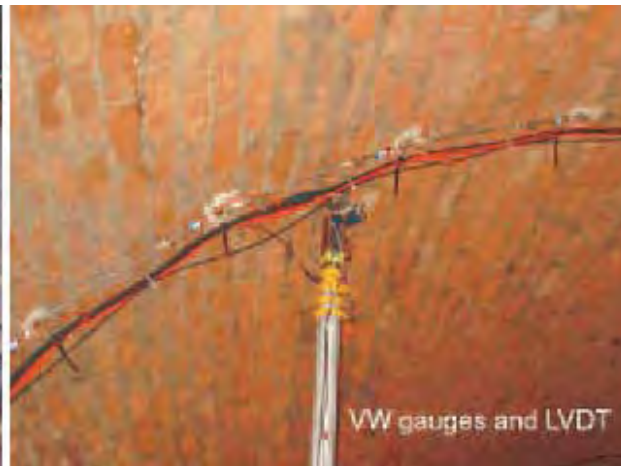
The Bridge

Pop Bottle Bridge in South Lincolnshire is a skewed twospan brick masonry arch bridge. Each span is approximately 5.0m measured in the skew direction and rise at their crowns 2.3m. The barrel is built from three rings of brick with bricks laid to the English or Helicoidal Method and has a skew angle of 25°. The overall barrel thickness is 355mm. The central pier is 800mm wide and approximately 2.1m high. Using modified MEXE and mechanism analysis the live load rating of the bridge was originally calculated to be 13 tonnes. The construction and previous use of Pop Bottle Bridge make it an ideal representative of British arch bridge stock and the disused and dismantled railway permitted easy access for test instrumentation.

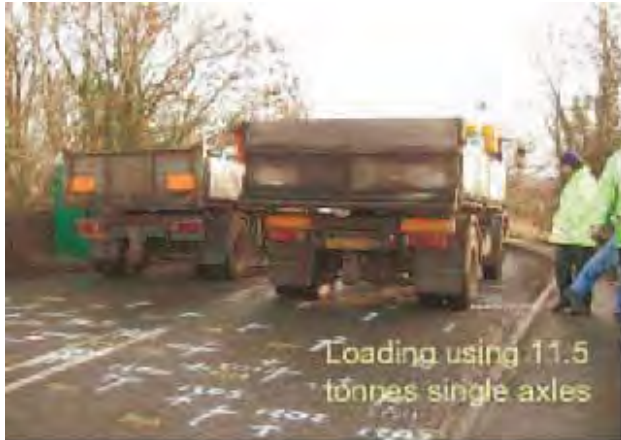
Loading using 11.5 tonnes single axles

The bridge was loaded before and after strengthening using two 18 tonne lorries in 28 different positions and instrumented to

record intrados strains, vertical displacements and strengthened bridge anchor strains.

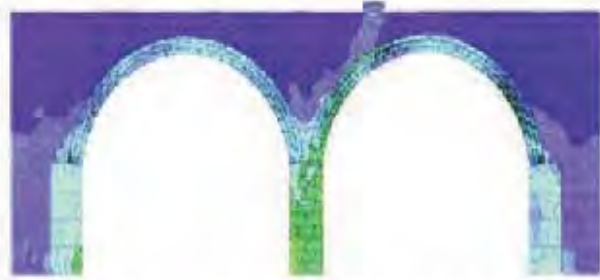
Typical test simulation illustrating principal compressive stresses; blue, green and yellow reveal increasing levels of compression

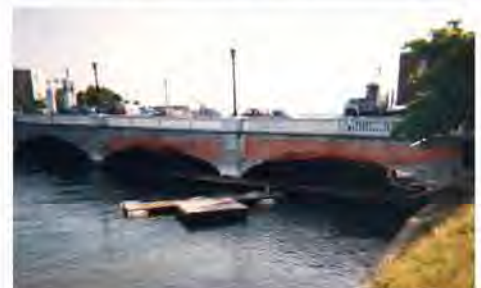
The Puente Laguna Condado is a principal entrance to San Juan Puerto Rico. It is multiple steel girder bridge built in 1926. The marine environment had substantially weakened the bridge and as an emergency measure, steel seat brackets were installed under each beam and connected to the concrete piers. This was achieved with corrosion resistant and highly compatible cementitious Cintec anchors.

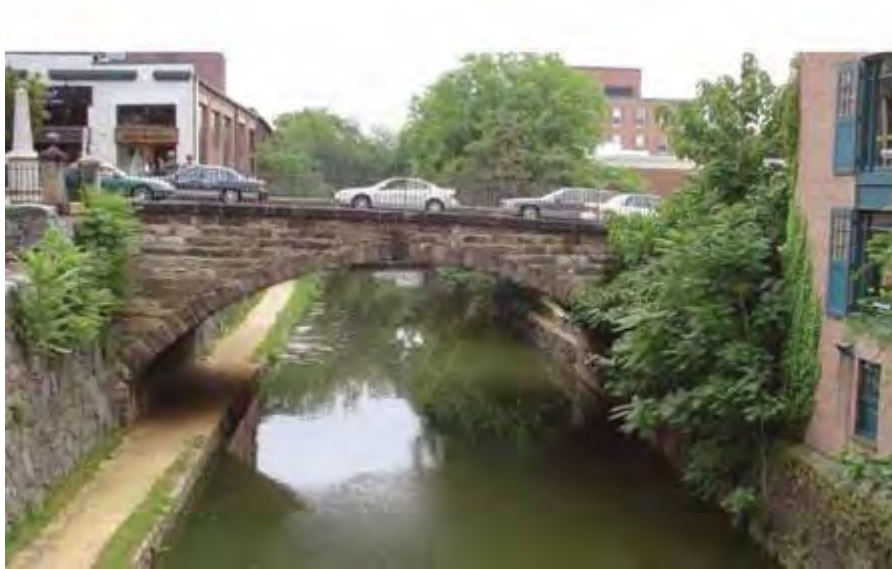
The Chesapeake & Ohio Canal flows under the stone masonry arch of the Wisconsin Avenue Bridge in the busy Georgetown area of Washington, DC. The towpath beside the canal serves as a footpath and recreation resource. The original wrought-iron railing dates back to 1831.

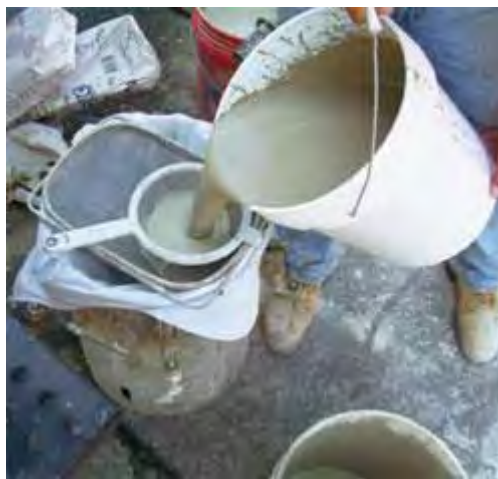
The masonry grout is strained to remove lumps before it is fed into the fabric sleeve.

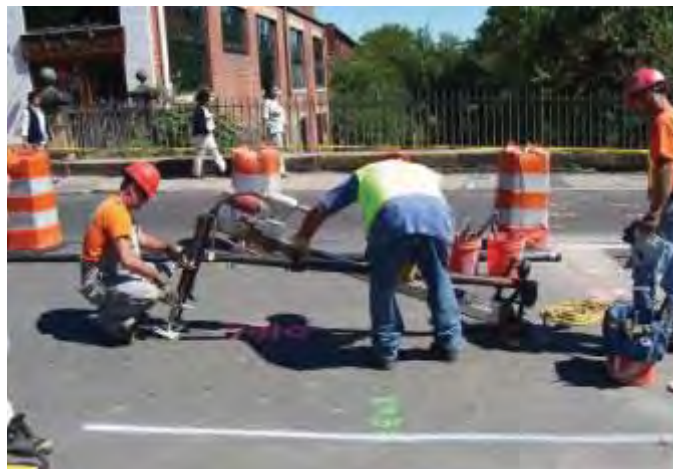
Workers bolt the drilling rig to the pavement on the bridge in preparation for drilling the 26 holes needed for the strengthening project.

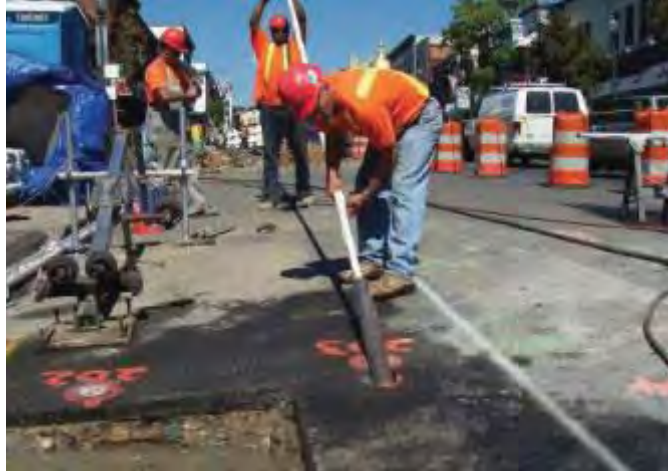
Workers insert the fabric sleeve and stainless steel reinforcing rod into the drilling pipe, which is later removed. In the background, traffic continues to move across the bridge during the work.

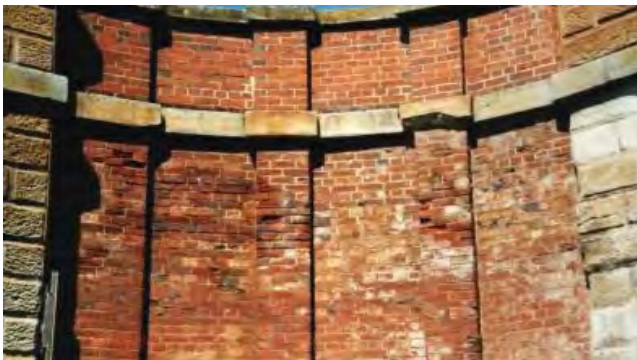
Damage to wingfall – note coloured cement render from 1930's and salt deposition caused by it.

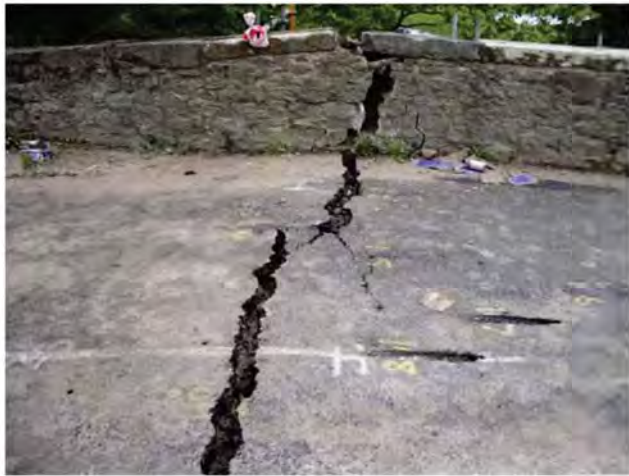
The east abutment appeared to be intact with no movement or cracking identified. The west abutment appeared to be intact at the upstream elevation. At the downstream elevation there was a large amount of dilatency of the masonry, with severe cracking and evidence of movement on both faces.

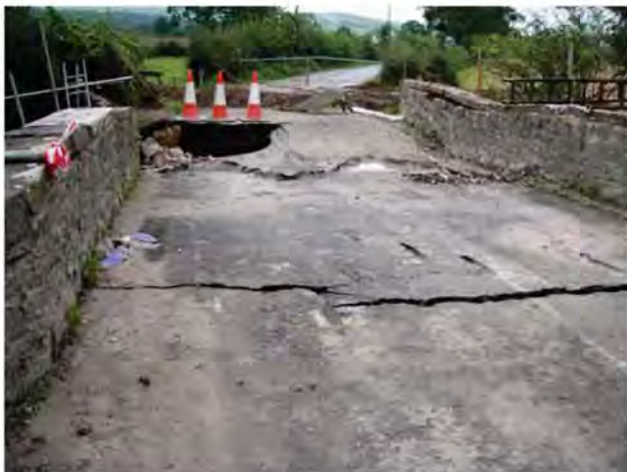
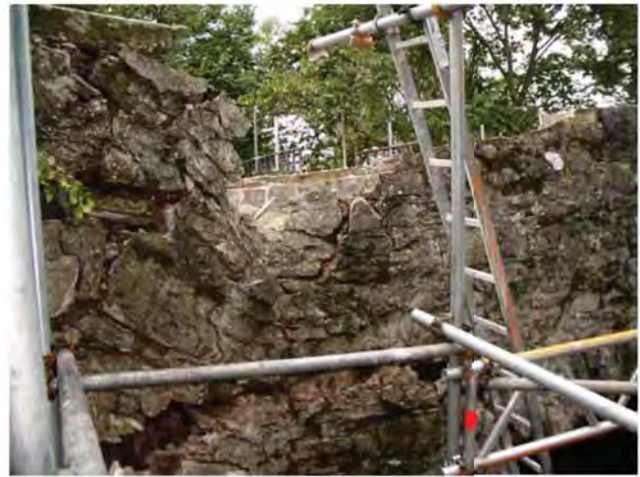
The movement of the road surface suggested that the arch barrel had rotated up to 4.5 degrees about the east springing. There was distortion of the arch barrel due to differential movement, resulting in a shear crack at the west upstream corner. The fact that this corner is lower than the adjacent arch barrel suggested that the abutment dropped vertically at this corner, followed by the adjacent arch barrel. Apart from this south west corner, the arch barrel was in reasonable condition.

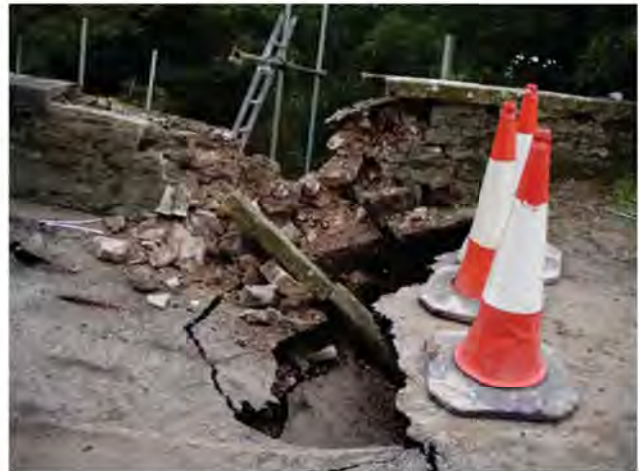
The damage to the upstream spandrel and parapet was mainly limited to the large area of damage above the west abutment and a significant crack above the east abutment. Damage to the downstream spandrel and parapet was more widespread, with cracking through mortar joints almost throughout the length of the wall.

The road surface showed three main failures, indicating tension failure above the east abutment, compression failure above the west springing and shear failure to the west of the bridge.

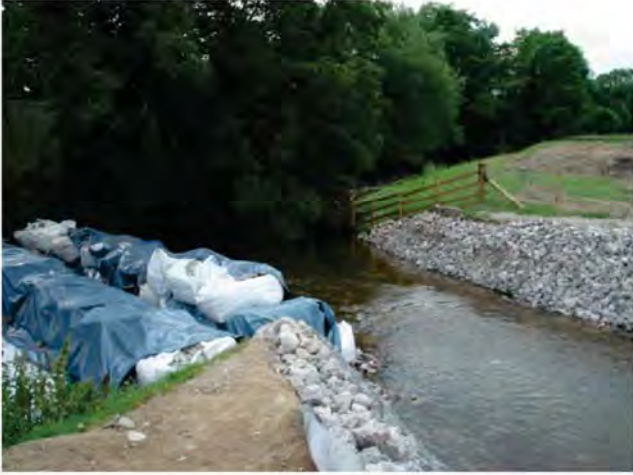
Cintec anchors were drilled and installed to stabilise the structure.

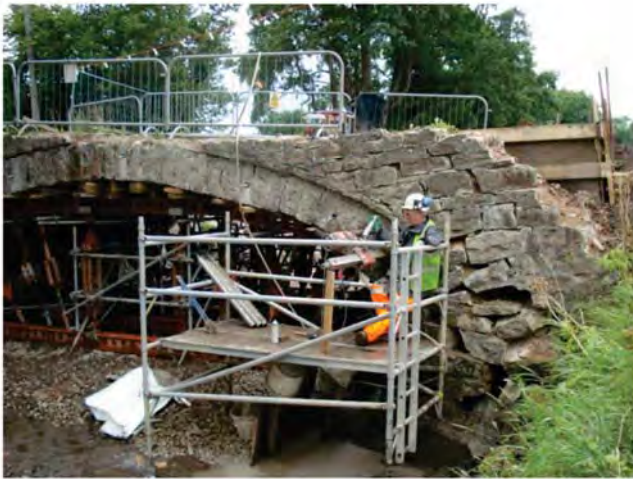
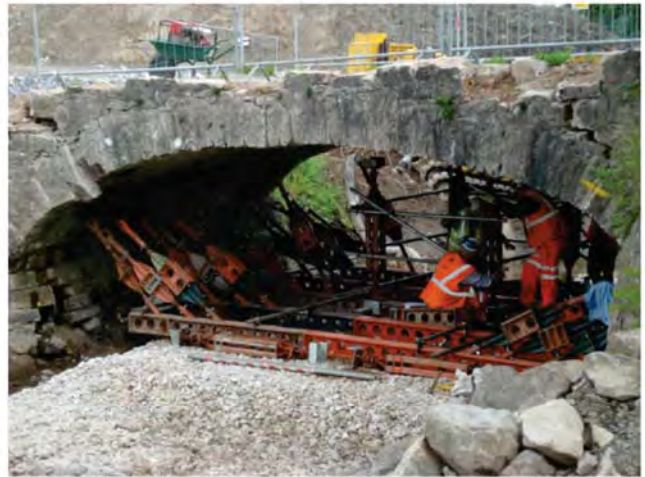
The arch was propped underneath and the parapet walls removed.

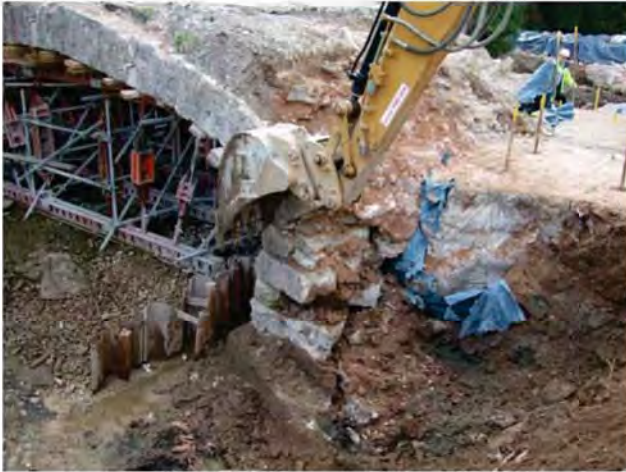
After the installation of the Cintec anchors to bring the bridge back to a 40 tonne capacity, the roadway was reconstructed to the original profile.

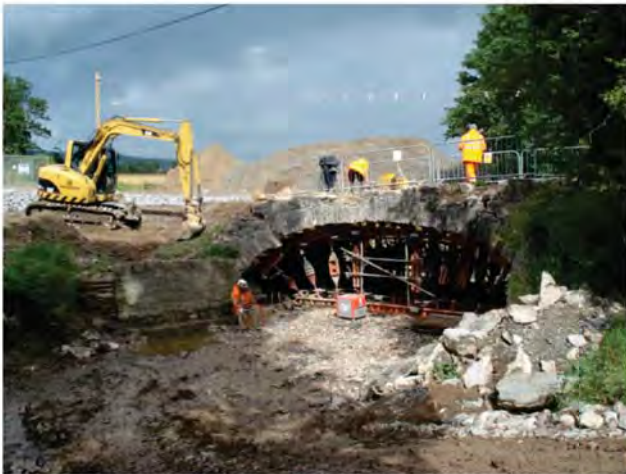
New culvert installed to act as a permanent flood relief system which was put to the test shortly after the project was completed.

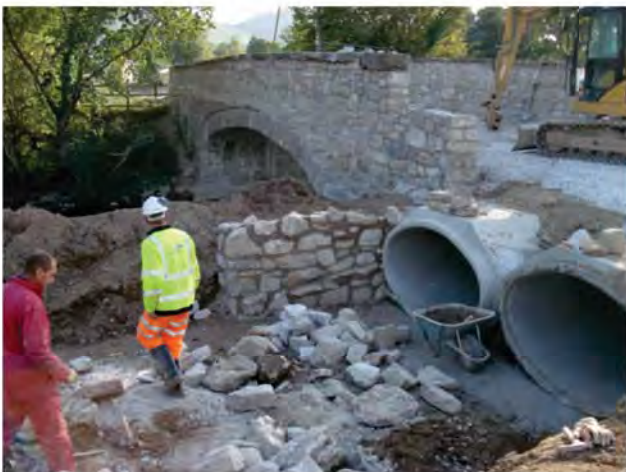
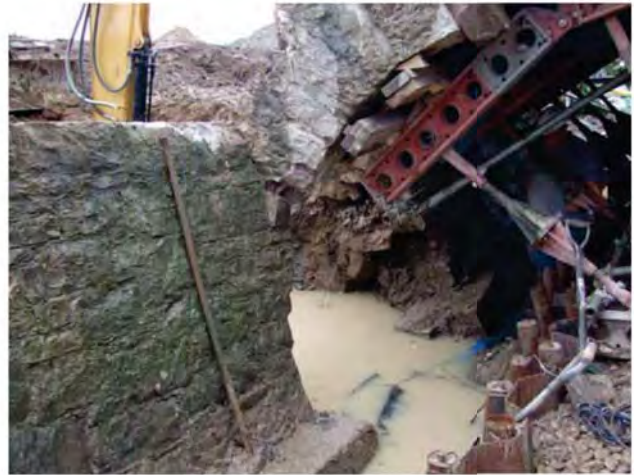
The flood had caused the abutment to move which necessitated the complete removal of the abutment and providing a new foundation and concrete abutment, which was subsequently faced with stone.

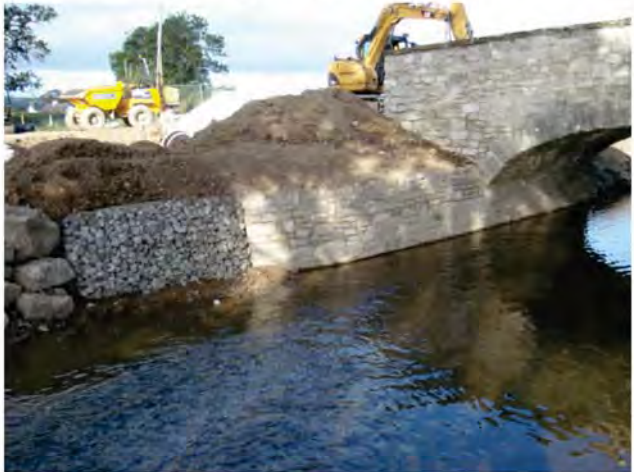
New gabions were placed to protect the river bank and training walls constructed, faced with stone to match the structure.

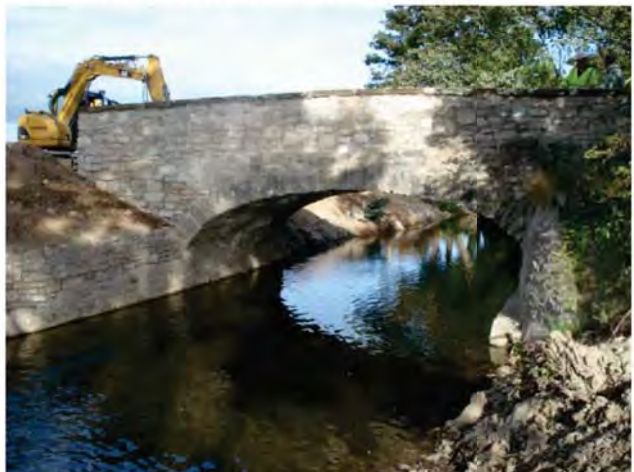
Parapet walls rebuilt and all fencing, landscaping, river banks and hedges were reinstated.

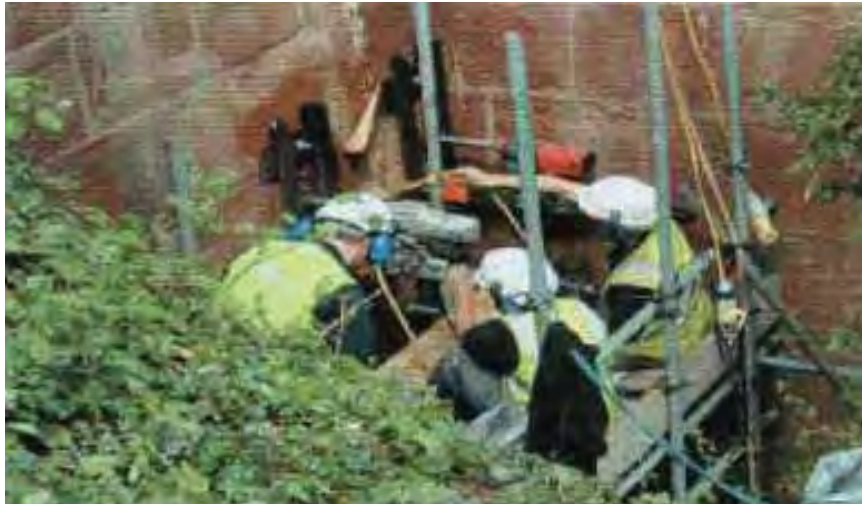
Following this, 20 CINTEC stainless steel rebar anchors were used to pin together the external and internal sandstone blocks cut through by the opening. These 16mm (5/8") diameter solid circular section anchors, measuring 1,500mm (59") long, were installed at an angle and at 300mm centers around the doorway. The anchors were inserted in 40mm (1 1/2") diameter predrilled holes, oversized to accommodate expansion of the anchor sleeve with grout. In order to maintain the aesthetics of the bridge the anchors were in set by 200mm (8") to ensure they would not be visible on the external sandstone face, achieving a sympathetic invisible bond around the new opening in the listed structure. Falcon Structural Repairs of Portishead – UK, undertook the stitch drilling and anchoring to create the new doorway, it required eight days to cut the opening and just two days to install the CINJTEC anchors. The work was approved by English Heritage as well as the local planning authorities.

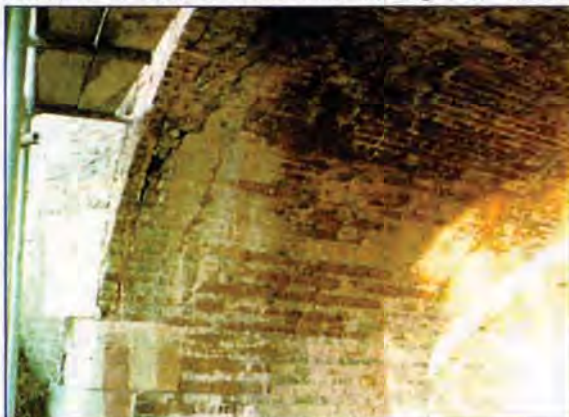
Typical damage to the soffit of the bridge

The most recent remedial work involved the repair of cracking in the brickwork. The concentration of the damage in the two side spans of the three span bridge suggested that the initial cause was possibly impact loading towards the ends of the bridge before the 'hump' was levelled out in 1982. This impact loading will have had the effect of forcing out the spandrel walls. Frost damage during the cold winters of 1936 and 1987 and washing out of mortar have further developed the initial effects. This has led to cracking of brickwork adjacent to the arch voussoirs, some movement in the spandrel walls, and delamination of the wing walls at the south end.

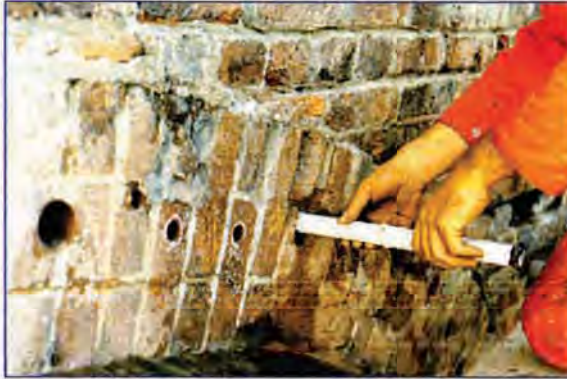
Placing the anchor in the prepared hole

To prevent any further spreading of the arches it was proposed to tie across the full width of the bridge. The main anchors are 20 x 20 x 2.0 SHS with the lengths, of 2.0m and 1.0m, staggered from both sides of the bridge. This ensures that the lateral stresses are not transferred to a single plane nearer the centre-line of the bridge causing new cracking at this point. Strengthening of the local edge damage to the brickwork of the arches is achieved with the installation of 450mm long RAC anchors formed with 8 x 1.5mm circular hollow sections. The interspacing of the two anchors allowed the 20mm diameter holes for the small anchors to be used for the fixing of the stand used with the diamond drilling of the 52mm holes for the main anchors, thus keeping the making good to a minimum. Following grouting of the anchors the holes were made good with coloured mortar to match the brickwork.

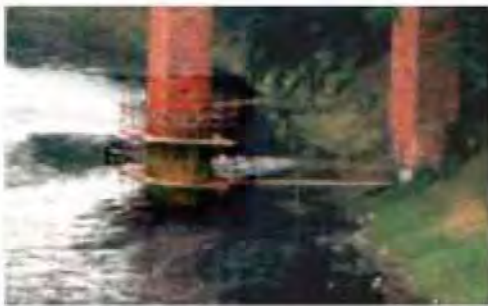
View of drilling platform

Under the supervision of the local river authority, holes were drilled at a downward angle through the boots and into the piers. These instantly filled with river water, however due to the unique nature of the Cintec anchor - filling a mesh fabric sleeve from the rear to the front, all water was fully displaced upon grout injection. The visible cracks were sealed manually by inserting lengths of sock into the fissures and expanding them. The subsequent watertight seal allowed conventional grouting to be injected into any remaining internal voids without danger of release into the water system.

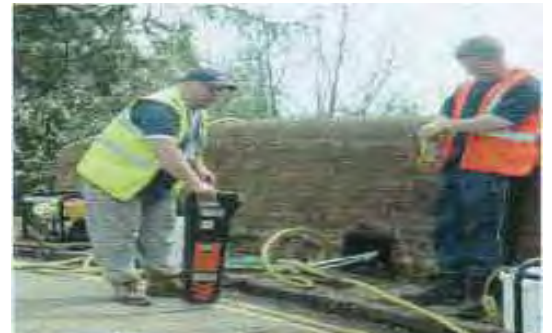
Checking for sub-surface services during bridge survey

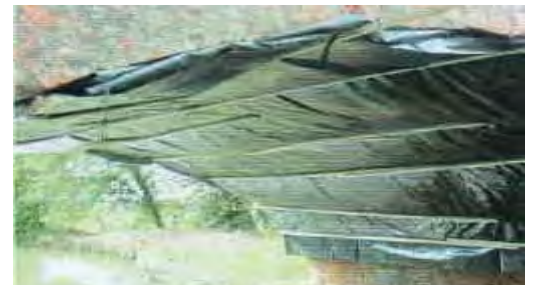
Temporary below arch protection during the installation process

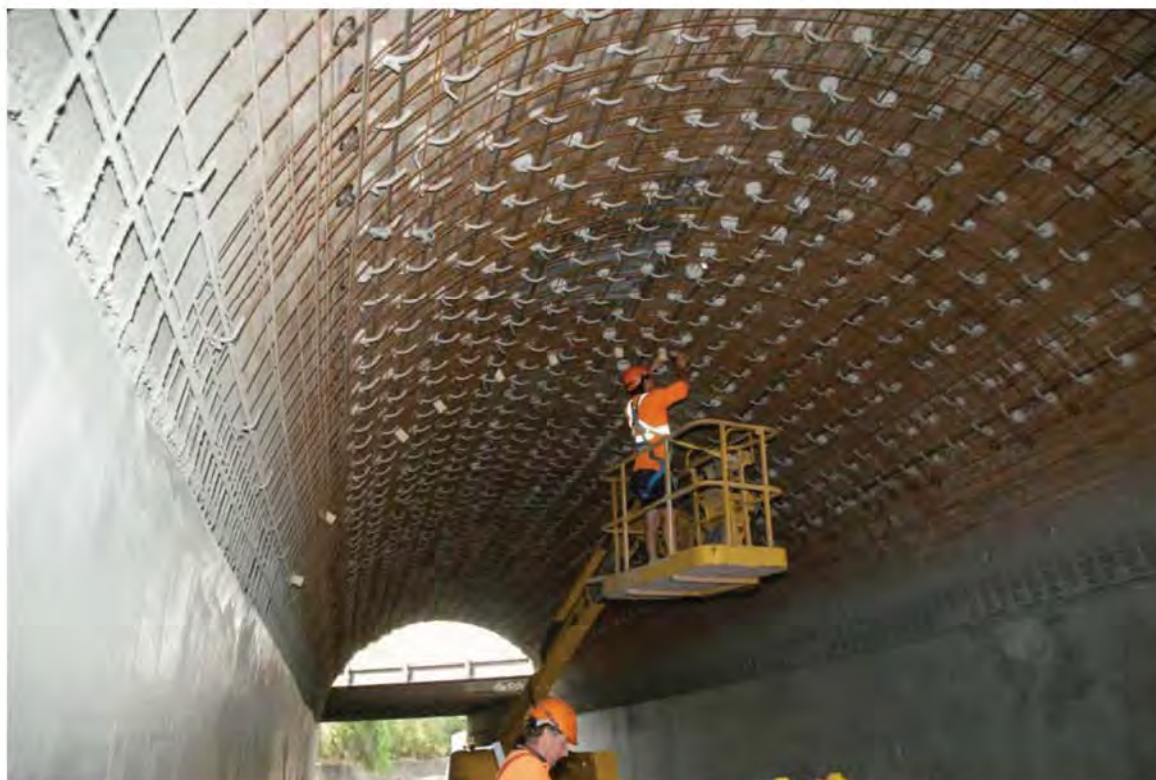
DUCK CREEK CULVERT, GRANVILLE FOR NSW RAIL CORPORATION SYDNEY , AUSTRALIA

The 6 metre span brick arch culvert at Granville in Sydney's western suburbs carries three tracks of the suburban railway system. Structural failure had occurred through overloading producing a crack along the top of the arch.

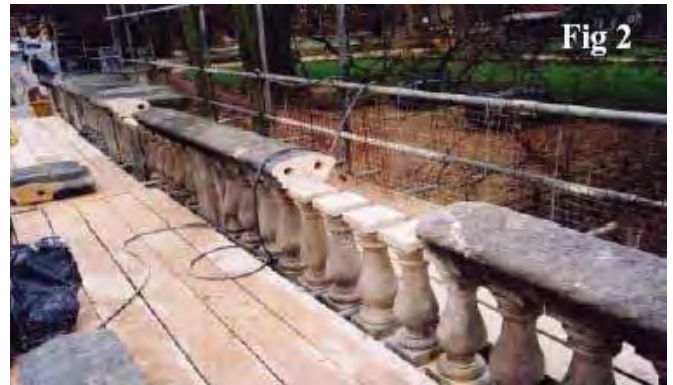
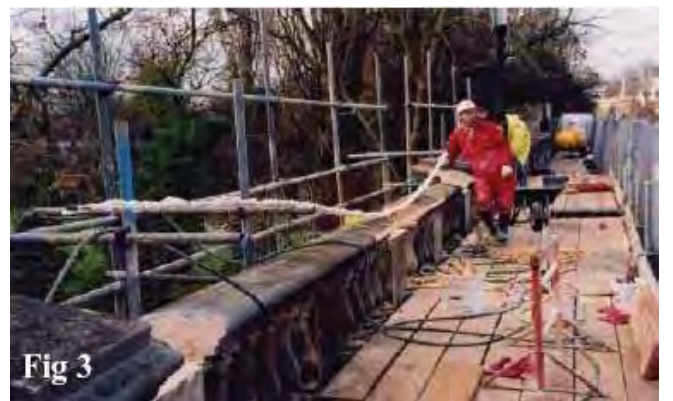
Figure 2 shows the holes drilled horizontally through the parapet. Figure 3 shows a horizontal Cintec anchor prior to installation

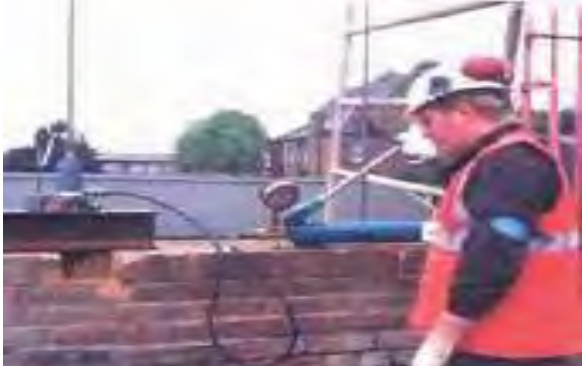
Post-Tensioning Cintec anchor in test panel..

Two 16mm diameter 2 stage anchors were installed vertically, the anchorage length within the supporting structure was then inflated and left to fully harden. The anchor was then tensioned and the second sock occupying the remaining space in the masonry wall was inflated.

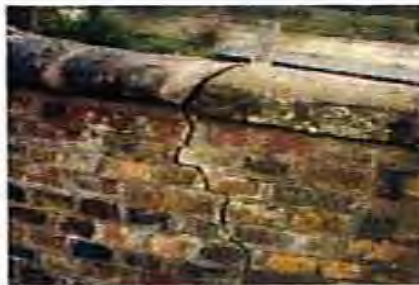
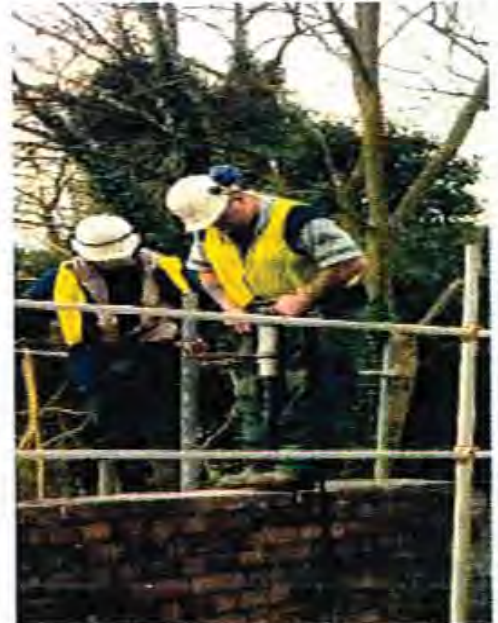
A solution was achieved by the installation of Cintec 16mm studding anchors, of between 1.5 and 3metres in length. These were designed with two individually inflated socks and were installed vertically at 1metre intervals through the parapet walls and into the barrel of the arch. The lower (arch barrel) sock was then inflated and left to cure. The second sock was then inflated and placed under a tension of 10kN by using a tensioning plate. This sock was then cured and the tensioning plate removed.

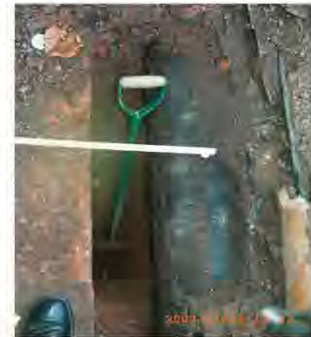
Fig 1. Excavations revealed a large gas main close to the north wall.

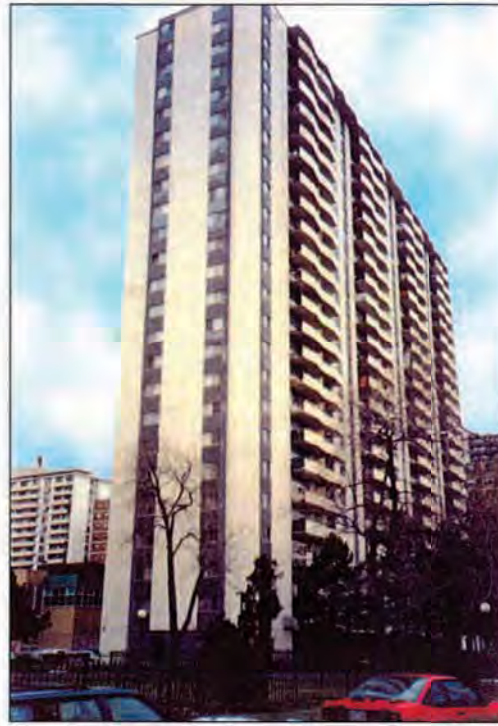
- a. Use of the Cintec corbel anchor to transfer vertical loads from the exterior walls to the back-up walls.
- b. Broken header ties to be restored using Cintec stitching anchors. These concepts were proven with full laboratory load tests. Results available upon request.

In areas where the exterior walls were beyond repair, Cintec anchors were installed with retaining plates to prevent collapse of the panel, while it was being dismantled. The anchor was used to tie the new brickwork to the back-up wall.

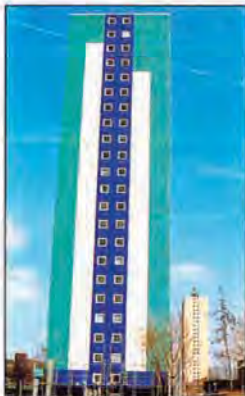
The anchor body was of high tensile stainless steel studding, capable of carrying the load, surrounded by a fabric sock to contain the cementitious grout. At the outer end, an exposed stud protruded by approximately 200 mm to facilitate the termination to the outer panel via a counter bored hole and heavy gauge large washer and nut.

Concrete repair techniques were used to finish and hide the bore hole.

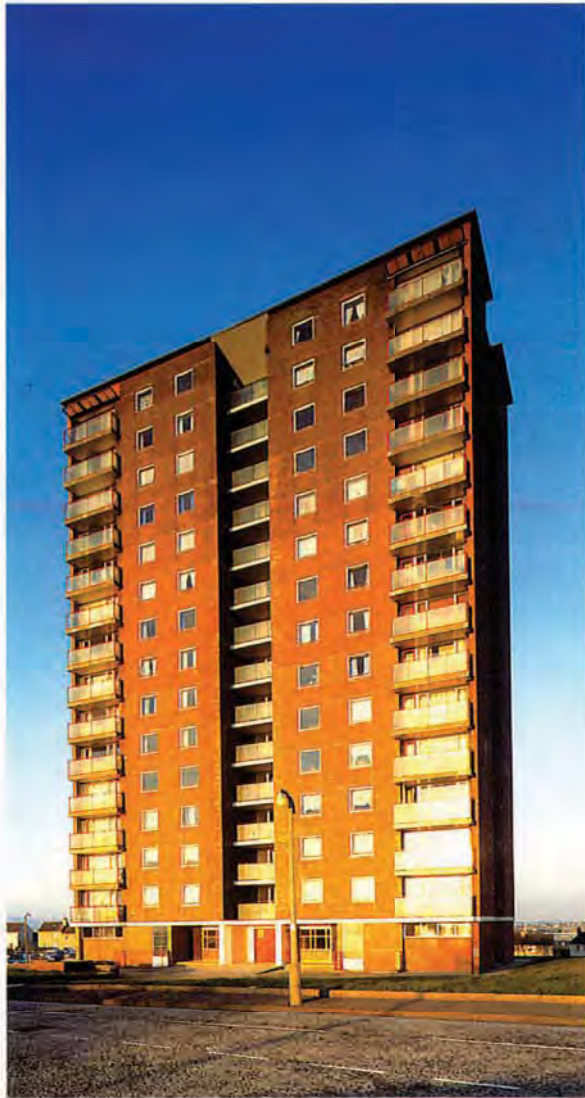
OLIPHANT COURT, PAISLEY, STRATHCLYDE

Scottish Special Housing Association designed and supervised the renovation of this fourteen storey apartment block using the Cintec corbel anchors and wall ties during 1987/88. The block was constructed of an insitu reinforced concrete frame with concrete floors and an insitu edge beam with an overhanging nib to support the external brickwork. creep and shrinkage of the concrete frame were primarily responsible for cracking and bowing of the external brickwork.

The external brickwork required replacement, so the outer leaf was dismantled. Re-building of the outer brickwork leaf was accelerated by the provision of the stainless steel angle supports at each floor level. The simple horizontal corbel anchor into the slab could not be employed because it would have cut the top edge beam reinforcement. Instead, Cintec corbel anchors inclined at 45° were supported over the downstand beams and used to support the stainless steel angles supporting the external leaf of brickwork. The

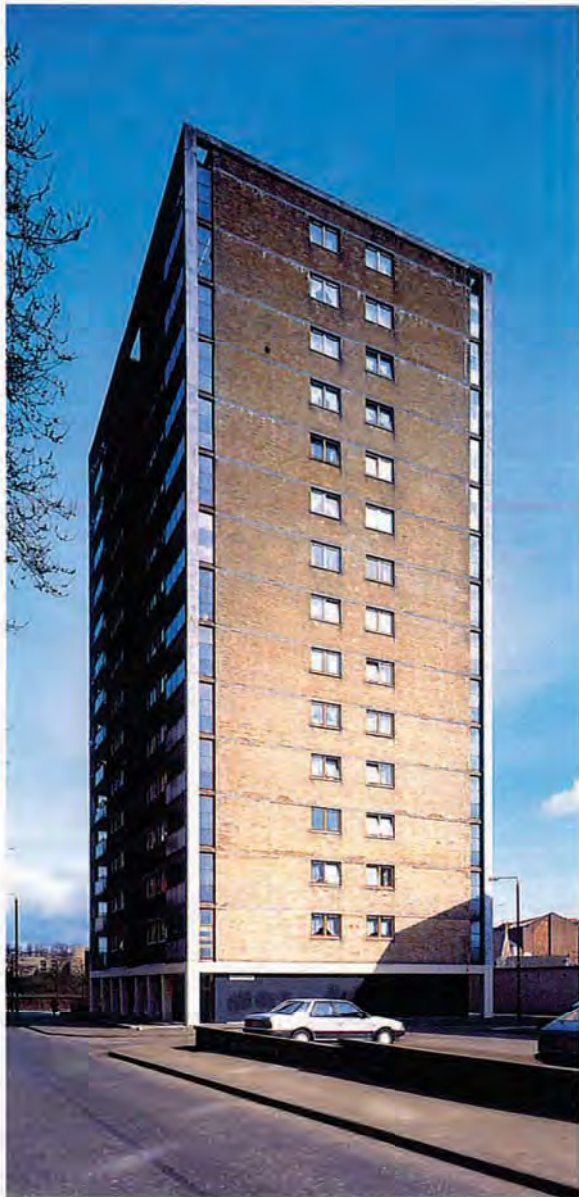
HIGH RISE APARTMENT BLOCKS, GLASGOW

Scottish Special Housing Association designed and supervised the renovation of 18 No. fifteen storey apartment blocks using Cintec corbel anchors and wall ties during 1984-1987. Typically the blocks were constructed of insitu reinforced concrete inner walls, columns, beams and floors with brickwork cladding on the edge of the floor slab and supported by the concrete frame. The major defect was the deterioration of the concrete nib supporting the brickwork cladding with subsequent cracking and bowing of the external brickwork. These problems were caused by creep and shrinkage of the concrete frame.

The support provided by the concrete nib was replaced by the installation of Cintec corbel anchors at approximately 700mm centres at each floor level. The anchors were embedded approximately 90mm into the inner concrete leaf

The corbel anchors were 30 x 30 x 3 SHS stainless steel sections with an external sock in a 60mm diameter core holes, which was filled with grout injected under pressure of approx. 3 bars. The external face was filled with a high-bond expanding mortar to match the existing brickwork. Cintec wall ties, 10 x 1 CHS stainless steel sections in a nominal 20mm diameter core hole, were used to restore the integrity of the brickwork panels to the required standard. Laboratory tests were undertaken on the compressive strength of the grout and the metallurgical and tensile properties of the stainless steel sections, whilst the installed anchors were checked using borescopes for deformed shape and adequacy of fixing.

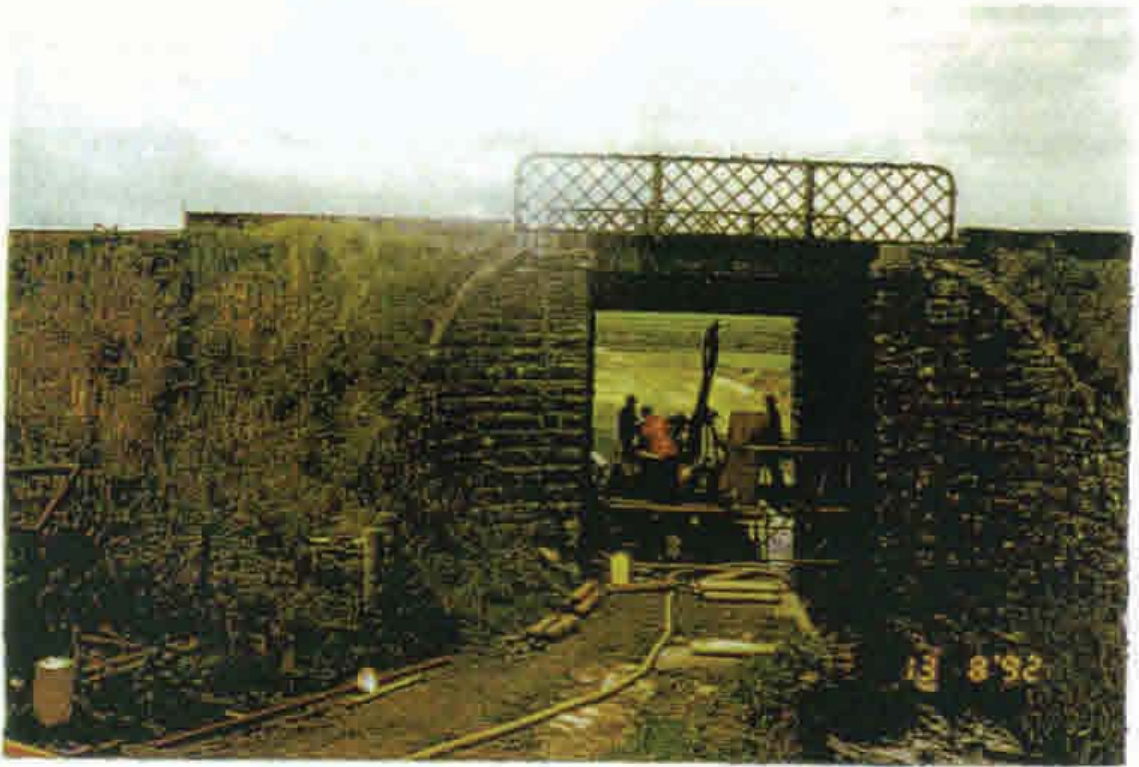
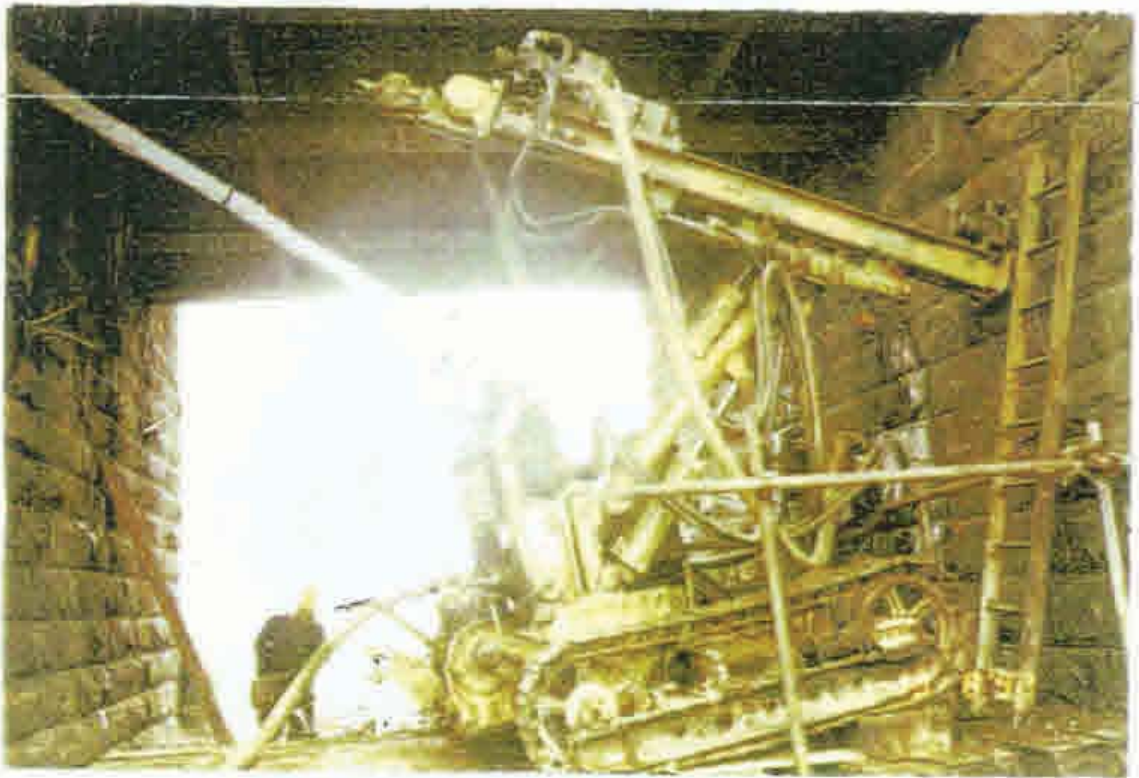
**Installation of Ground Anchors
Through Railway Bridge Abutment**

- a) A high tensile steel bar (ribbed type 2) forming the central element and load transferral mechanism to the abutment wall.
- b) The reinforcement bar has been epoxy coated to provide the first layer of corrosion resistance in accordance with British Standard for Ground Anchors BS8081: 1989.

- c) The corrugated sleeve of UPVC forms the second barrier against moisture and therefore corrosion resistance. The corrugations form a shear key to permit the transfer of forces from the ground to the central bar and then back to the structure.

- e) The grout forms the interlocking mechanism between the steel bar and the grout interface. The grout is a patented formulation developed specifically for anchor applications, it is delivered under pressure and is designed to obtain compressive strength capabilities of between 40 – 50 N/mm². Shrinkage is avoided by the use of additives premixed with the grout. The grout itself, being cementitious provides a highly alkaline protective environment against potential corrosion of the steel and the passage of moisture in the unstressed areas.

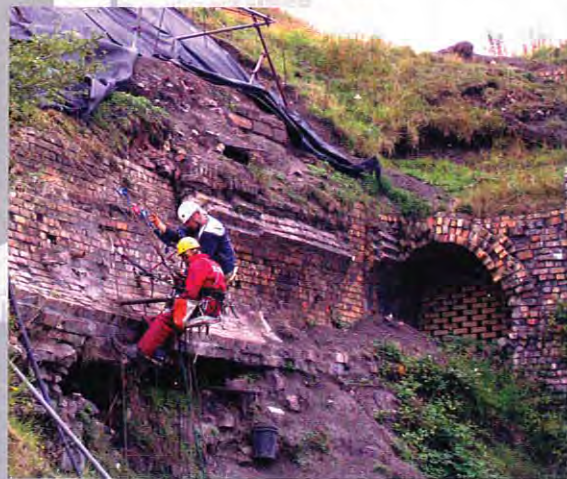
A double mining barrel, with an inner and outer sleeve, was used in areas where drilled cores could collapse before reinforcing members could be introduced due to the instability of the wall materials. The outer sleeve then creates a rigid conduit for the inner sleeve to work through, allowing core to be extracted to the required depth. With the outer sleeve still in place, the inner sleeve is removed and the Cintec anchor system inserted. The outer sleeve is then withdrawn before the anchor is permanently bonded into position with injection of grout into the Cintec sock.

A total of 29 deformed round bar stainless steel anchors, measuring 20mm diameter and 4m long, were used in this stage of conservation. A further combination of 8m long consolidating stitching anchors, 30mm by 30mm by 3mm SHS (square hollow section), and ground anchors approximately 11m long, were also used near the water tower.

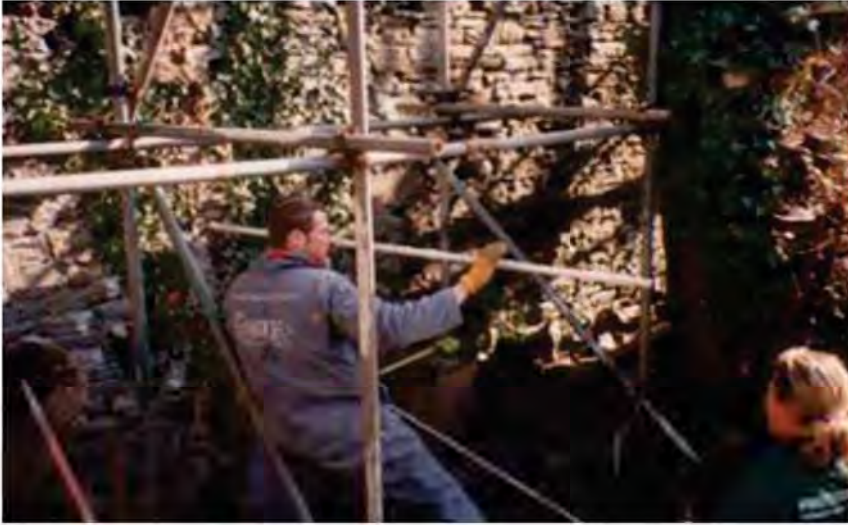
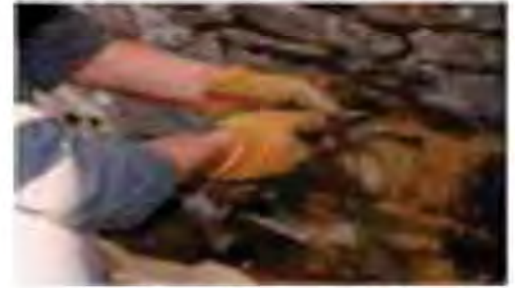
Insertion of 3m Cintec Anchor (left). Its inflation using cementitious grout, (above).

Cintec ground anchors were installed horizontally through the bed joints and into the ground infill retained behind it. This infill comprised mainly of broken brick, stone, clay, pottery shards and other assorted material. The core drilling technique employed to create the holes also revealed many voids within it, a significant feature of the Cintec anchor is its ability to bridge such gaps by retaining the flow of grout with its polyester sleeve. The 3 meter long Cintec anchors were installed at 1 meter horizontal intervals and tested to a working load of 15kN each.

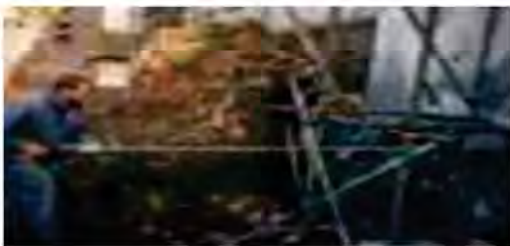
The process of diamond drilling (above). With the subsequent core samples produced, (left).
