CINTEC

DESIGNED ANCHOR SYSTEMS

Structural repair solutions
for stabilisation & conservation

**Structural Repair,
Stabilisation &
Conservation System**

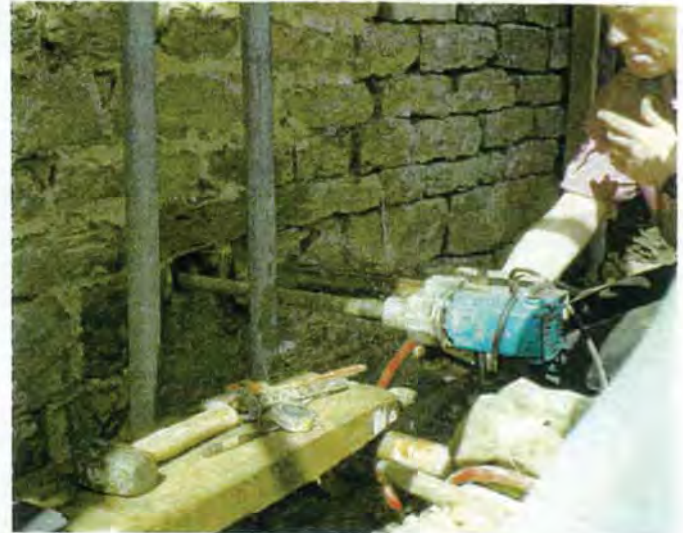
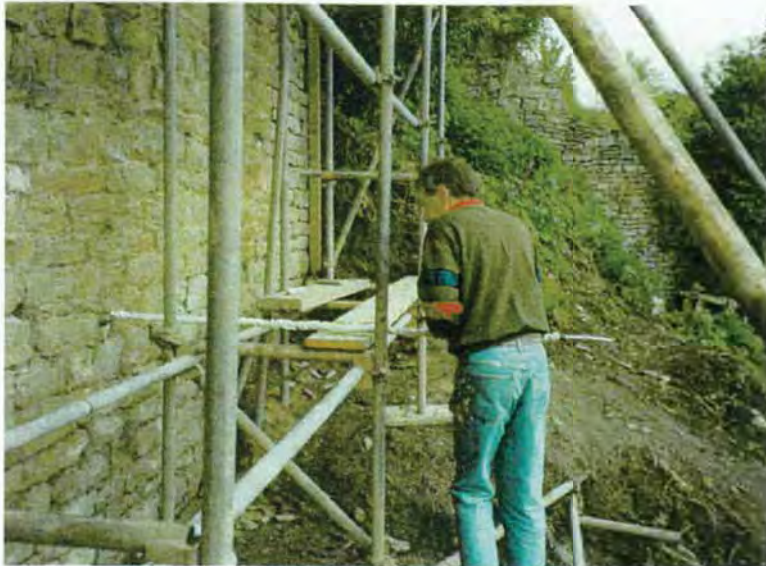
Diamond drilling (right) and anchor insertion (below).

The anchors were installed through the joints of the stonework following the completion of gravity grouting of extensive voids within. To facilitate this process, clay was used to seal the open joints between the stones in order to retain the original historic grouting. This was later removed and the wall pointed with lime mortar to match the original material.

The Cintecground anchors were tested to a working load of 15kN. Other, smaller Cintec anchors were also used for wall consolidation.

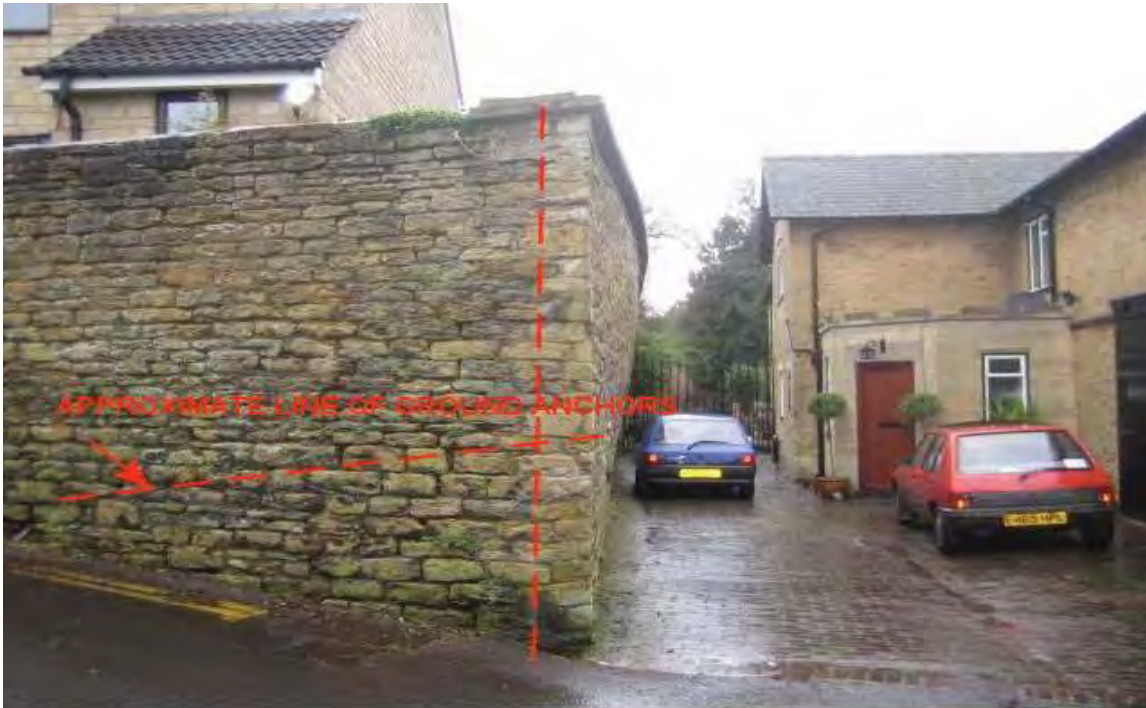
Malmesbury Church Street Rotation, U.K

As can be seen from above photograph this retaining wall has seriously rotated towards the next property. Understandably the neighbors were becoming extremely concerned about its safety. The wall retained the garden and some imposed load from the house foundations.

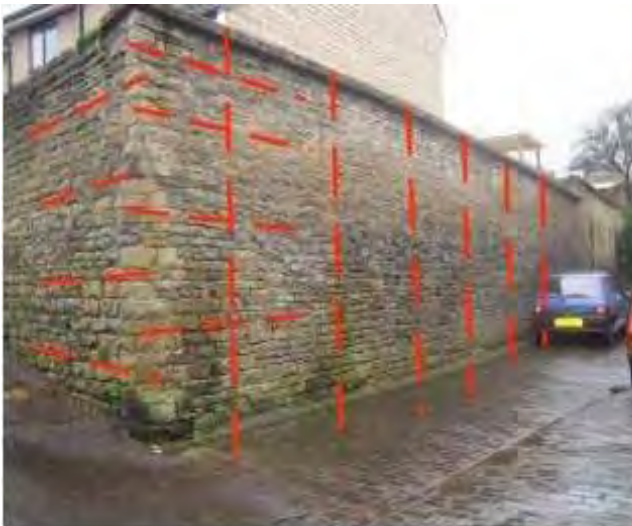
Engineers Mann Williams devised a scheme to save the situation by installing Cintec ground anchors through the wall at one-third height together with vertical Cintec anchors to reinforce & mobilize the full height of the wall to resist the rotational effect. Anchors were located as shown by dotted red lines.

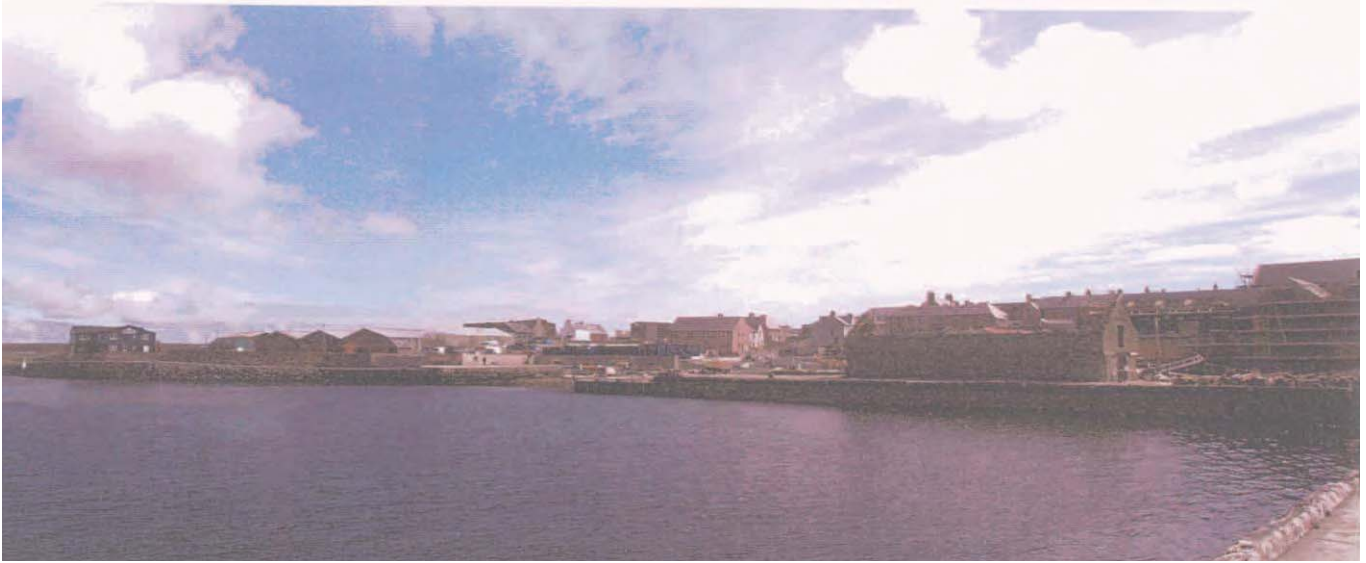
Panorama of Hay's Dock with the Heritage Centre under construction in the background (right), the restoration of the old sail house on the quay (centre right) and Cintec stablisation work (end of the quay left of sail house).

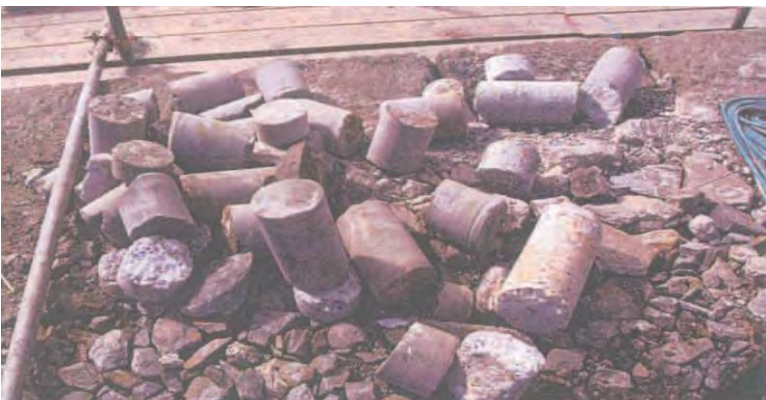
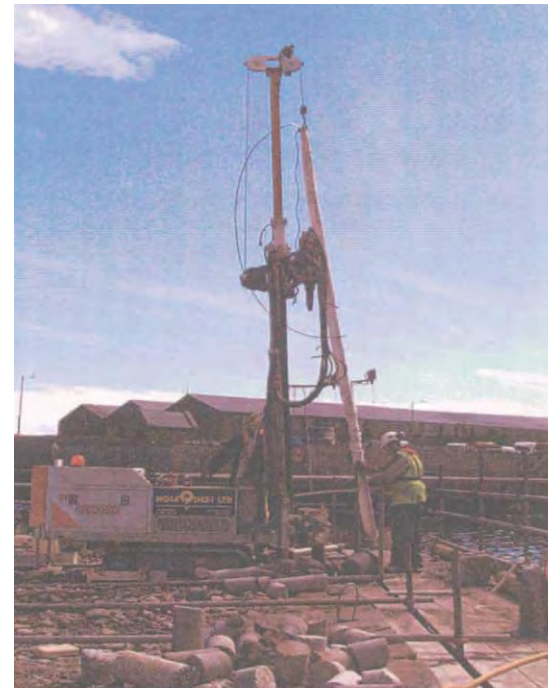
A mobile rig was employed firstly to core drill the anchor holes, then to temporarily install a metal tube hole lining, following by the lifting and lowering of the Cintec anchor (above) and finally the removal of the temporary core lining prior to anchor injection

Consulting Engineers Elliott & Company proposed a solution for installing Cintec anchors to both secure the individual blocks of stone masonry and also to underpin the whole structure to the bedrock below. 18 Cintec Multibar anchors were installed by the drilling contractor Holequest Ltd, each anchor being five meters long and consisting of four strands of 16mm diameter 316 high grade stainless steel rebar in square formation. A drill rig was used to diamond bore each 150mm diameter hole prior to the installation of the mulibar anchors. The two man cycle of drilling and installation proceeded at a rate of one anchor extremely variable weather even in the month of June.

High grade stainless steel was chosen to improve the long term resistance to the corrosive effects of the salt water. Before installation, the polyester sock of each anchor was completely saturated in fresh water, not only to facilitate the injection and inflation of the anchor, but also to provide a temporary barrier between the reinforcing bars and the external sea water. The low pressure injection of the cementitious grout expanded the anchors from the far bedrock end upwards and so displaced any sea water within the drilled holes and locking the anchors were installed, the original surface edge stones and inner cobbles were placed back into position, concealing the stabilisation work beneath.

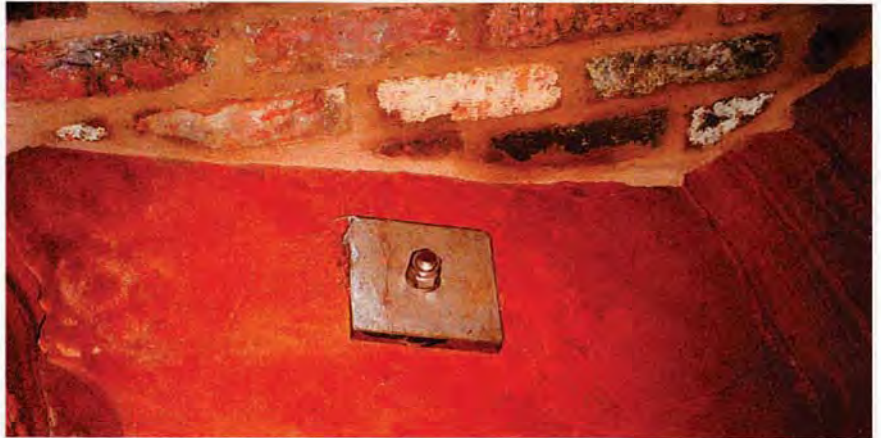
Roof bolt support to ballroom ceiling.

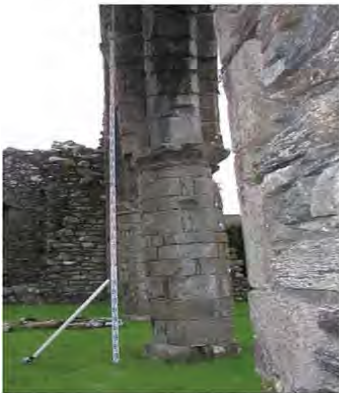
Image revealing the extent of wall and column rotation prior to stabilisation

Temporary support frames were positioned either side of the arcade wall (left). With plastic in place to protect the wall, a soft grout was injected between the jacking frame and the masonry and left to set. Pressure was then slowly applied and the wall rotated into the vertical position. Open joints required the careful hand sawing of the original ashlar followed by repointing. 4No. 20mm diameter stainless steel Cintec stud anchors were installed vertically into 76mm diameter holes centrally through the arcade columns and through the wall. A similar horizontal anchor 14m long was then installed horizontally along the arcades length. Finally, numerous small consolidation anchors and arch radial anchors completed the Cintec stabilisation. (See below)

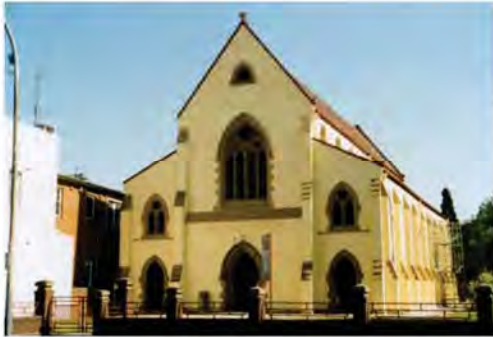
◀ Methodist Church, Maitland, NSW (1858). This building suffered damage in the 1989 Newcastle earthquake. 6 m Cintec anchors were used in the wall buttresses to provide the additional strength required to resist future seismic damage.

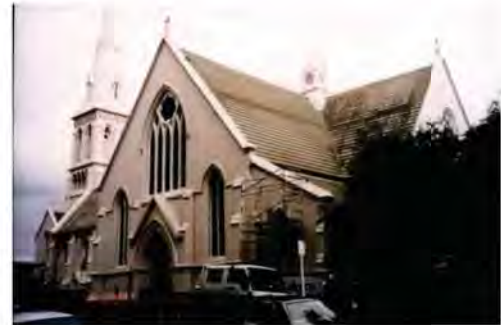
St Patrick's Cathedral, Auckland New Zealand (1885/1907). Cintec anchors up to 3 m long have been used to repair cracking from foundation movement. ▶

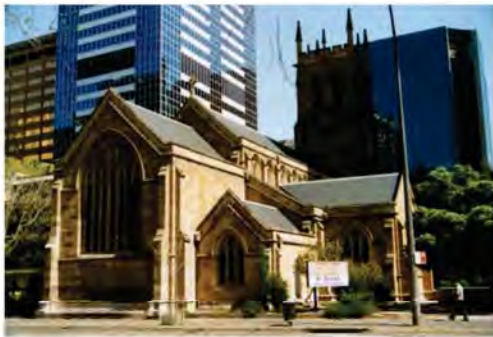
◀ St Philip's Church, Sydney, NSW (1856). Roof spread had led to wall cracking at eave level. Cintec anchors provided the economical repair solution with a guaranteed long life with no visible affect on the building.

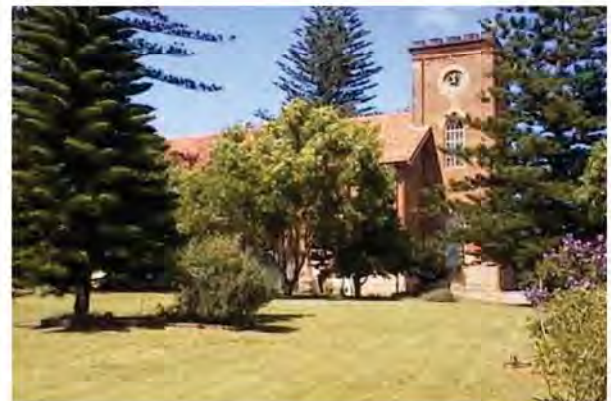
◀ St Paul's Church, Spring Hill, Brisbane, Queensland (1889). In order to protect the deteriorating stone spire of this church with a copper-clad cover, the tower had to be strengthened. 6 m long Cintec anchors in each corner of the tower provided the necessary extra strength. The tops of the anchors were threaded to fasten the frame of the cover.

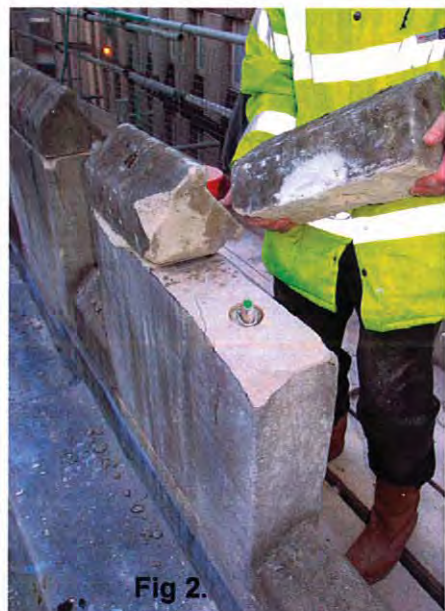
Twin socked anchors designed to tension the upper parapet sections into the base of the parapet.

The capping stones of the limestone parapets were removed and vertically core drilled by the installers Protectahome Ltd with 40mm diameter holes and 2150mm in length. The 16mm diameter stainless steel anchors were twin socked (Fig 1) in order they be post tensioned - a process of firstly inflating the lower sock while applying tension to the anchor with a metal plate screwed onto the exposed thread on the upper end on the anchor. One set the second sock is inflated and the tensioning plate removed. The capping stones were then replaced to conceal the anchors within (fig 2). In all No.64 parapet anchors were installed and another No.8 deformed bar anchors were used to strengthen the medieval spire buttress as well as their ornate pinnacles (Fig 3).

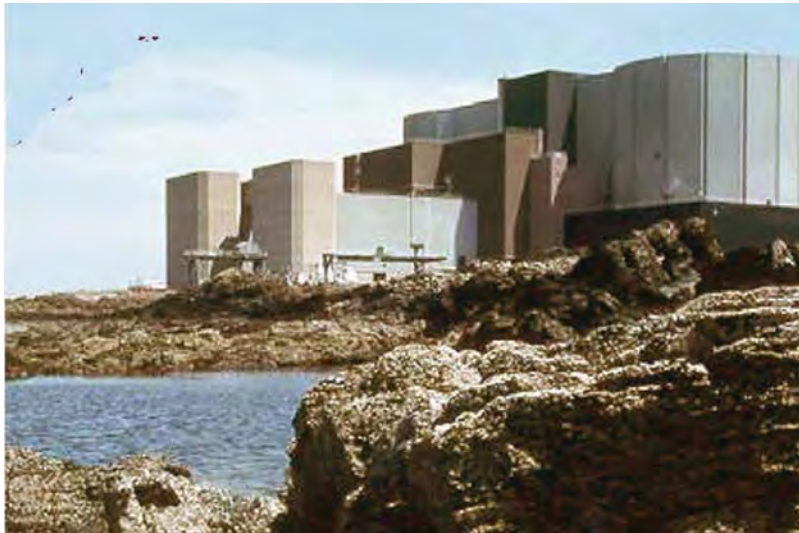
Wylfa Power Station, Anglesey, North Wales UK

A brick concrete structure near to the central core of Wylfa Power Station was deemed to be at potential risk of collapse in the unlikely event of strong seismic activity. The walls consist of an inner and outer leaf of brick and concrete and the connections tying the two together were considered unsatisfactory. Heavy duty high tensile ferrous 12mm diameter wall ties were installed to secure the structure in the event of an earthquake. A number of Cintec Stud Anchors were also installed to provide anchorage for electrical equipment (fuse boxes, cable ducts, pipes etc) which were subsequently attached to the inner leaf.

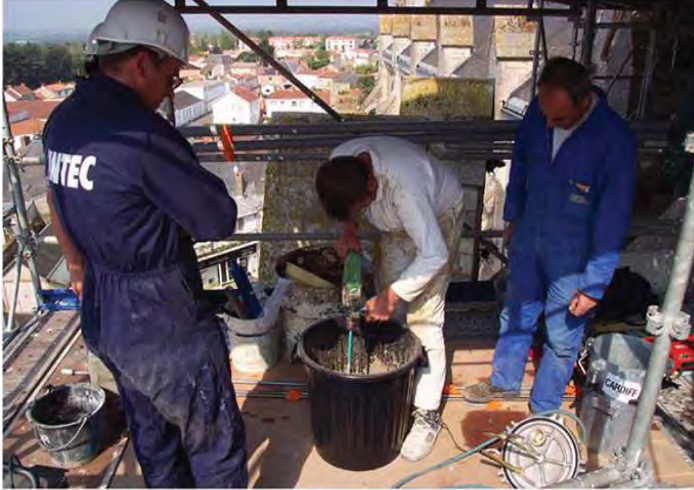
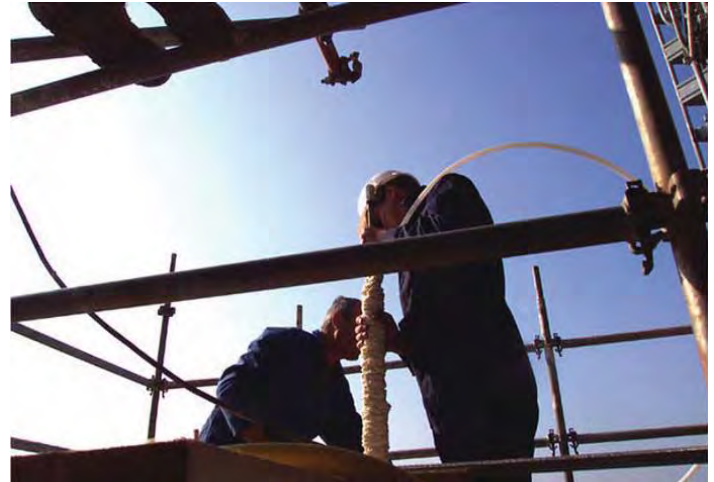
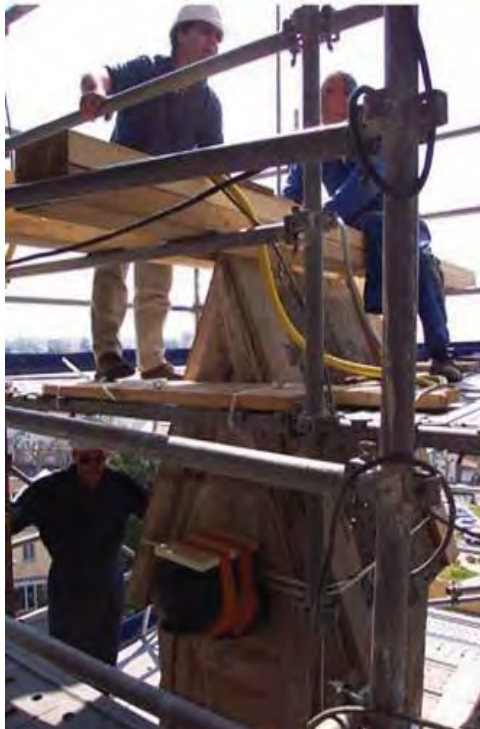
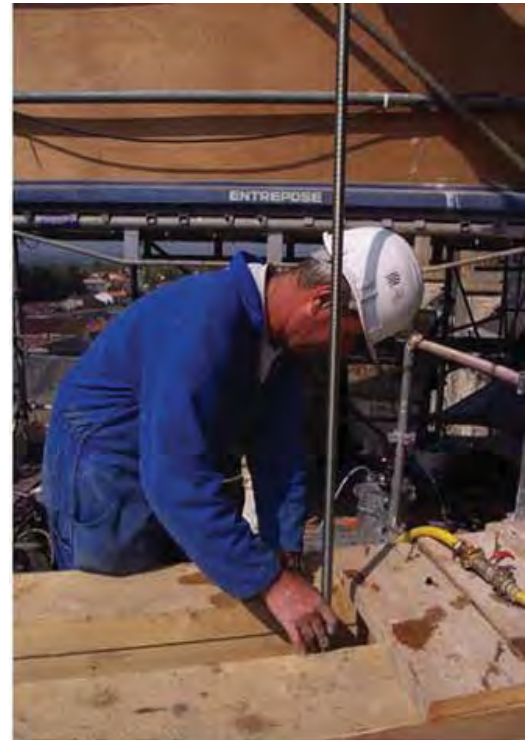
In order to repair damage caused by centuries of seismic activity, This French project involved the installation of 11 meter vertical anchors through the flying buttresses together with 260 RAC consolidating anchors comprised of 40 No. 1500mm 10mm CHS RAC's plus 110No. 1300mm and 110No. 700mm of the same type

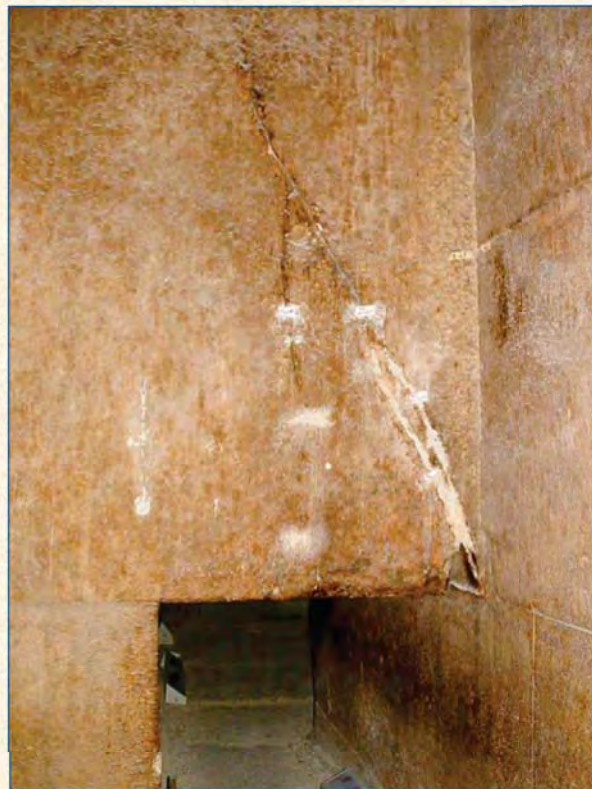
Front elevation of cracked beam

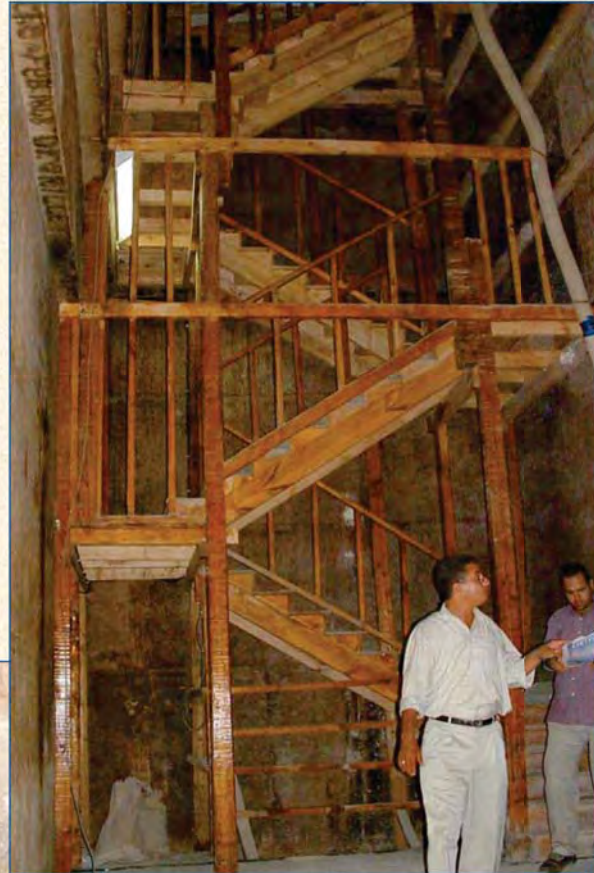
The high burial chamber

The present problem was not on the exterior of the pyramid but one on the corridor between the corbelled burial chambers. The beams spanning the low corridor opening were cracked, from the base of the stone beams, up through the centre of the beams, to a position just adjacent to the centre at the top of these stone beams. It was impossible to drill at right angles to the corridor due to the mass of the core of the pyramid. However, it was possible to drill at an angle of 43 degrees in the respective burial chambers at both the entrance and exit of the corridor and secure the beam with a row of 20mm diameter Cintec stainless steel consolidation anchors. Work was completed at night after the monument was closed to the public because the position of

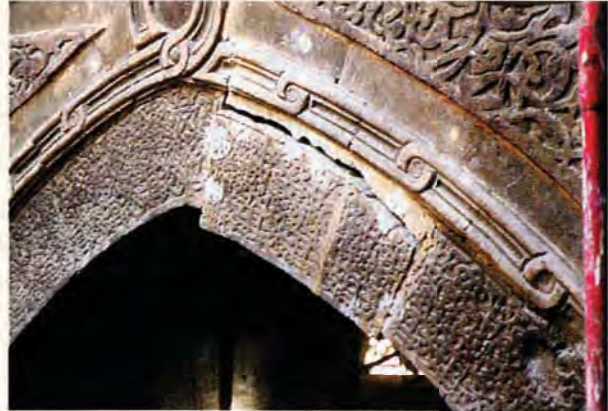
Seismic damage to decorative arches

An inspection of the Madrasa revealed some very severe long-standing problems. The floor of the mosque undulated dramatically, providing evidence of very significant foundation problems of the masonry vaults supporting the floor. Attempts had been made in the past to underpin the sleeper walls supporting the vaults, these had failed. All of the walls of the mosque exhibited very severe fractures. The problems were brought about by earthquake damage in October 1992 and by the rising contaminated ground water. Further problems in the external walls had been caused by the activities of the shopkeepers trying to enlarge the space available for selling their wares. As a consequence, sections of masonry have been demolished at ground floor level to create this additional space.

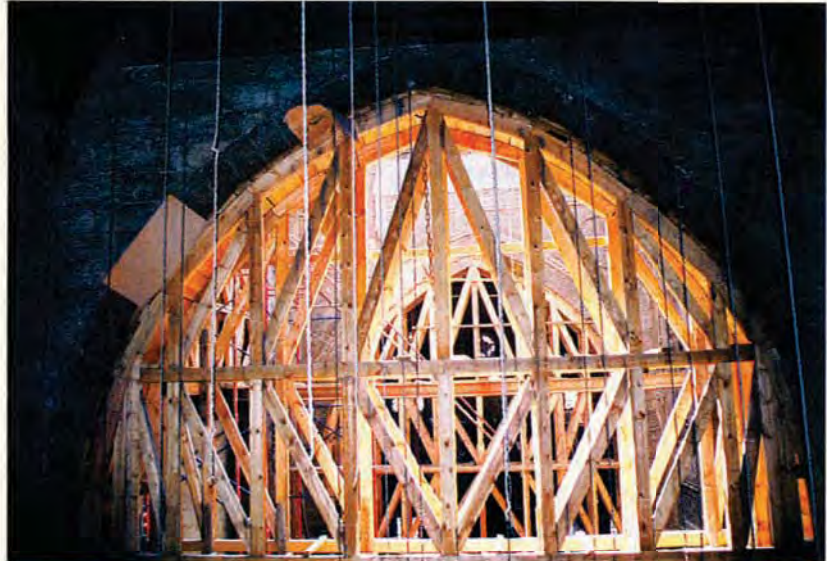
Temporary support of the Dikka arches

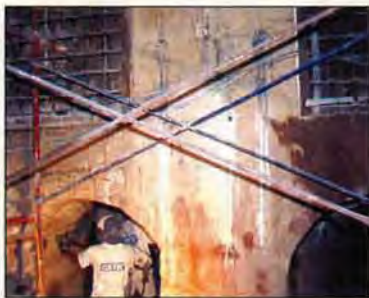
Drilling the vaults

The Cintec stitching system was extensively used at al-Ghuri. These reinforcement anchors, up to 12 metres long, serve to stiffen each individual wall immensely. The walls of al-Ghuri are generally of two facing skins in-filled with a core of rubble. The large arched openings in the mosque are particular points of weakness in the structure. Longitudinal ties in each of the stone facings of the wall above the arch would serve to resist the thrusts naturally produced by the arch as well as serving to assist the walls to resist the next earthquake. In addition to longitudinal ties, transverse ties of length equal to the thickness of the wall were introduced to increase the strength of the wall.

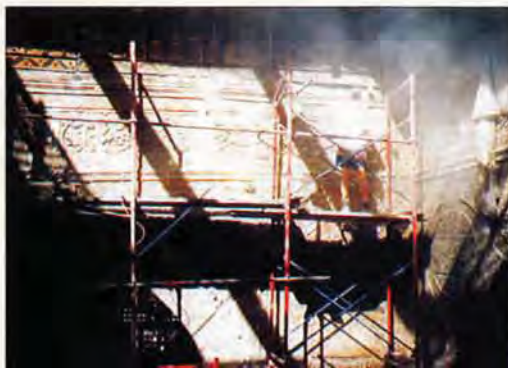
Decorative panels being drilled ready for installation of consolidation anchors

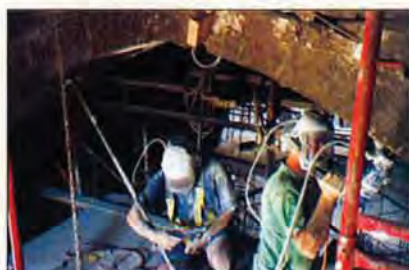
Diamond drilling the arch stones

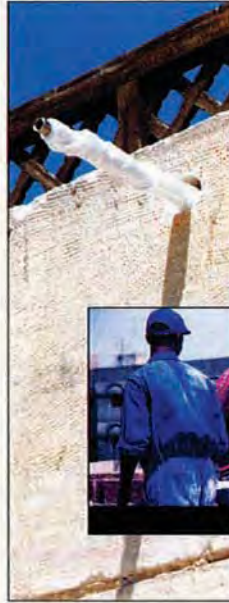
typical consolidation anchor prior to grout injection

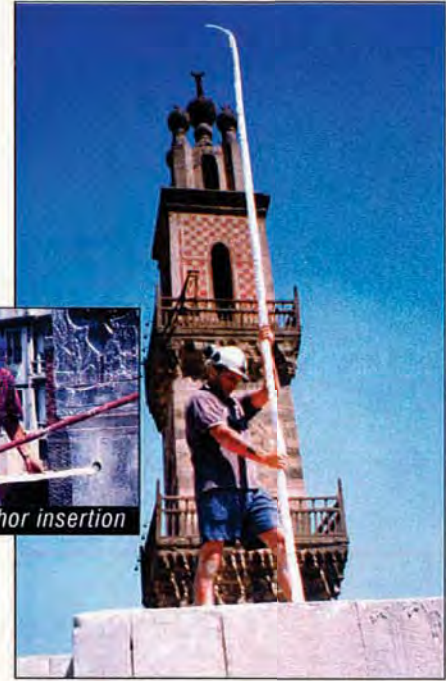
5 metre long vertical anchors at roof level

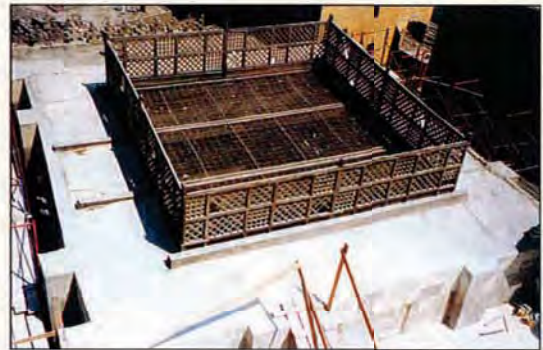
Roof section above central courtyard

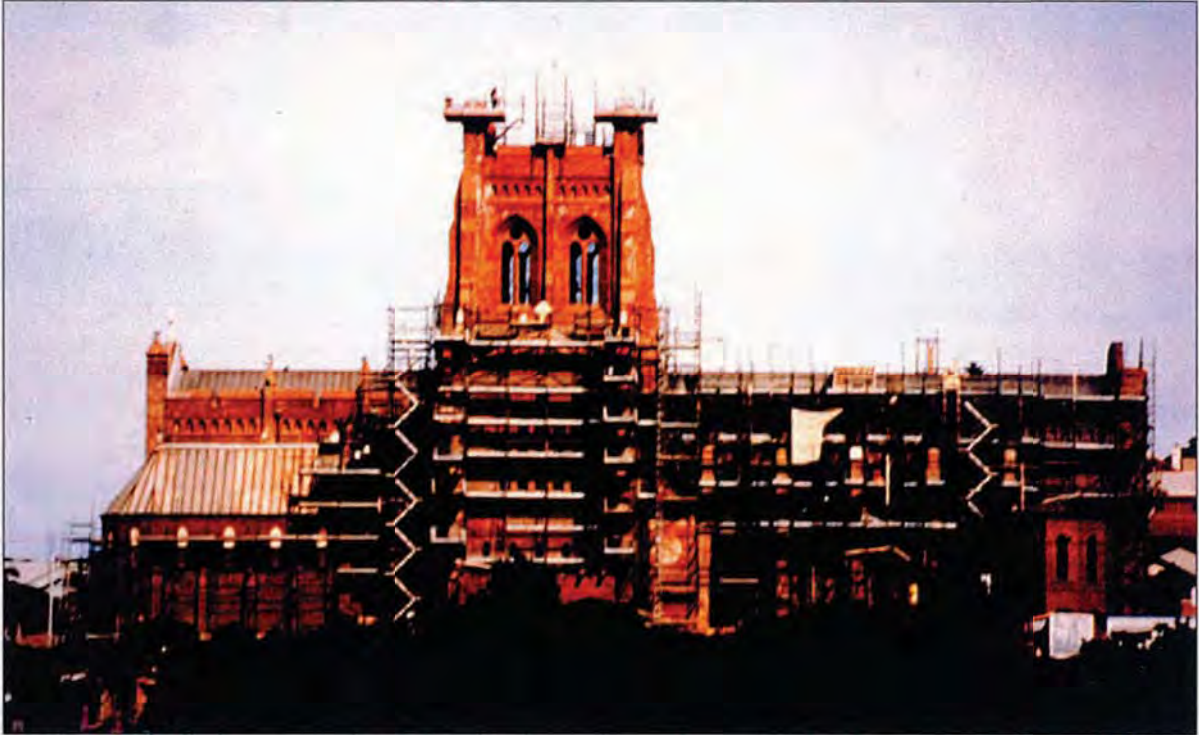
The effect of the earthquake was largely as might be expected: high set stone crosses and other decorations fell to the ground, flying buttresses were dislodged, shear cracking occurred in the north and south walls and out-of-plane movements occurred in the east wall, dislodging windows.

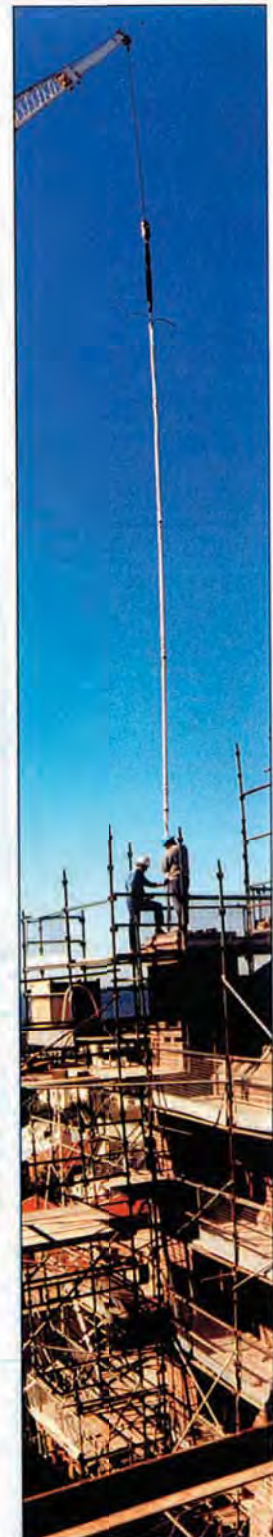
20 m vertical anchor being placed by crane in the project which saw anchors up to 32 m horizontally, Cintec's longest to date.

Cintec anchors used on the project ranged from 215 mm long RAC cavity ties to 32 metre long anchors in the nave walls which were manufactured from 32 mm diameter "Hi-proof" grade 316 deformed stainless steel bar. All the long anchors had to be manufactured on site, with long vertical anchors being installed by crane.

The 32 metre anchors were the longest ever installed by Cintec and amongst the longest in the world.

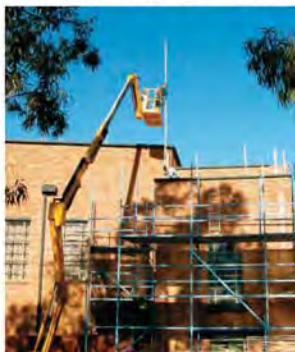
Anchor being inserted in protection sleeve in cavity – sleeve later removed

All anchors are made from Grade 304 stainless steel deformed bar and comprise 12 mm, 16 mm and 5x8 mm Multibar anchors. Cintec RAC8 remedial cavity ties are used adjacent to the vertical anchors to prevent the cavity widening during main anchor inflation and to ensure the bond is maintained between the anchor and the two leaves of brickwork.

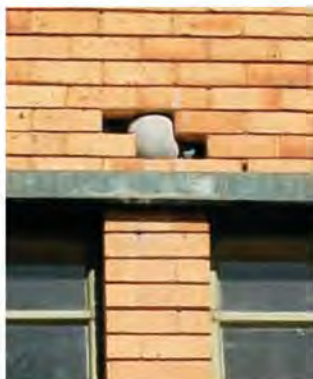
Anchor sock expansion where bricks removed for inspection

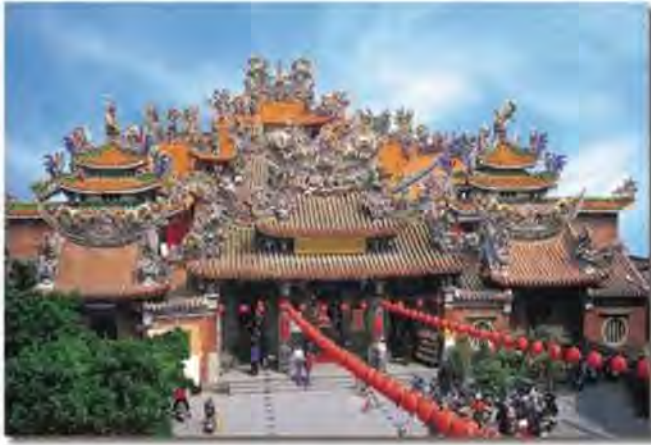
Taiwanese Temple

Constructed in an area of seismic activity, previous earthquakes have taken their toll upon this brick built Taiwanese temple. Some form of remedial work was clearly necessary. With their extensive experience in this field, Cintec has provided the ideal solution; by August 2003, Cintec will supply 720 metres of M16 studding anchor installed in lengths of between 5 and 15 metres. These anchors, located both vertically and horizontally, will both repair the damage previously incurred, and furthermore act as a semi-flexible steel skeleton within the masonry fabric enabling the structure to better survive future seismic events.

The temple is of high architectural and historical importance. The Cintec solution not only fulfills the engineering requirements, but because it is 'invisible' when installed, there will be no visible change the temple's original appearance.

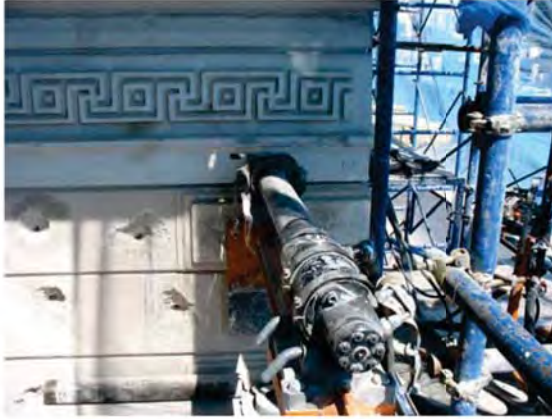
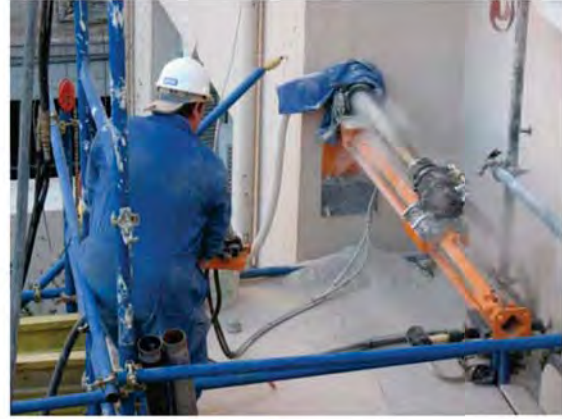
Horizontal holes were dry drilled through hard limestone random rubble walls using 86mm core barrels on lengths up to 10mts and 101mm core barrels for the longer lengths, these were reinserted after drilling to facilitate the anchor installation.

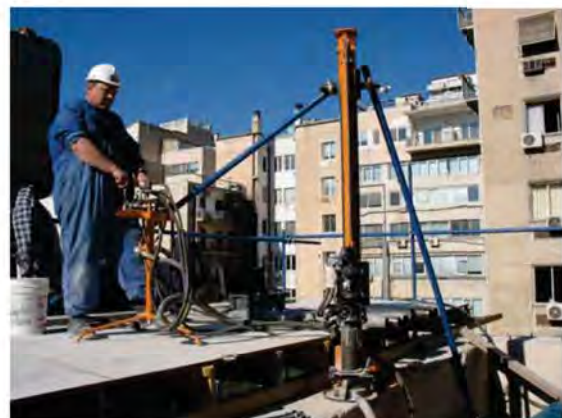
The dry drilling used compressed air as the cooling and flushing medium. Heavy duty vacuum extractors were used to minimise dust levels, both internally and externally.

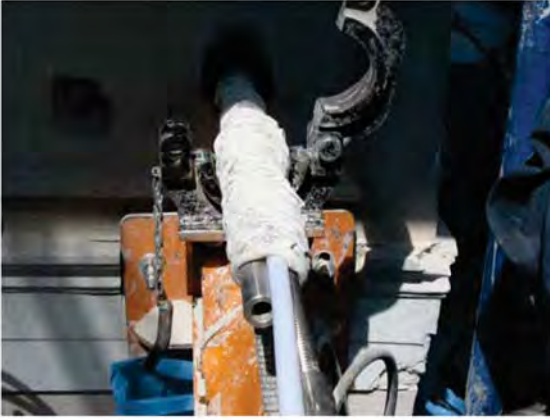
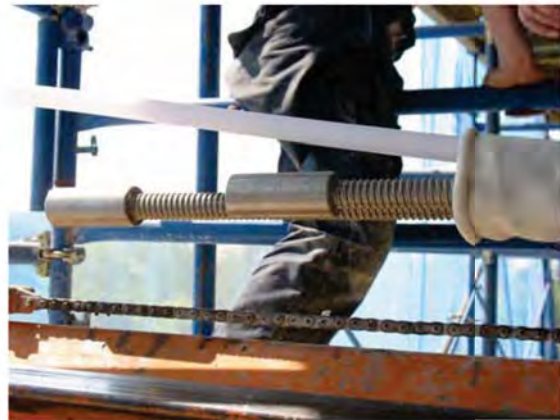
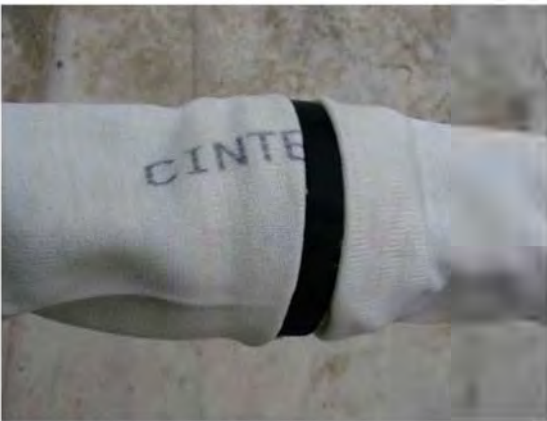
Cintec Multibar anchors comprising two 25mm ribbed stainless steel bars were assembled in sections to achieve anchor lengths up to 29 metres. Each anchor had integral plastic spacers, to ensure centralisation of the anchor along its length, within the drilled hole.

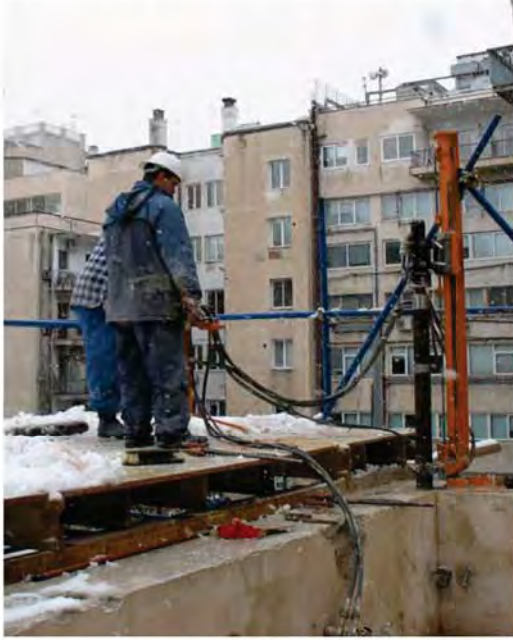
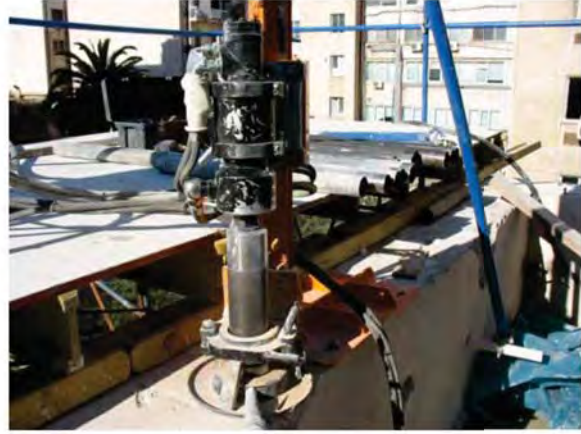
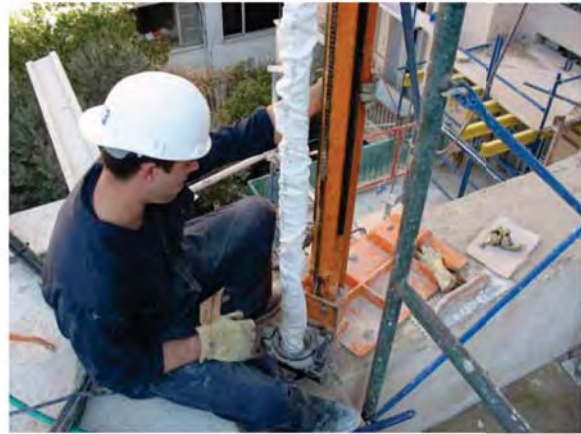
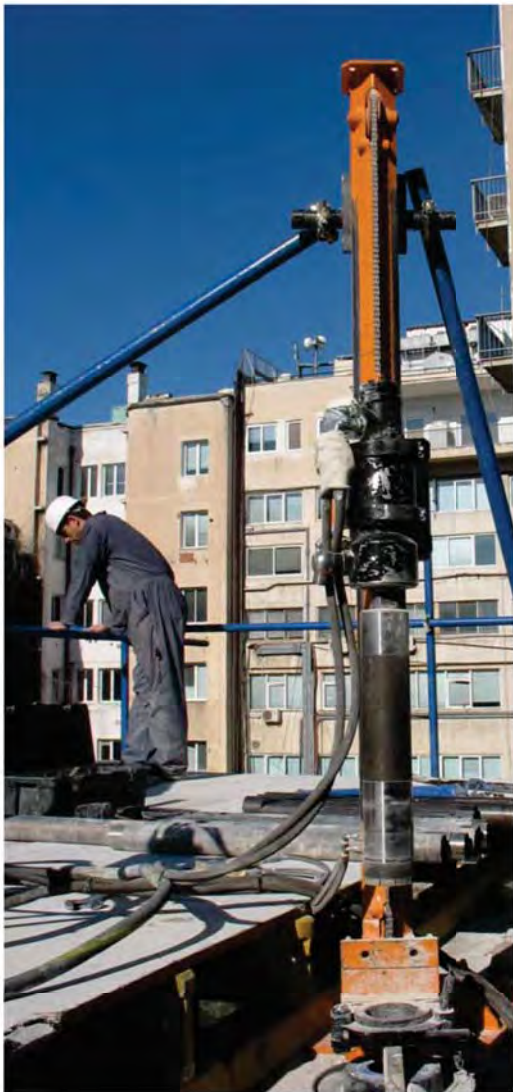
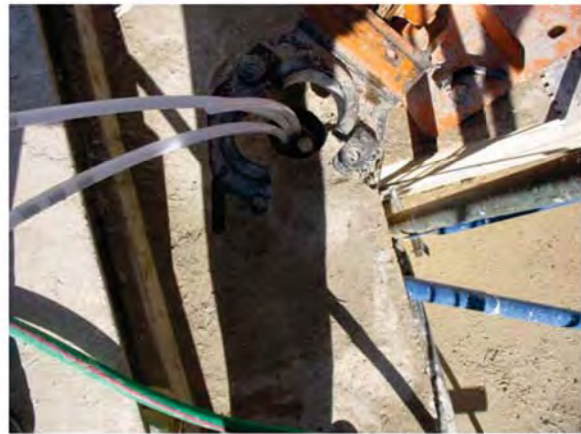
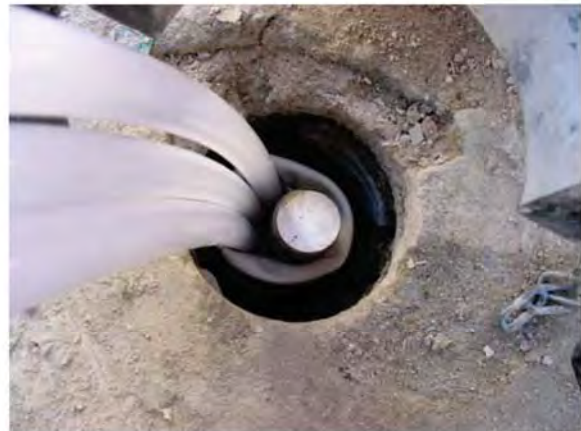
Vertical holes dry diamond drilled.

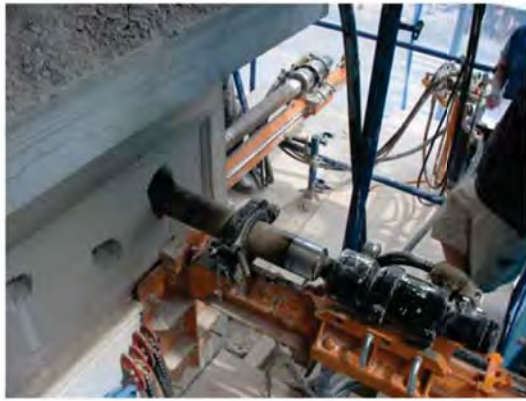
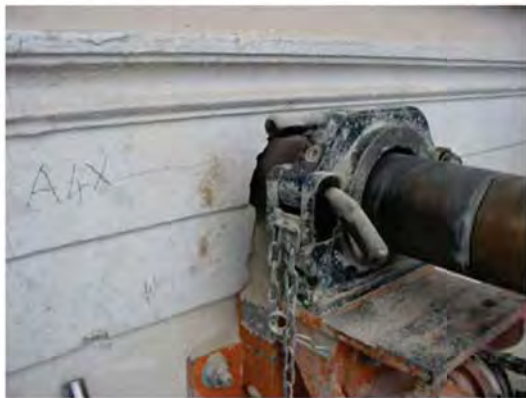
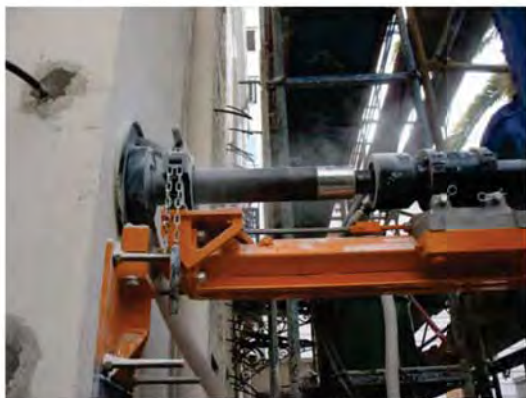
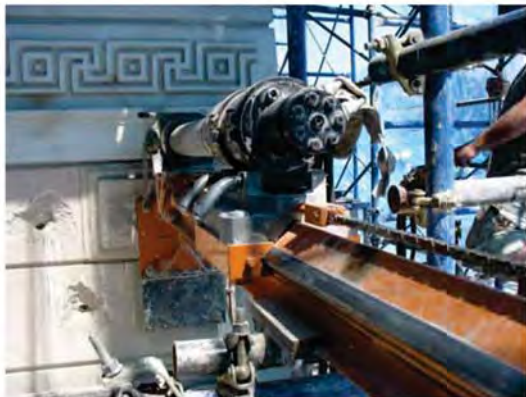
Anchor positions were carefully marked out and drilled with extreme precision to avoid intersecting anchors.

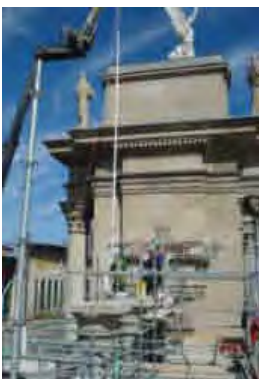
The annular rings had a 3 inch centre hole precast and the centre of the pile cap was precision cored 4 inch diameter by Davis Structural with a PCD type bit to give a 1/8" X 1/4" groove for improved attachment. Two stage anchors, 35 feet long were fabricated by Cintec, each comprising #9 carpenter stainless steel, 4" diameter polyester Cintec sock for the 7 foot first stage and 3" diameter sock for the second stage.

The anchors were carefully lowered into place by crane and the first stage inflated using Cintec Presstec® grout. After 7 days, tension load of 25,00 lbs. was applied, bearing plate secured and the second (27 foot) stage was inflated.

Each column consists of several, tapering, annular rings stacked to a height of 27 feet and sit on a concrete pile cap some 7 feet thick. The project required an anchor that would extend the full depth of the column and pile cap, mechanically and adhesively tie all components together and allow post tensioning load of 25,000 pounds per column.

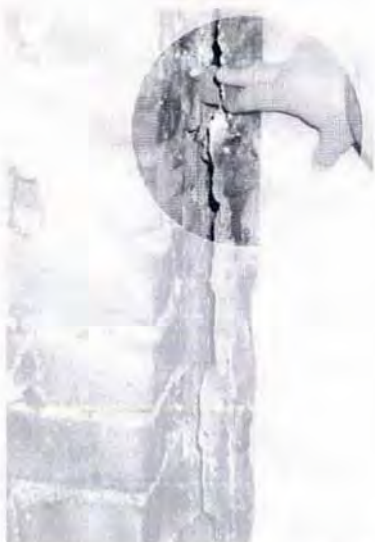
Remedial anchors installed prior to the fire. The anchors are still functioning. The grout cover protected the main steel body of the anchor.

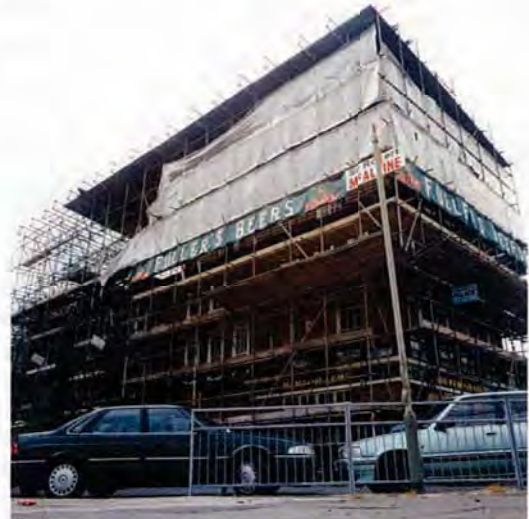
Even though the brickwork had been subjected to extreme temperatures, the anchors survived well; pull out tests revealed that they still performed to their original design specification.

Despite being subjected to extremely high temperatures, tests revealed that the cementitious Cintec anchors did not fail. They retained their integrity and could be reused for the repair work. Had a resin alternative been specified they could have melted. In point of fact, where anchors were installed, there were no cracks in the structure. However where there were no anchors there were distinctive signs of distress due to the intensity of the fire.

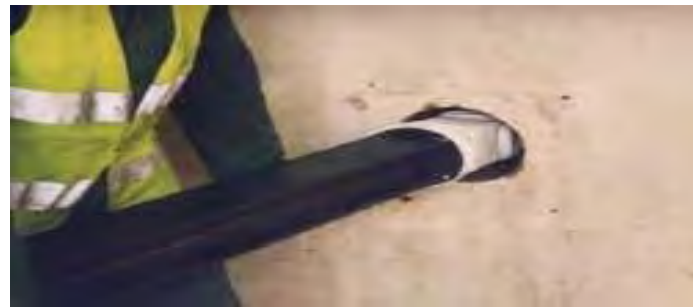
Insertion of Cintec anchor section of `I` beam into brickwork

A 200 mm (8 inch) diameter, 450mm (18 inch) deep hole was hand cored by diamond drilling into the brickwork. All the 100 x 100 (4x4) `I` beams were fixed to supporting scaffold after insertion and leveled by surveyors.

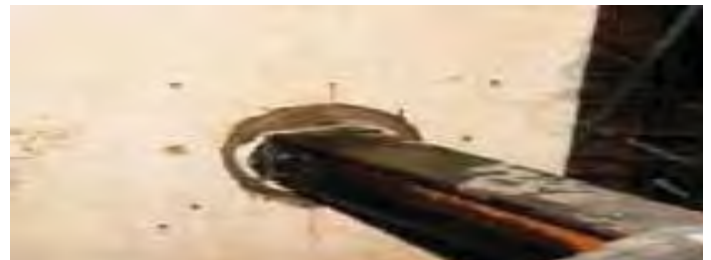
`I` beam following anchor grout injection

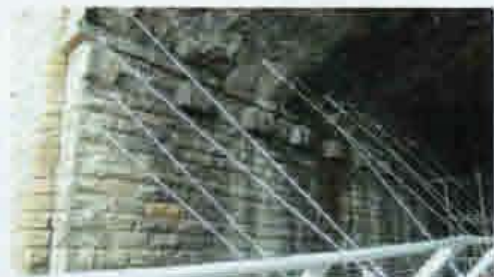
View of the supporting cables under the arch after lifting bridge from supporting scaffold.

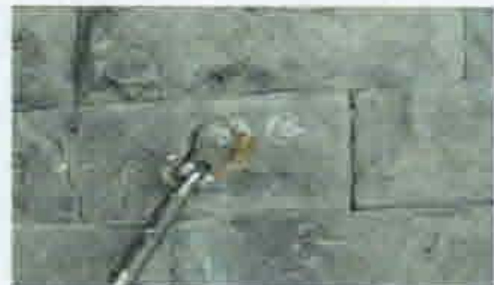
Upper Fixing Detail - Cintec Stud Anchor with Eye Nut attachment.

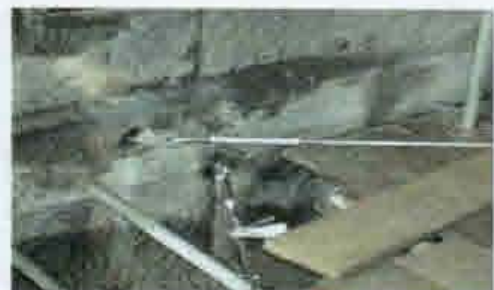
Lower fixing detail with turn buckles.

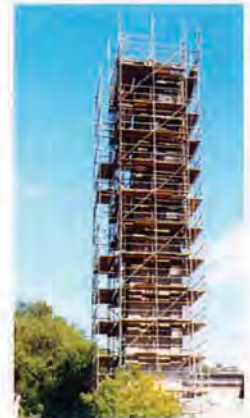
Chimney Restoration
In Progress

The Chimney, built in about 1890, had serviced three adjacent downdraft kilns. The shaft had been deteriorating through the years and had become a pigeon roost! Significant cracking appeared on the east and west elevations and it was found to be leaning almost 43 inches to the south and a bit to the west. The corrective action was to stitch two sides together using the Cavity Lock Systems Ltd (CLS) Cintec Anchoring System. The CLS Cintec Canada Company had had previous experience in similar projects obtaining excellent results in what is truly corrective surgery on buildings. The restoration work also included substantial repointing and some brick replacement.

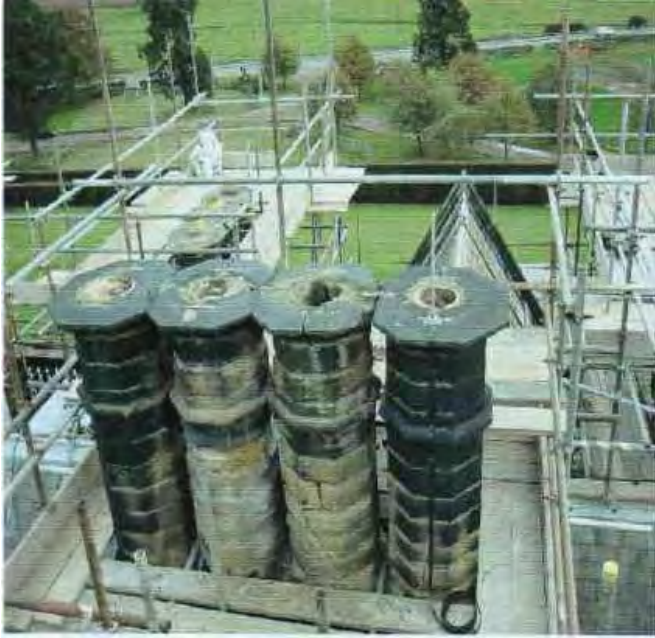
Partially missing ceramic liner ->

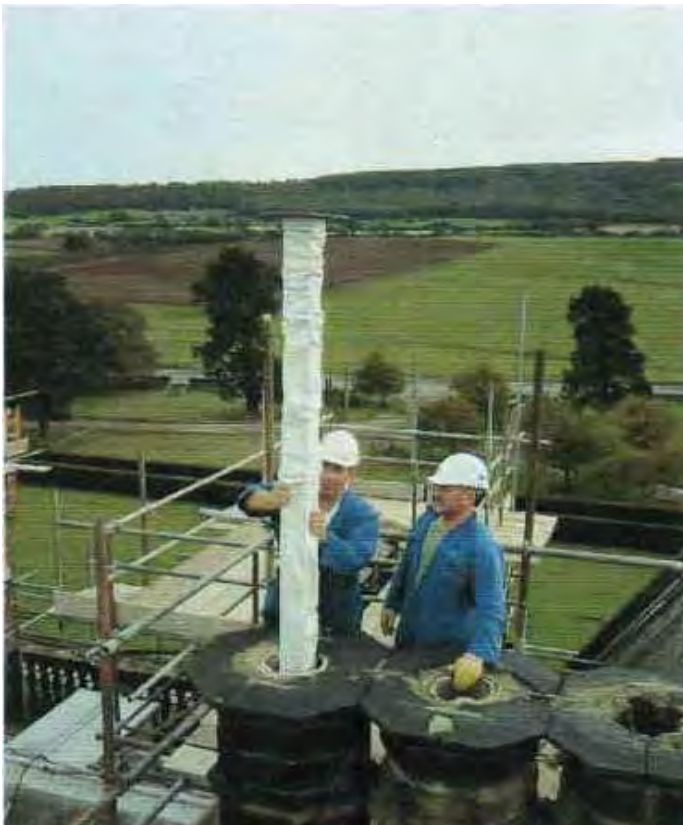
Chimney's capped with a stainless plate. ->
