CINTEC

DESIGNED ANCHOR SYSTEMS

Structural repair solutions
for stabilisation & conservation

**Structural Repair,
Stabilisation &
Conservation System**

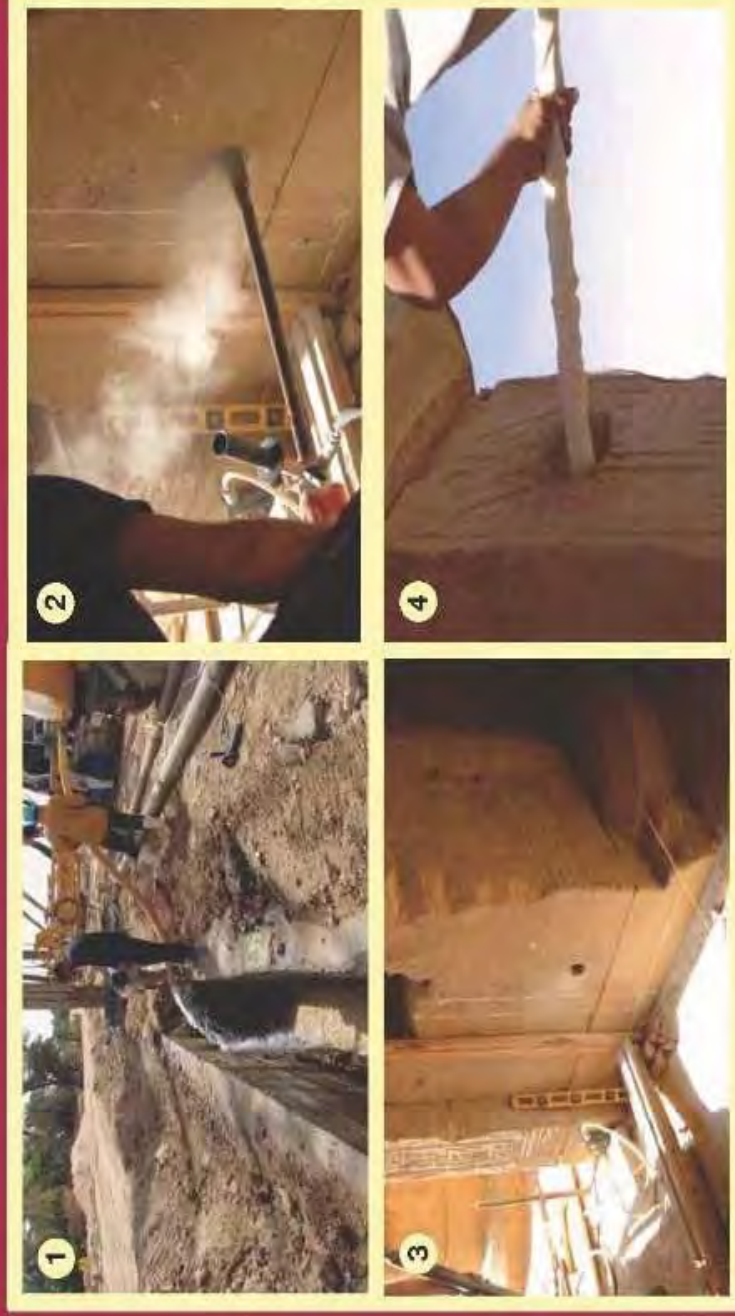
(1) Securing the Ground
(3) The finished hole ready for the anchor

(2) Drilling for the Anchor
(4) Inserting the CİNTEC Anchor

The installed drainage trench around the monument will prevent further disturbances in the soil around temple. Due to the nature and condition of this temple no vibration could be introduced in the drilling stage so dry diamond drilling techniques were used using compressed air to cool the drill bits and flush the dust from the holes.

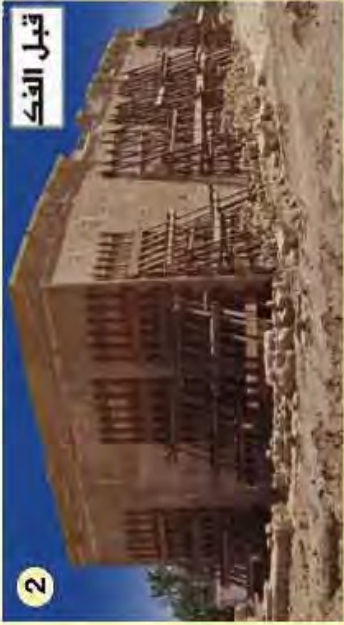
(2) The original, supported corner

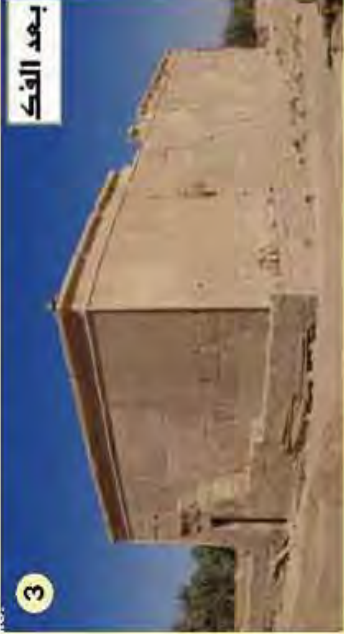
(3) The finished, secured corner

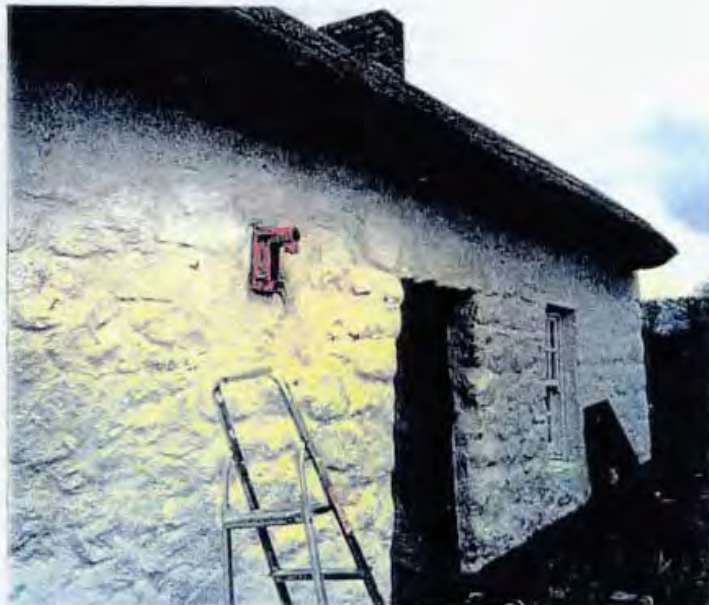
(a) Drilling Rig Base Plate fixed to wall.

The anchor is installed into a 60mm diameter hole drilled with a Diamond Drilling Rig.

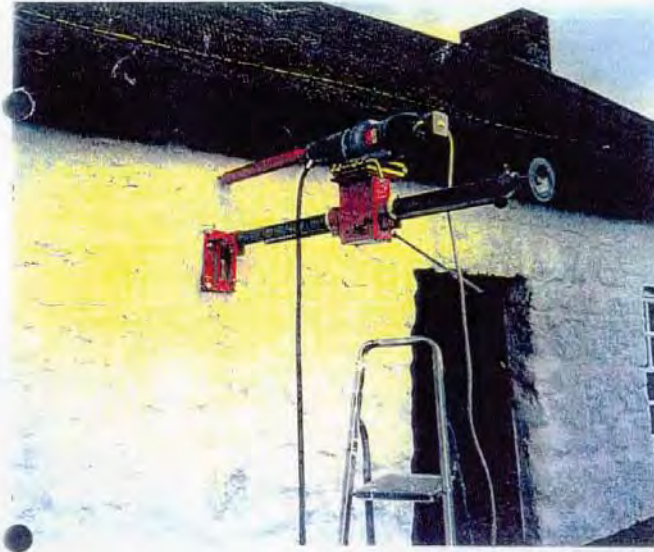
(b) Drilling Rig in place.

(c) Drilling one of two 60mm holes.

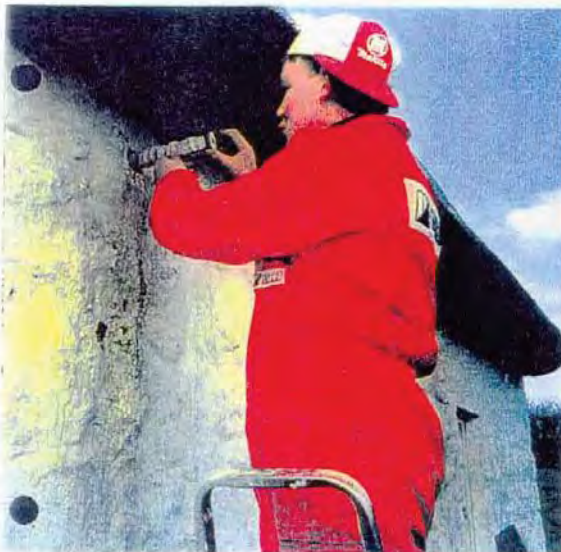
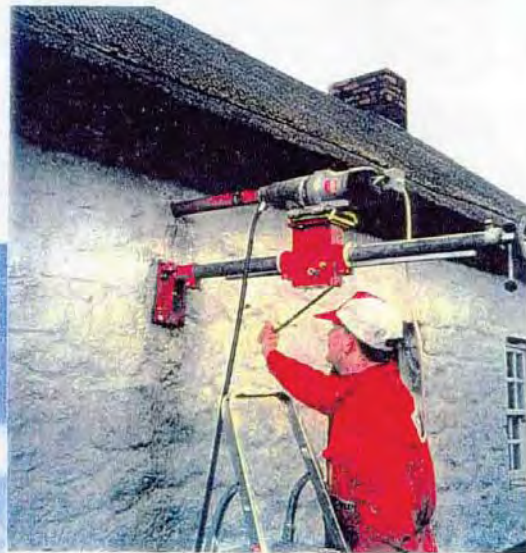
(d) Installing the anchor.

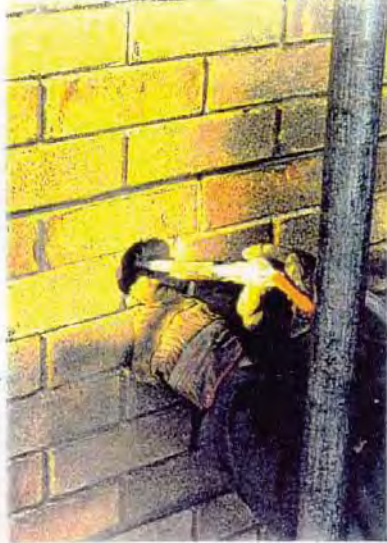
(e) Inflating the anchor with grout. (Note the photograph taken of the actual operation did not come out).

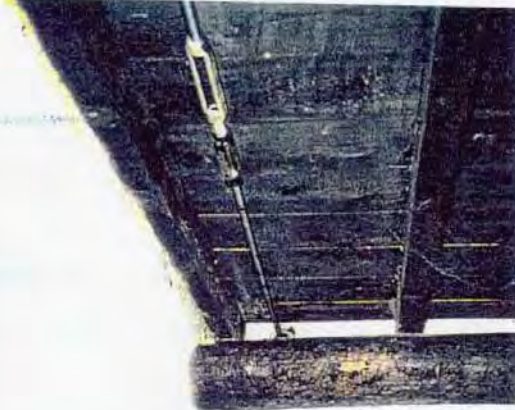
(f) Internal view of one installed anchor with the bar (connecting to the other anchor) and showing the bottle screws.

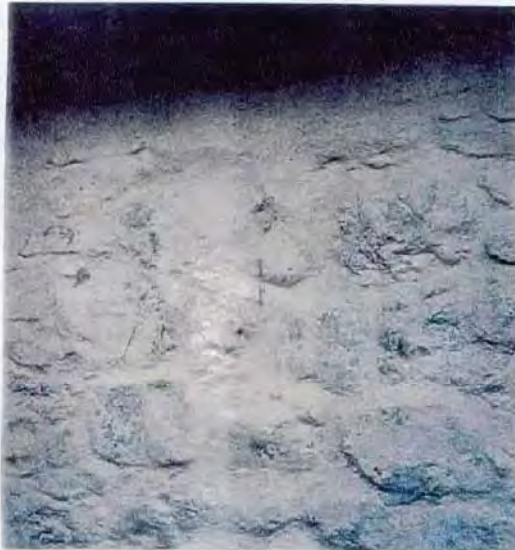
(g) The finished wall after installation of anchor and before white washing.

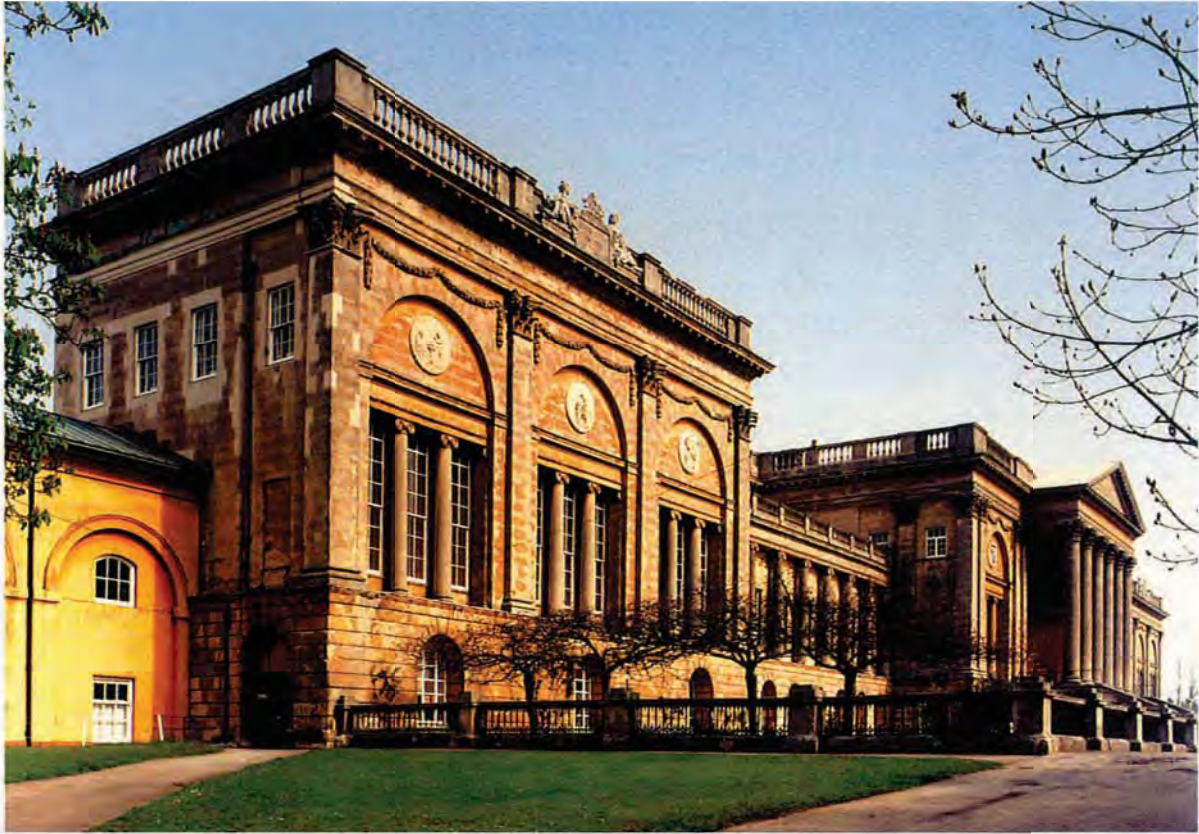
Originally the country residence of Lord Buckingham, Stowe House has long been the home of a leading public school (that is a school funded by private fees). The wall construction is an external leaf of Bathstone with rubble infill and an internal masonry wall, having an overall thickness of up to 1150mm. A length of this wall was to be stabilised by grouting the rubble infill. However, the wall required strengthening to withstand the pressure of this grouting.

The solution was to install Cintec 20 x 2 CHS stainless steel anchors in a nominal 40mm diameter drill hole of centres in the range 750-900mm. Anchor lengths of 850mm and 1075mm were employed to cater for the variable wall thicknesses. To maintain the external appearance, all anchors were installed from the inside of the building. They were allowed to project into the building to permit the standard circular crimped anchor body. The anchor projection was cut off flush internally and plastered over.

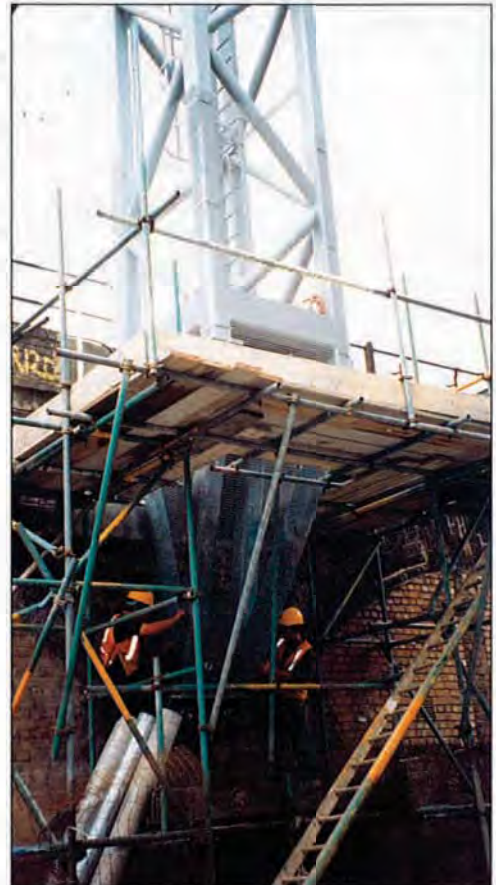
The torquing of the anchors

The proposed solution involved three CINTEC Anchor types. The central one was a compression anchor of stainless steel comprising a 32mm shell rebar inside a 114 x 6.3 CHS installed in a 200mm hole, 8000mm deep, at an angle of 30 degrees to the horizontal. Below it was a tension anchor, comprising a solid stainless steel body, 12m x 25mm installed in a 50mm drilled hole, and attached to the gantry support to prevent any rotation. Two smaller shear anchors 20mm x 800mm were similarly installed to complete the support. Load tests were carried out, with the placing of a 20m steel beam in position.

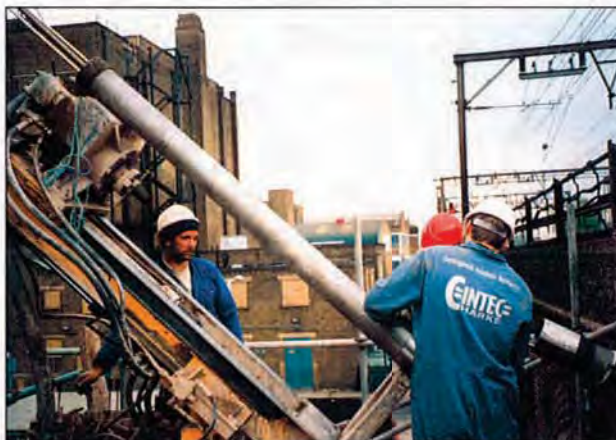
The assembling and installation of a compression anchor

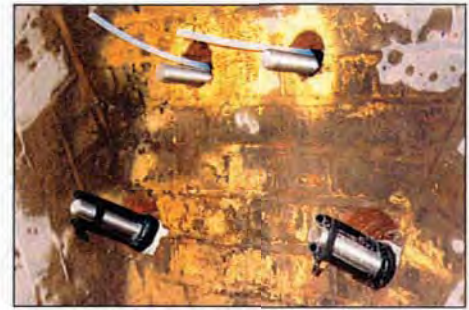
Shear anchors shown at the top and tension anchors at the bottom

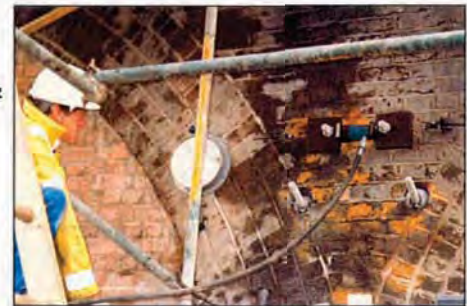
In shear

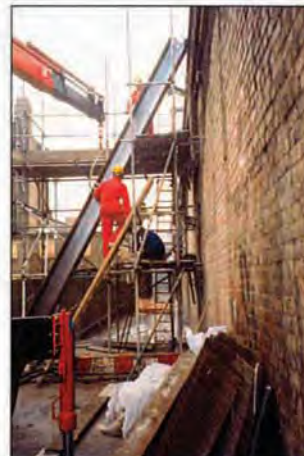
In tension

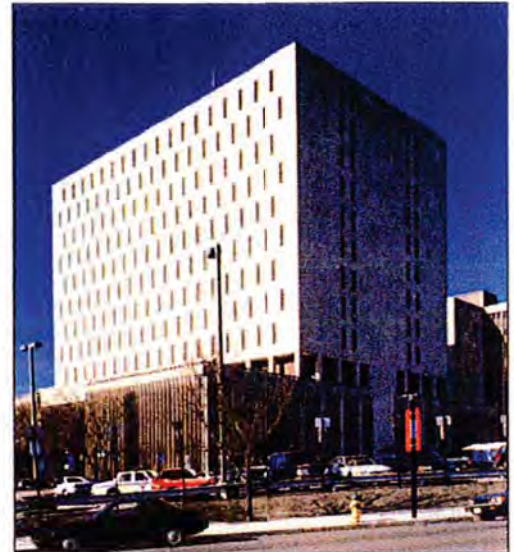
Limestone cladding of Essex County New Courts Building and Jail was one accident away from catastrophic failure. More than 20,000 Cintec anchors now prevent masonry's collapse.

Zemsky's general contractor for the courthouse project, Jim Papandrea, says that before they inserted more than 20,000 Cintec anchors into the building, they had an independent lab test the system by measuring the strength of the anchors' hold on the masonry. "The pullout tests exceeded 4,000 pounds," Papandrea says of the procedure, in which steadily increasing force is applied until the anchor fails. "The block broke before the anchor did."

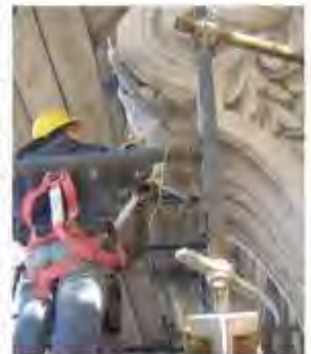
Grout being pumped into the terra cotta anchor assembly to engage and stabilize terra cotta units.

We specified stainless steel anchors set in pressure-grouted fabric socks in the cracked terra cotta brackets, and stainless steel staples at the building's corner cracks.

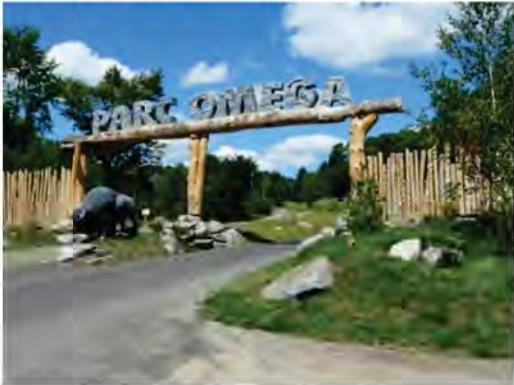
Cintec was called on, by a Regional wild life park, for a solution to their need to join and stabilize large tree trunks that made up its unique entrance arch. Concrete footings were formed and poured as the base at each column and at the same time a stainless steel rod was placed in the centre of the base and allowed to protrude upward some 5 feet. The trunks were hollowed out, banded (to prevent splitting as the timber dried), and then carefully placed over the rods and allowed to rest on the base ensuring a seal between wood and concrete. Fill and vent ports were drilled from the outside of the tree trunks into the hollow chamber and Cintec Presstec Grout was carefully injected and left to cure. Afterwards the holes were made good by inserting wood plugs resulting in a near invisible installation.
