the award winning
CINTEC

*strengthening,
repair and stabilization
of high-rise buildings*

CINTEC
NORTH AMERICA

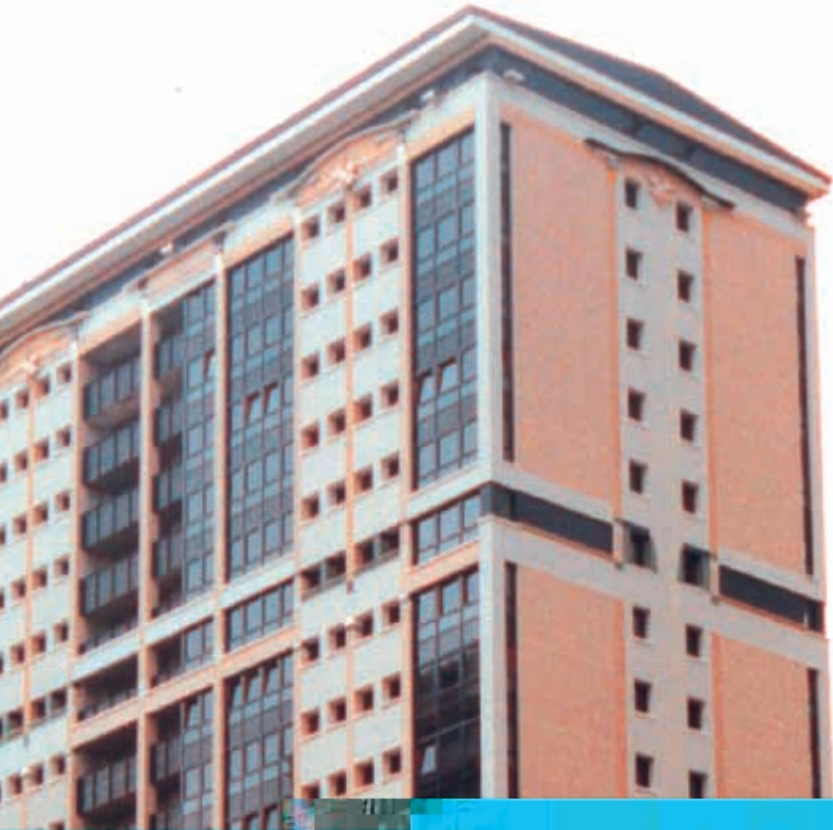
Apartment Blocks

Every block revealed a variety of problems. The number of wall ties required by the original drawings were not always present, particularly to the side of the windows. The galvanised steel ties were nearing the end of their useful life. Overall, wall ties were found to be skewed, deformed, off level, rusting, mismatched between dovetail and slot or inadequately anchored. Many of the panels were consequently deemed to be sub-standard and ineffective, even to the earlier lower requirements and standards for both quality and quantity.

Problems with gables were numerous: the dovetailed bronze ties were present in irregular quantities, but the tail was sometimes deformed or the tie mismatched with the slot. "L-shaped" galvanised mild steel ties from previous repairs were found to be sub-standard.

Brickwork was showing evidence of stress: corners developed vertical cracks, gable brickwork seating was inadequate, slip bricks were debonded from nib bricks spalled above and below nib levels, damp-proof course had squeezed out, pointing had eroded, cavities were dirty.

External concrete elements, including floor slab nibs and balconies were problematic: reinforcement was very close to the surface and local rusting, there was minor stress cracking, the face of nibs were palling from the gables at corners, balustrade posts were corroding where inserted into the balcony; and patches on balcony soffit were loose or missing. Chloride ion levels were found to be low and carbonation depths were very variable.

Amidst a number of alternative proposals, the Cintec Anchor that was considered to provide the most appropriate overall repair solution.

In total, five contracts involved the installation of over 40,000 Cintec Anchors and ties. Additional repair work included concrete repairs to the floor slab nibs, balcony soffits, balcony edges, and also concrete windowsill replacement.

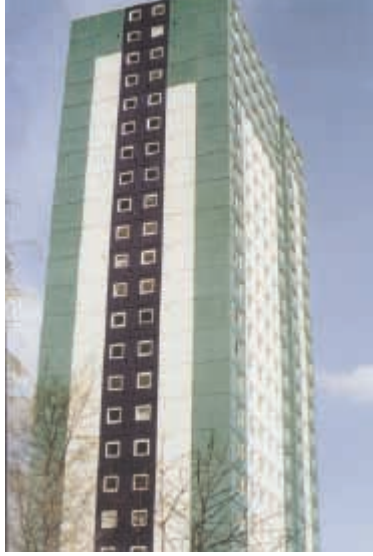
Fitzwarren Court is a large panel high rise construction. Over its life it had suffered from the ingress of water which not only caused the normal structural damage and inconveniences, but also led to the deterioration of the panel fastenings.

The design required a working load per anchor of 8900 lbs. (40kN) and 16,741 lbs. (75kN) ultimate in tension. During installation, tests showed that the anchors exceeded the required parameters. The high tensile stainless steel studding anchor was more than capable of carrying the load.

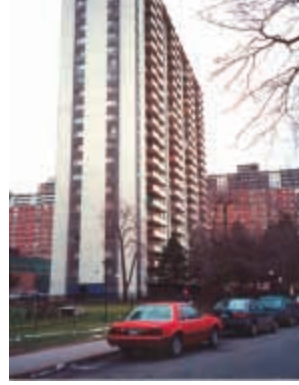
77 Howard St.

Deterioration was caused by a shortening of the structural frame. Lack of soft joints below the shelf angles to accommodate movement resulted in bowing of walls and crushing of over-stressed units, as well as rotation of shelf angles. Corrosion deterioration had also occurred in the shelf angles and connecting bolts.

Repair was accomplished with two strategies: Cintec Corbel Anchors were installed to transfer vertical loads from the exterior walls to the back-up walls, and Cintec stitching anchors were installed to restore broken header bricks.

These concepts were proven with full laboratory load tests. In areas where the exterior walls were beyond repair, Cintec Anchors were installed with retaining plates to prevent collapse of the panel while being dismantled. The anchor was used to tie the new brickwork to the back-up wall.

During construction, the back-up wall was found to be not fully supported on the edge at some locations. A special 5/8" x 5/8" (15mm x 15mm) square hollow section two stage anchor was designed and supplied to provide the necessary support. This special two-stage anchor had an oversized second stage sock. This was secured into the floor slab, and the second stage was inflated under the inner leaf overhang to provide support.

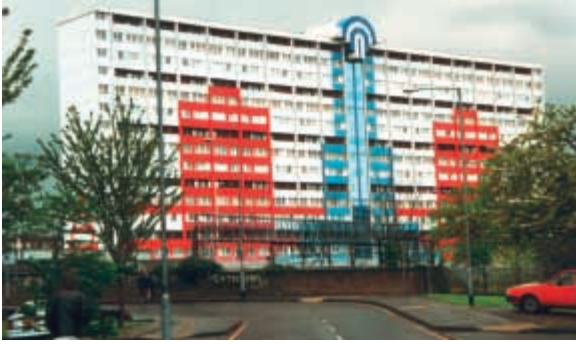
Barking Highrise

In acknowledging the inherent danger of gas explosions, Barking Council decided to reinforce the concrete end panels on a number of its highrise properties. Gas meters located on the inside of the external end walls were a cause for concern as a gas leak is more likely at one of their pipe connections. In the worst case, an explosion could cause a 'house of cards' effect from a progressive collapse.

Extensive insitu load testing on the stainless steel tube anchors proved that loading potential was more than double the requirement. The smaller external load transfer anchors also performed well beyond their required parameters. In all, several hundred Cintec Anchors were installed.

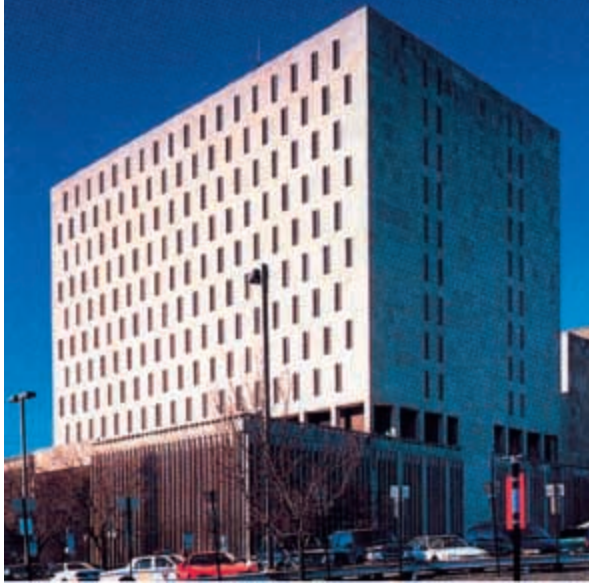
Essex County Courthouse

"One of the best things about this system is that the material is cementitious, not epoxy-based," explains Westfield, New Jersey, architect Micheal Zemsky. "The most interesting part is that the nylon sock expands to fill the cavity until it is completely wedged in." Zemsky recently specified Cintec Anchors on the Essex County New Courts Building and Jail in Newark. The 1966 building's limestone curtain wall panels had separated from the structure, causing damage so pervasive and severe that the building was, in Zemsky's words, "one accident away from catastrophic failure."

Zemsky's general contractor for the courthouse project, Jim Papandrea of Watertrol, says that before they inserted more than 20,000 Cintec Anchors into the building, they had an independent lab test the system by measuring the strength of the anchors' hold on the masonry. "The pullout tests exceeded 4,000 pounds," Papandrea says of the procedure, in which steadily increasing force is applied until the anchor fails. "The block broke before the anchor did."

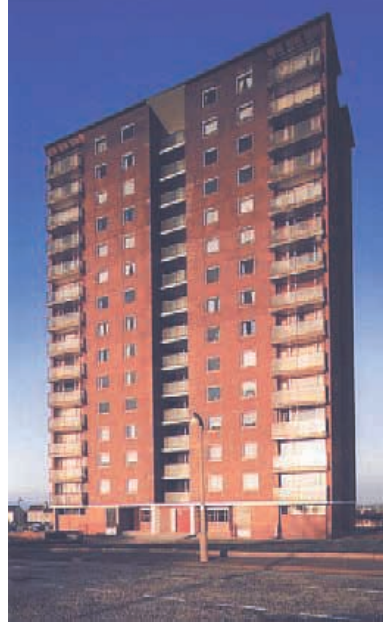
Oliphant Court

68,137 ft² (6330 m²) of marble facade was re-fixed using 12 RWT Cintec Anchors per panel in six variations, designed to hold the 220 lb. (100kg) cladding in position. Design, engineering, instruction and inspection was performed by local Cintec consultants, and the core drilling and anchoring were by a locally approved Cintec contractor.

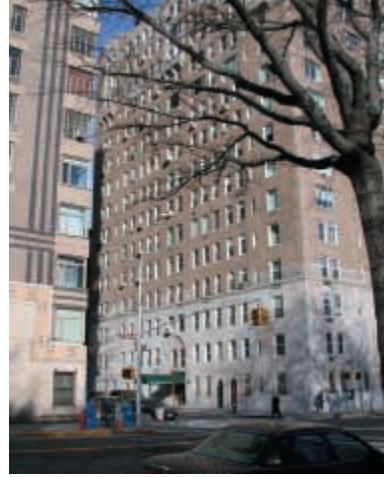
Cintec and fire rating concerns

The system is installed by first drilling small holes through the masonry to the surface of the structural steel member. A separate bit is then used to lightly mill away any surface rust or buildup on the surface of the steel member. A threaded stud is then fusion welded onto the steel member using a special adapter mounted on the standard stud gun. Following stud installation, a standard Cintec® masonry anchor with a special adapter is threaded onto the stud and completed in the standard manner.

This anchoring system has been used to restore ties to brick and terra cotta in situations which would have otherwise led to more extensive and costly removal. Applications have included both short term and permanent repair of masonry in which the original tie materials were either missing or severely deteriorated. In situations where eventual removal may take place in the future, the threaded studs can remain as the permanent structural tie for the new masonry.
