Cintec Strengthening and Repair for the Rail Industry.

**A Selection of Cintec Case Histories
Spanning Three Decades.**

INDEX

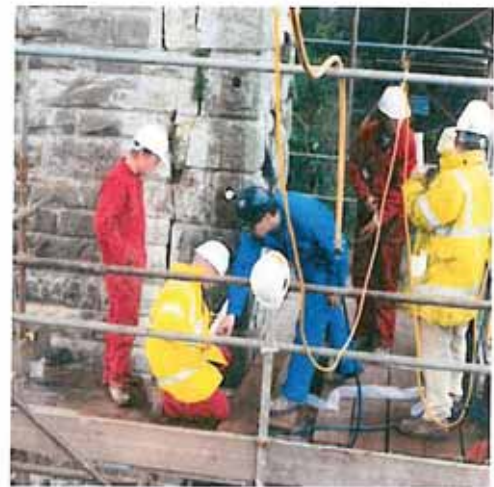
PART ELEVATION OF VOISSOIRS/SPANDREL FACE
120

The second phase of work involved interlocking the outer masonry walls of each pier. The original design drawings and the photograph (below and right) reveal the extent of the cracking and the subsequent Cintec solution. In total 112 anchors were installed.

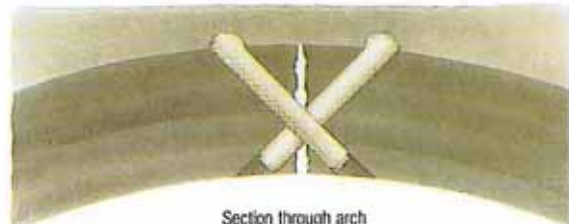
Section through arch

Transverse 30 x 30 x 3 SHS stainless steel WSA anchors were installed to restore the integrity of the spandrel wall/intrados arch connection at approximately 750mm centre-to-centre and alternate lengths of 2.0m and 2.5m. Stitching anchors were angled across the longitudinal cracks to restore structural integrity and the cracks were then filled. Transverse and diagonal stitching anchors, type RWT, 15 x 15 x 1.5 SHS stainless steel, were installed to restore the strength of the delaminated columns and the cracks filled. Drainage holes were drilled through the intrados and plastic pipes were installed to help relieve the existing water pressure. To date five spans have been renovated using the Cintec system and further spans will be renovated as part of an ongoing maintenance programme.

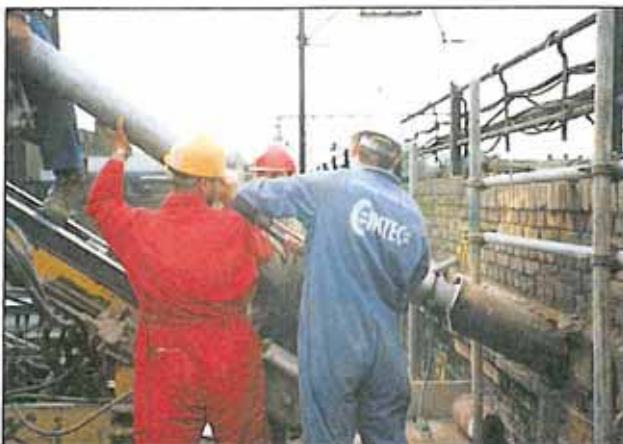
The assembling and installation of a compression anchor

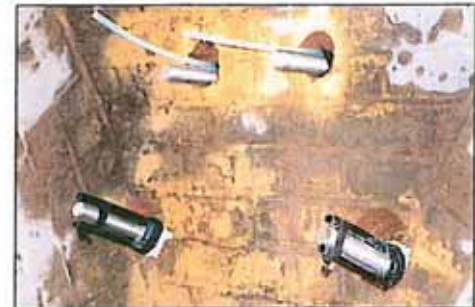
Shear anchors shown at the top and tension anchors at the bottom

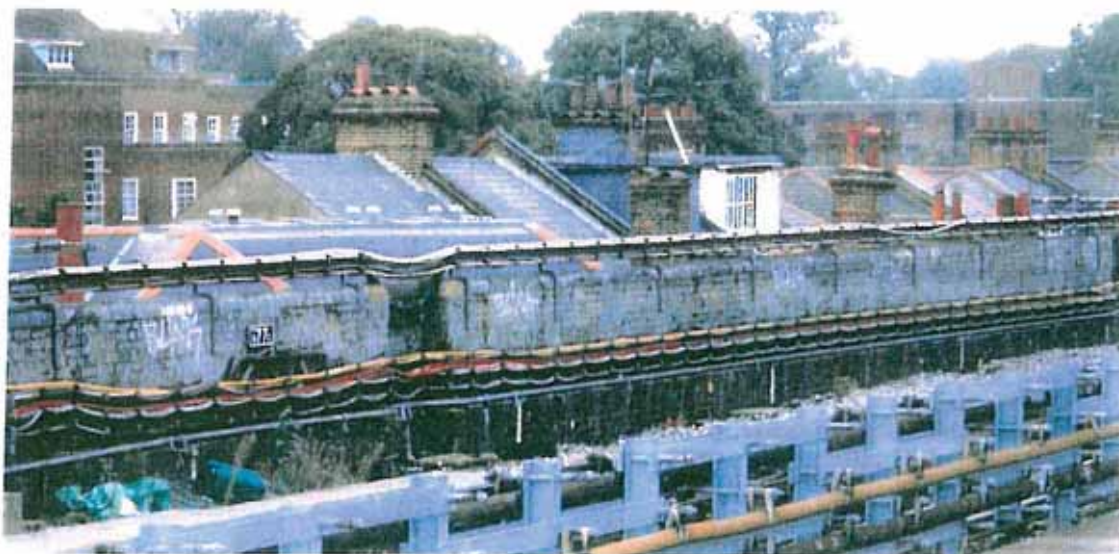
Figure 1 Parapet wall with bolted on utilities

The walls must be able to withstand wind loading, and where they are located beside roads or railways, there are extra windage effects caused by passing traffic. Additionally, there are traffic induced vibrations which can exacerbate the live loading and accelerate deterioration of the walls by loosening the old mortar. It is also not uncommon for walls, particularly those beside railway lines, to experience additional dead load effects due to utility pipes being bolted on, see Figure 1.

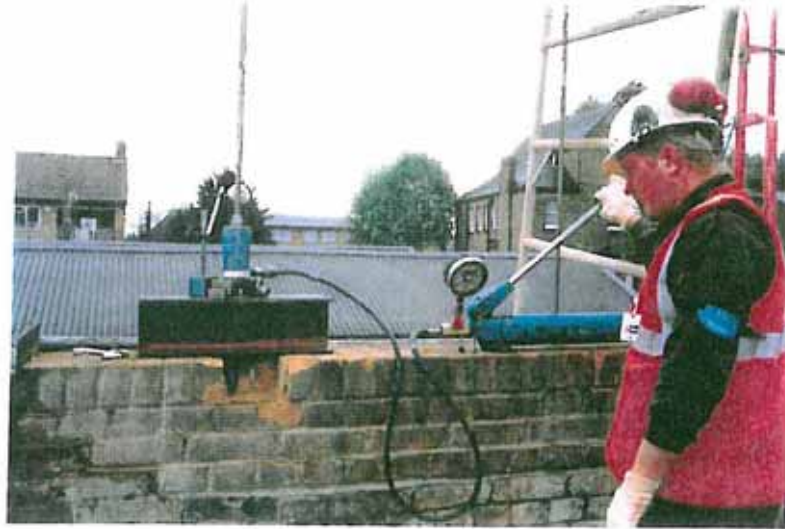
Figure 4 Post-tensioning Anchor in Test Panel

The vertical Cintec anchors were each tensioned up to 57kN and, during jacking, the behaviour of the wall and anchors was monitored, see Figure 4. The elongation of the anchor between the jack and the anchored end in the retaining wall was as expected. However, the wall itself was also found to compress by about 4mm at the top which was significantly greater than the 0.2mm expected. The wall was also found to deflect by about 4mm towards the platform.

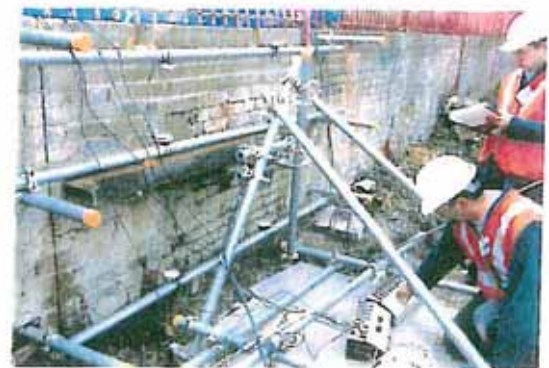
Figure 5 Testing Arrangement

For the supplementary load test, the applied wind load was simulated by the application of a lateral point load on a horizontal spreader beam positioned vertically at the centroid of the wind pressure. The lateral load was applied with a hydraulic jack pushing against a jacking frame anchored to the retaining wall supporting the parapet, see Figure 5.
