ANCHORBOND

**PETER
COX**

Wall Stabilisation with Anchorbond Vtek

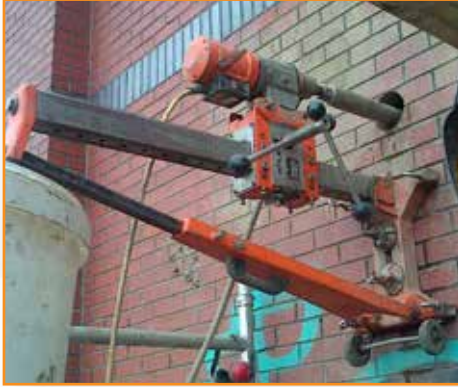
Drilling

Installation holes are created in the masonry using a wet diamond drilling process with extension drill bits added to achieve the required hole depth. The waste is removed in the form of cores.

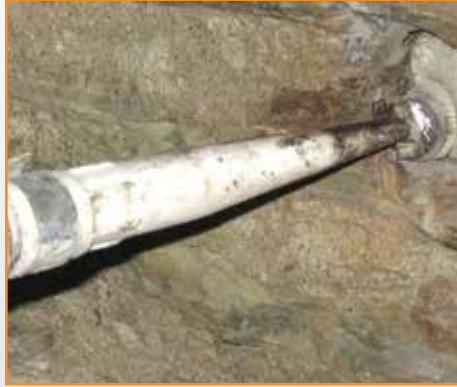
Injecting Grout

The cementitious grout is site mixed and then sieved before pouring into a pressure pot which operates at between 3 and 4.5 bar. The grout is forced into the sock around the anchor. This expands to fill the cavity, starting to harden after approximately one minute.

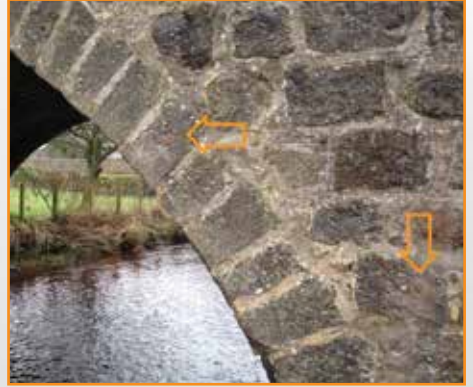
Surface Repair

Drilling holes are made good so that the repair will be almost invisible – this is particularly important in the case of historic property.

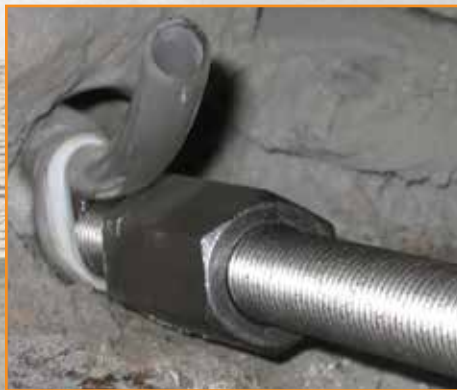
Anchor Sections

The grout is injected through the rod in the case of hollow section anchors but if solid single or multi bar sections are used, a separate injecting tube is inserted in the fabric sock. As illustrated here, threaded rods can be used to facilitate fixing attachments to the anchor head - for instance for tie bar extensions and support brackets.

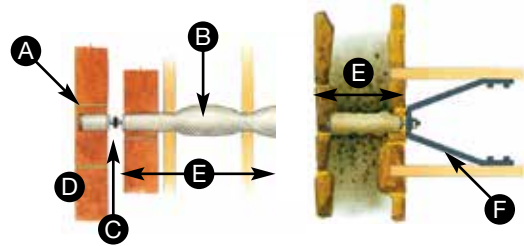
Lateral Restraint - Wall to Floor Joists (not relevant on bridges)

- A 20 or 30mm hole - to suit anchor length
- B Anchor expands to provide rigid support
- C Neoprene drip
- D Cavity wall
- E Length to suit
- F 'Armlock' fixed with stud anchor to joists at 90° to wall

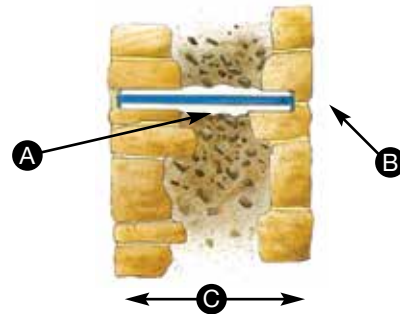
Stitching Anchor for Rubble Filled Wall

- A Sock expansion into the soft friable core
- B Anchor body design to suit load - std 15 x 15, 20 x 20 or 30 x 30mm square hollow section
- C Length to suit

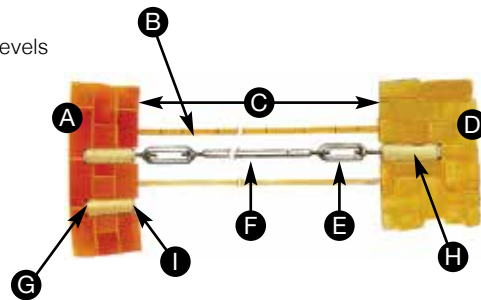
External Wall Anchored to Internal Wall

- A External wall
- B Anchor positioned at floor levels
- C Length to suit
- D Internal wall
- E Bottle screw
- F Solid bar
- G 30mm
- H 60mm
- I Delaminated brickwork stitched together

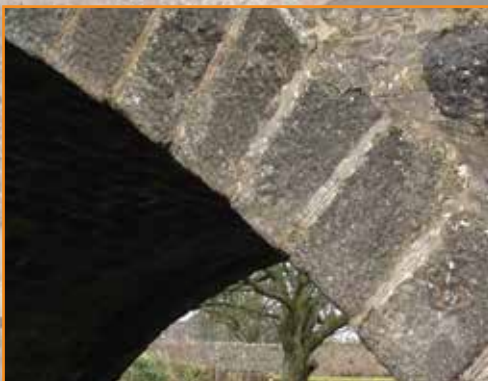
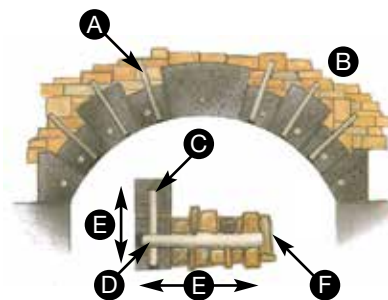
Arch Consolidation

- A 30mm drilled holes
- B Anchors positioned to suit individual constructions
- C Stitching anchor at 90° to the normal
- D 60mm drilled holes
- E Length to suit
- F 30 x 30mm anchor to carry main load

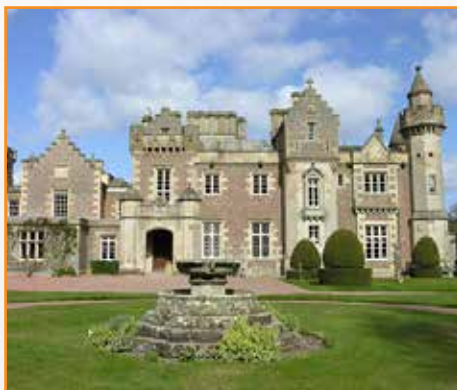
Abbotsford is the home of Sir Walter Scott. Created almost 200 years ago on the banks of the River Tweed in the Scottish Borders, Abbotsford was the culmination of Scott's creative ambitions as a writer and the fount of his inspiration. Our technicians stabilised part of the rear wall during a major refurbishment project. The wall, part of the original house was bowing and moving outwards and the anchors we installed ensured the wall was made safe and secure. During the process, we had to meet the exacting standards of Historic Scotland.

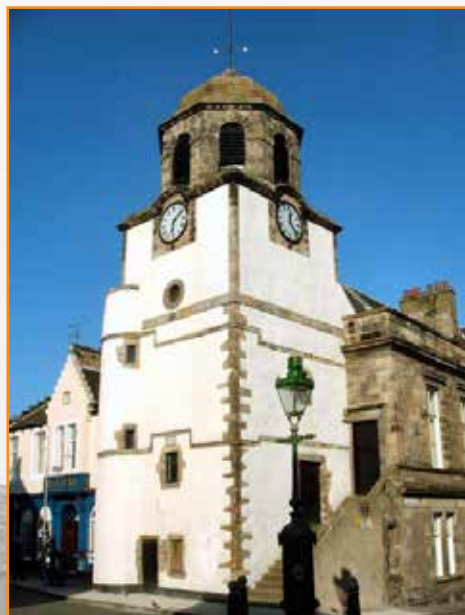
Dysart Toll Booth

This medieval Tollbooth in Fife was comprehensively repaired in 2009, following centuries of neglect. The building's fascinating history includes surviving a gunpowder explosion that blew off the top of the building in 1746. Major cracks were still evident from this and we repaired them with six meter stainless steel rods drilled through the building in hidden locations.

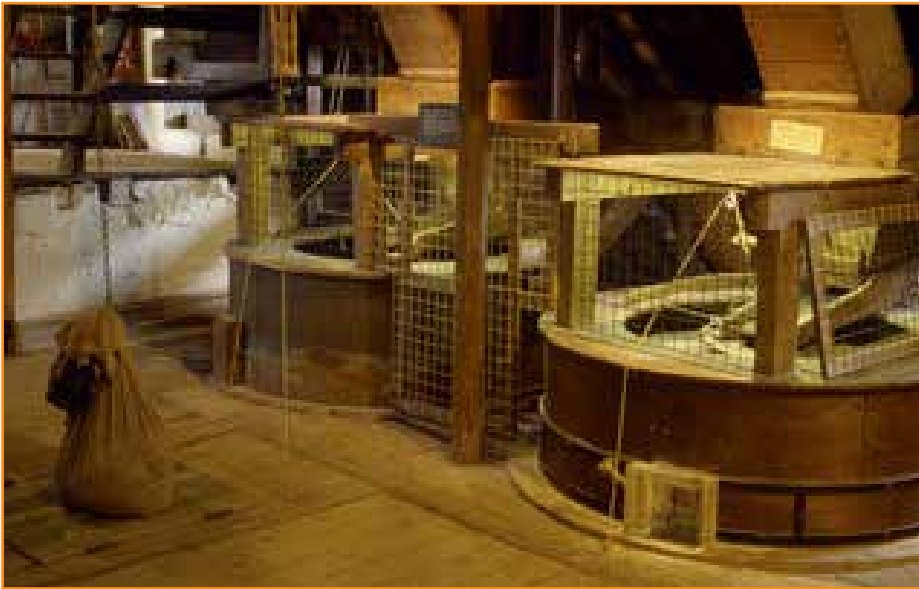
Nether Alderley Mill

The machinery at the mill is over 100 years old, with some parts dated to 1871. The millstones weigh over a ton and our technicians secured the old mill stone to the floor using 4 x 1m anchors to ensure it was safe when the public visited.

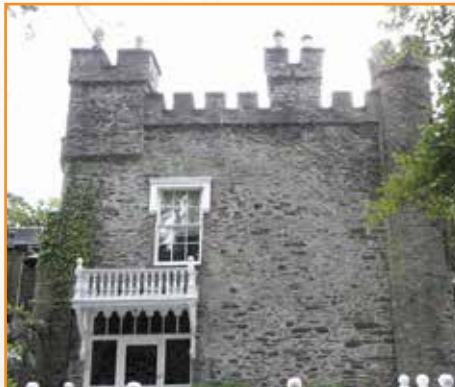
Greeba Castle

This is one of two Victorian castellated residences built in 1849 on the Isle of Man. Built in an elevated position, a false side turret was added to the building at the turn of the century. However, it was not bonded in correctly and was actually coming away from the main building and so we anchored it securely back in place.

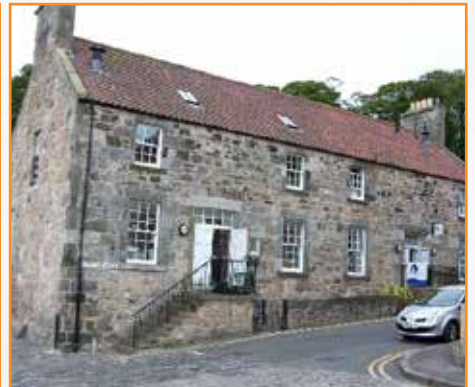
Built in the 17th Century, The Harbourmaster's House overlooks the historic harbour of Dysart. In 2006, the building was renovated and refurbished as part of a £1 million project and our experts installed ties to keep the gable wall attached to the rest of the building.

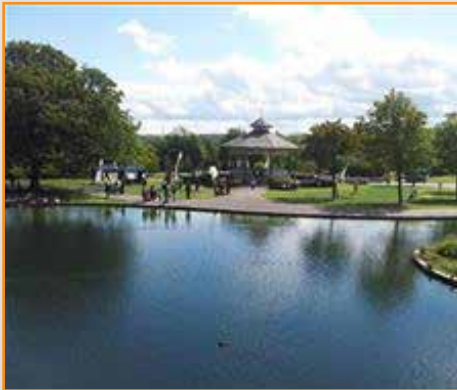
Greenhead Park opened in September 1884 and as it's only half a mile from the centre of Huddersfield it has proved to be popular with locals, providing an oasis of calm from the hustle and bustle of urban life. In 2010, a major project to restore the park to its Victorians splendour included new drainage put in to reduce problems with waterlogging, a new lake to replace one removed in the 1950s and the restoration of the Italian fountain. Our job was to help with the revamp of the Lakeside Arbor, originally designed to overlook the lake. The arches and roof were falling in and so our anchor systems were installed to make it secure.

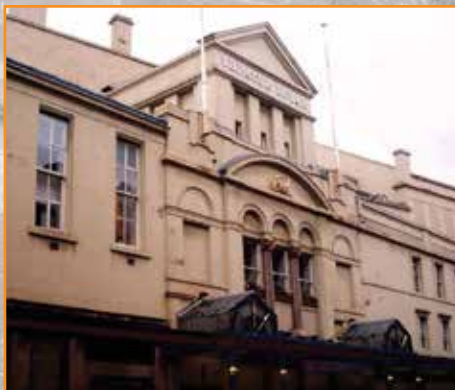
The Theatre Royal

This is the oldest theatre in Glasgow and is the home of Scottish Opera and of Scottish Ballet. When the owners wanted to replace the old canopy fronting the building with a new one, they used our anchor system to hold the new cantilever glass canopy firmly in place.

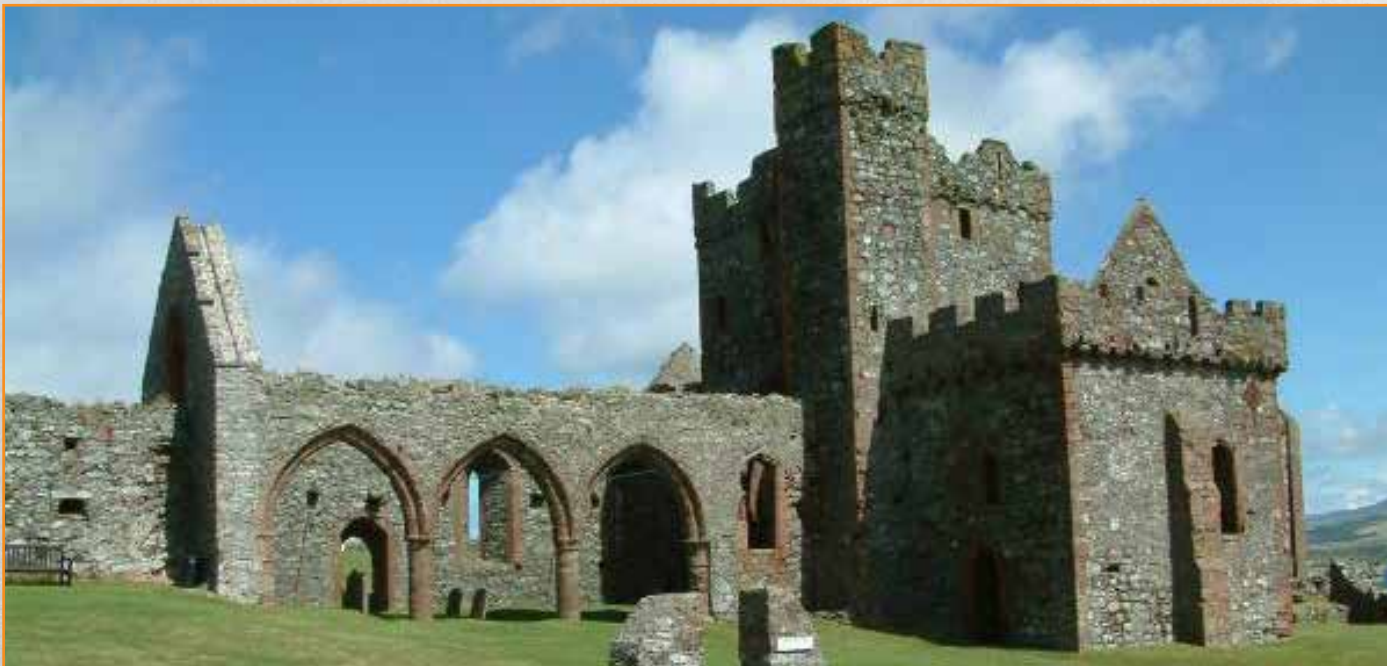
Peel Castle was originally a place of worship before becoming the fort of Magnus Barefoot, 11th century Viking King of Mann. The structure has no roof and the two side walls were leaning out and so our technicians used Anchorbond Vtek to secure them to each other via tie beams. These stainless steel beams prevent movement in the walls of this ruined chapel and stop them from collapsing.

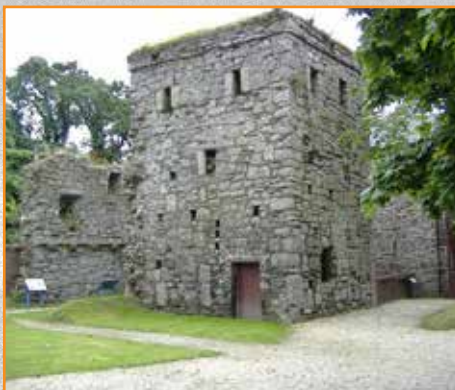
Rushen Abbey

Today on the remains of this ancient monastery remain sitting in the peace of the Abbey Gardens. Our team was asked to install anchors into the pigeon tower which was cracking and so needed to be secured and held together. Ironically, although the tower was built to attract pigeons, our Peter Cox bird prevention team were then asked to install bird deterrents to stop birds entering this historic structure!

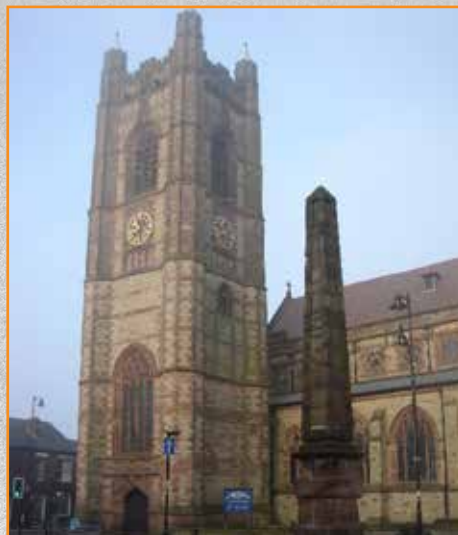
St John the Baptist

The church was built in two phases, the first in 1878 and the second in 1896. In 1991 the east end of the church was badly damaged by fire which caused damage to the arches above the windows. Our technicians installed anchors to strengthen the arches above the first floor windows to ensure they were safe during rebuilding of the roof.

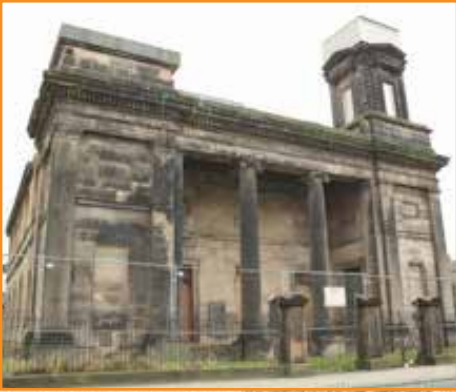
St Andrew's

This grade II listed building was built in 1823 and closed in 1975. The building was seriously damaged by fire in 1983 and Liverpool City Council acquired the site in 2008. It has recently been developed into student accommodation which included the rebuilding of a turret and a remodelling of the exterior. Our team was part of the project and used wall ties to stabilise the stone the cornices together.

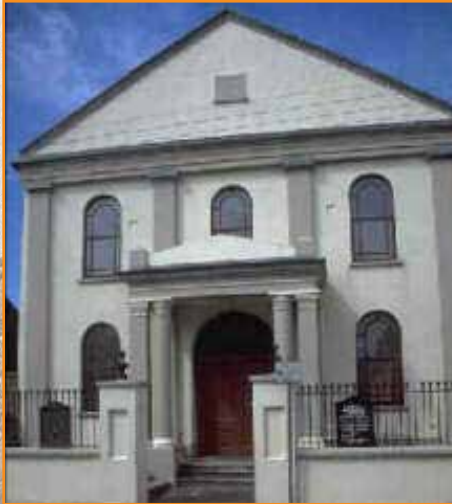
Peel Methodist Chapel

Only the façade remains of the original chapel which was built in 1878. The building has now been converted into apartments and our technicians used lateral restraint anchors to tie the walls back to the floor structures.

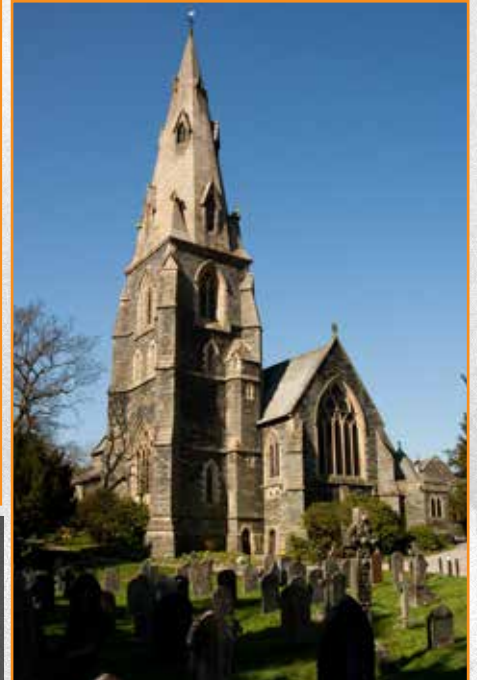
St Mary's Church

Built in 1850 this Ambleside church has an impressive tower. However, throughout the church's history the combined weight of stonework and bells has been too much for the foundations and caused cracking and so we installed a series of anchors across the beams to stabilise the tower. This is a fairly common problem and something we have rectified across several church sites.

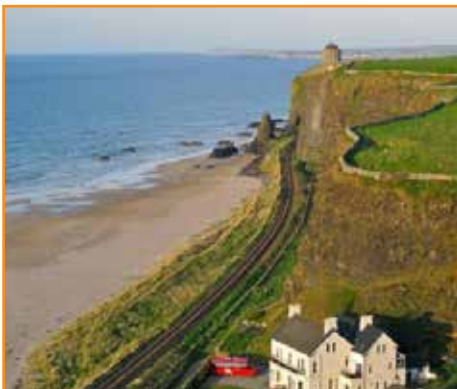
Downhill Beach Bridge

This concrete bridge on stone piers carries the Belfast – Londonderry railway across a stream. Our technicians installed a series of anchors to Northern Ireland Railway's specifications which would stabilise the rail bridge which went over the pedestrian access to the beach.

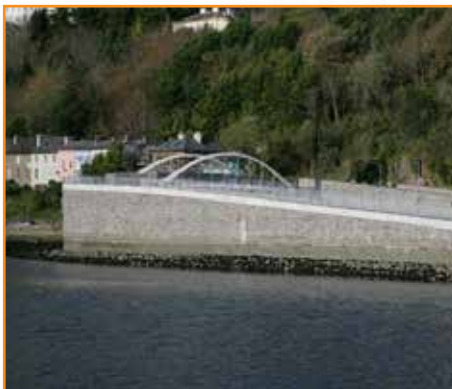
Glouthane

A series of three bridges that spanned the disused Cork railway line had to be brought up to EU regulations which meant the bridges had to be able to withstand the impact of small car. We installed anchors to upgrade the bridges for legislative purposes.

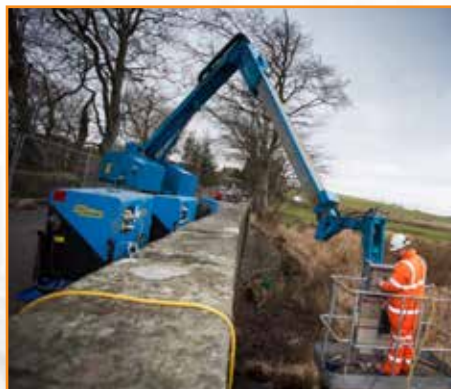
Middleton Viaduct

The electrification of the railway will mean faster, greener and quieter journeys. At Middleton Railway viaduct, Manchester, Balfour Beatty Rail Projects Ltd is charged with electrifying the line. They are installing steelworks to carry the new gantries which will hold the electric cables. These huge loads of up to 200 kn mean the viaduct walls must be strengthened. The anchors for the gantries were installed over a distance of two miles and are around 6m long, going in at a 45 degree angle. In some places it was necessary to drill through the viaduct horizontally to enable installation of the cantilever gantries. As the line is live, work had to be done out of hours.
