CINTEC

SPECIFIC PROJECT TEST DATA

CINTEC ANCHOR TESTING

**Load test to failure on a ring-separated arch repaired using
Cintec Anchor System**

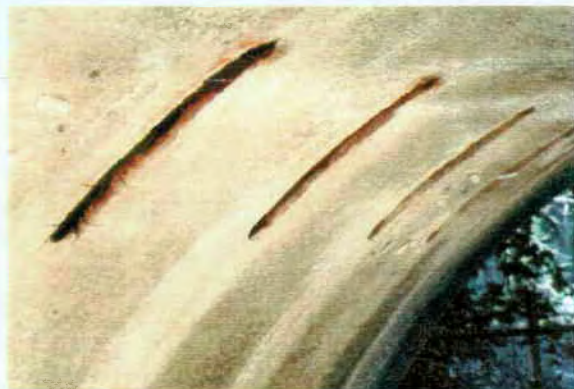
Figure 10 Installation of J-Bars

The disposition of the J-bar strengthening scheme is shown in Figure 11. Seven stainless steel ribbed bars were installed in each of the $\frac{1}{4}$ -points of the arch. This scheme was calculated to raise the load carrying capacity of the bridge by 60 per cent.

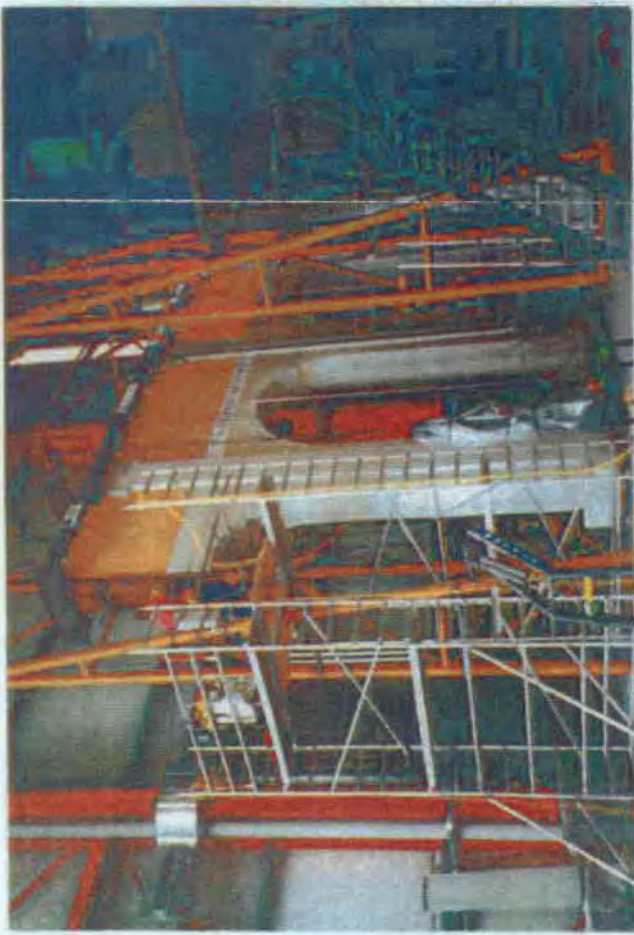
The drilling and installation of Cintec Reinforcement Anchors retrofitted to full-scale model.

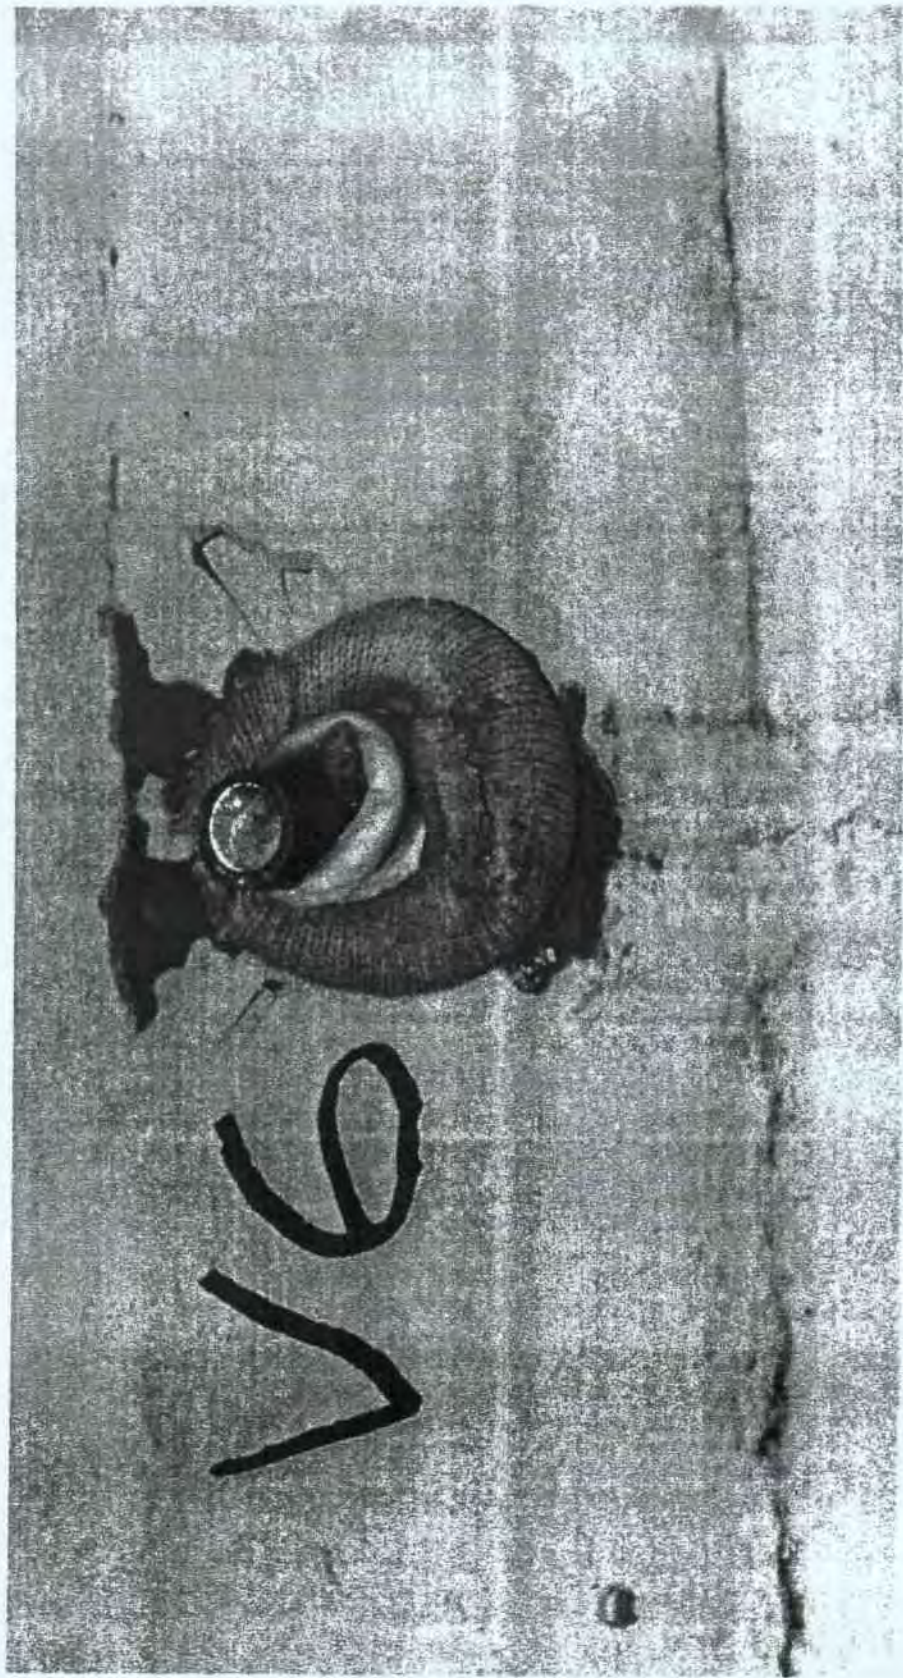
Typical anchor after vertical shear test. Note brickwork spalling and bar deformation.

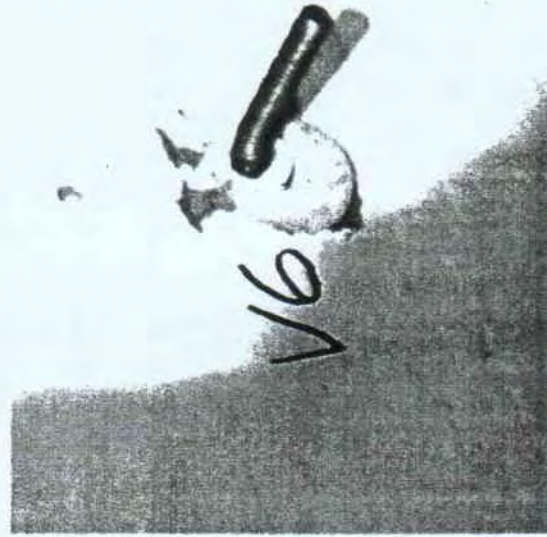
Typical anchor after vertical shear testing showing significant vertical deformation of the projecting bar.

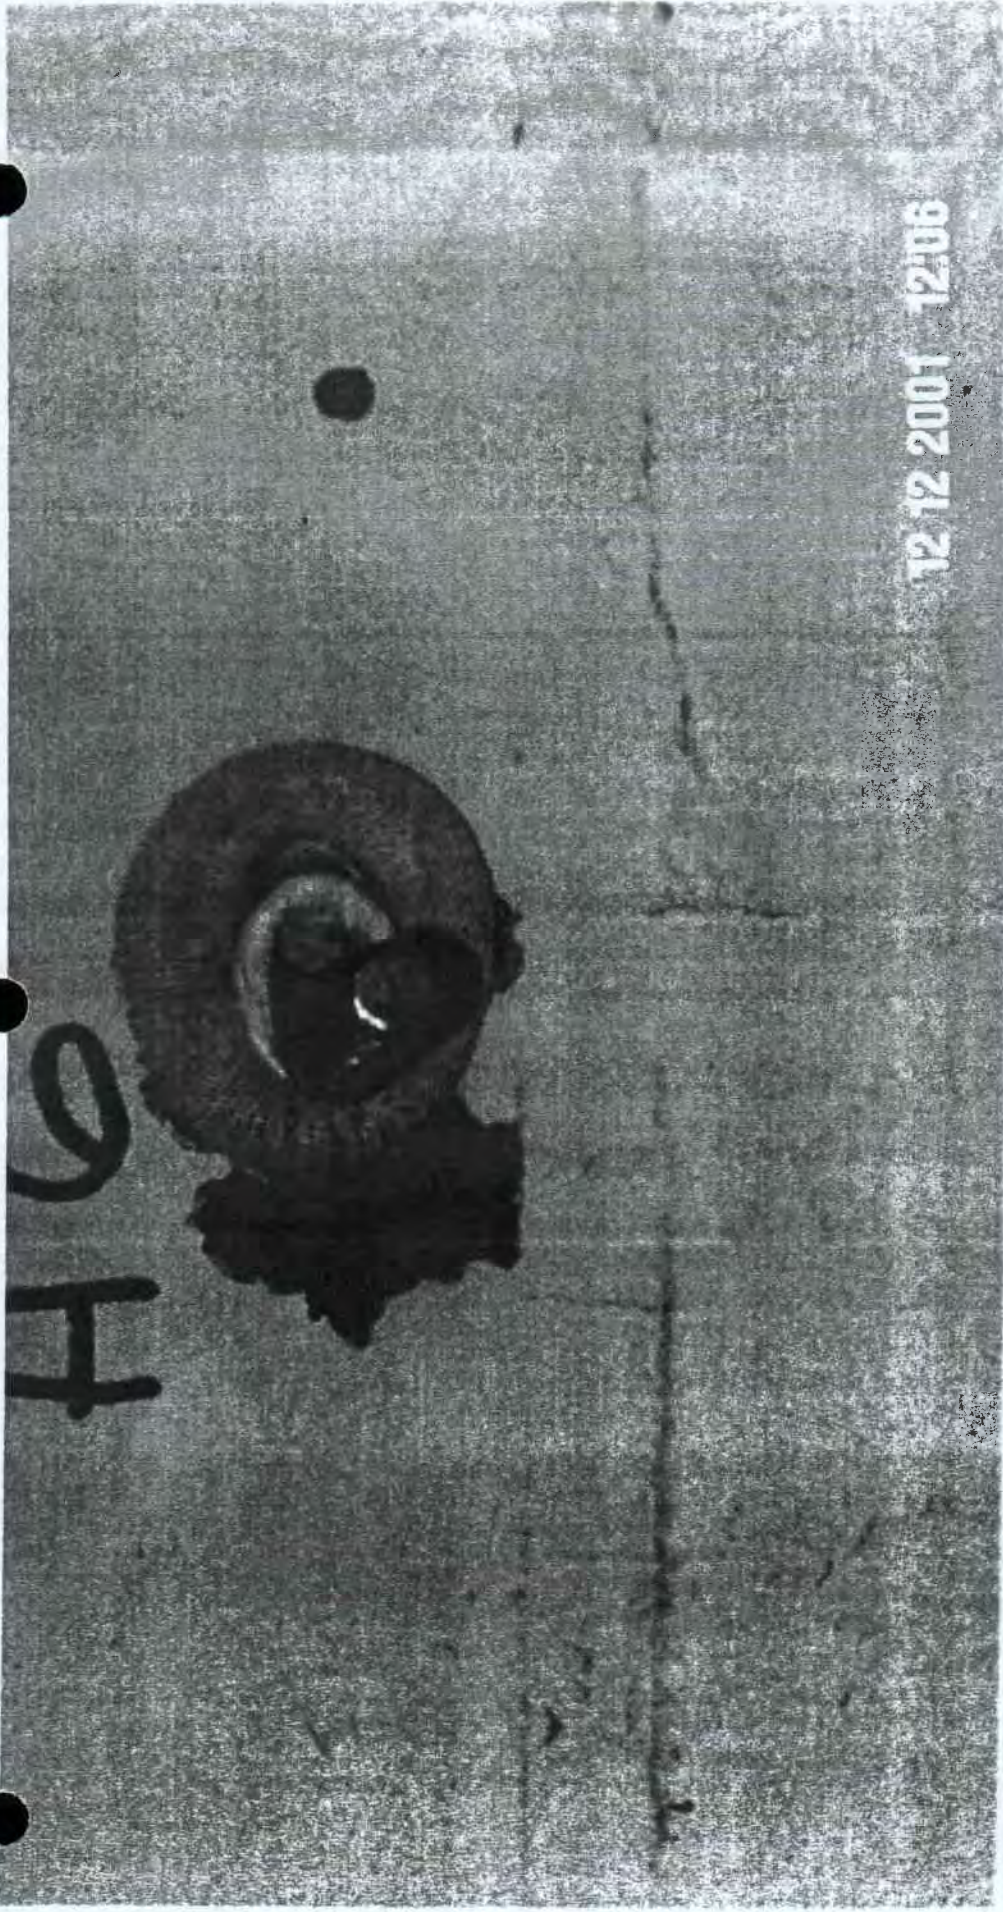
Typical anchor after horizontal shear test. Note spalling of brickwork and deformation of bar

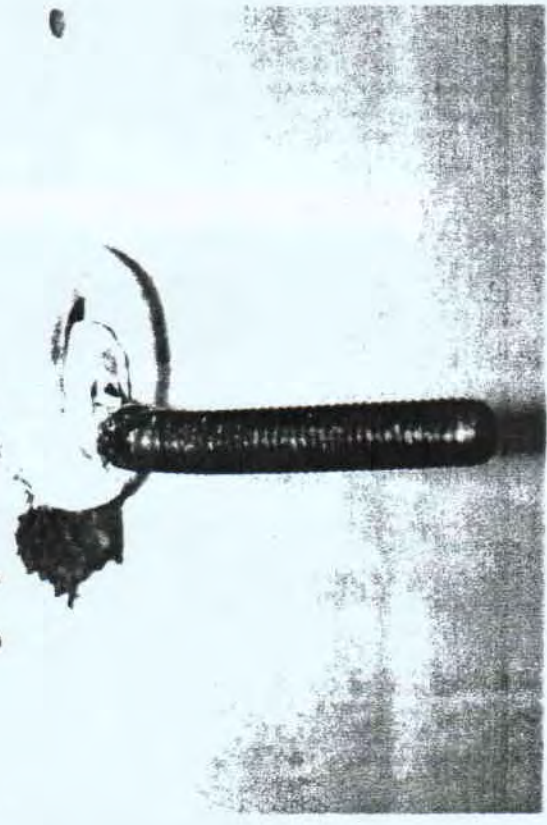
Typical anchor after horizontal shear testing showing significant horizontal deformation of projecting part of bar.

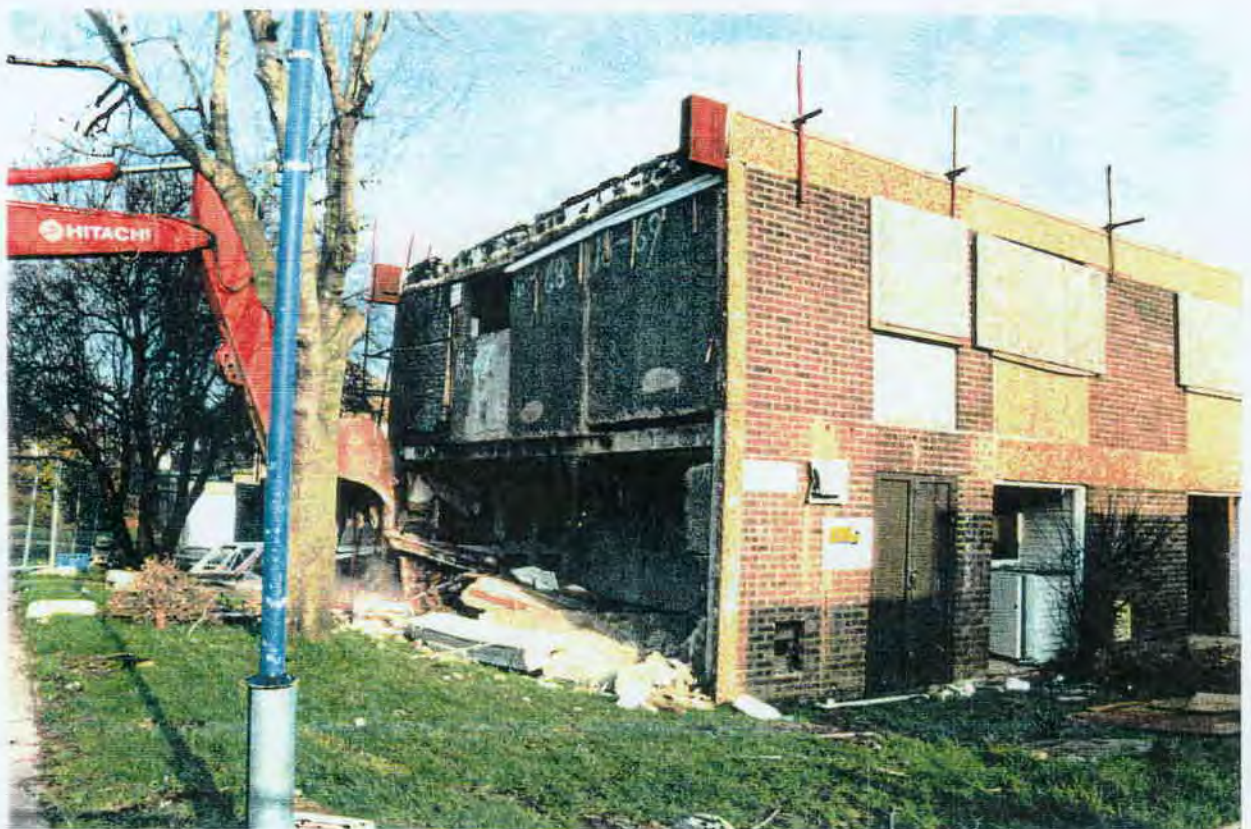
A5 The last remnants of the supports are removed and the first floor starts to fail slowly under the weight of the panels above.

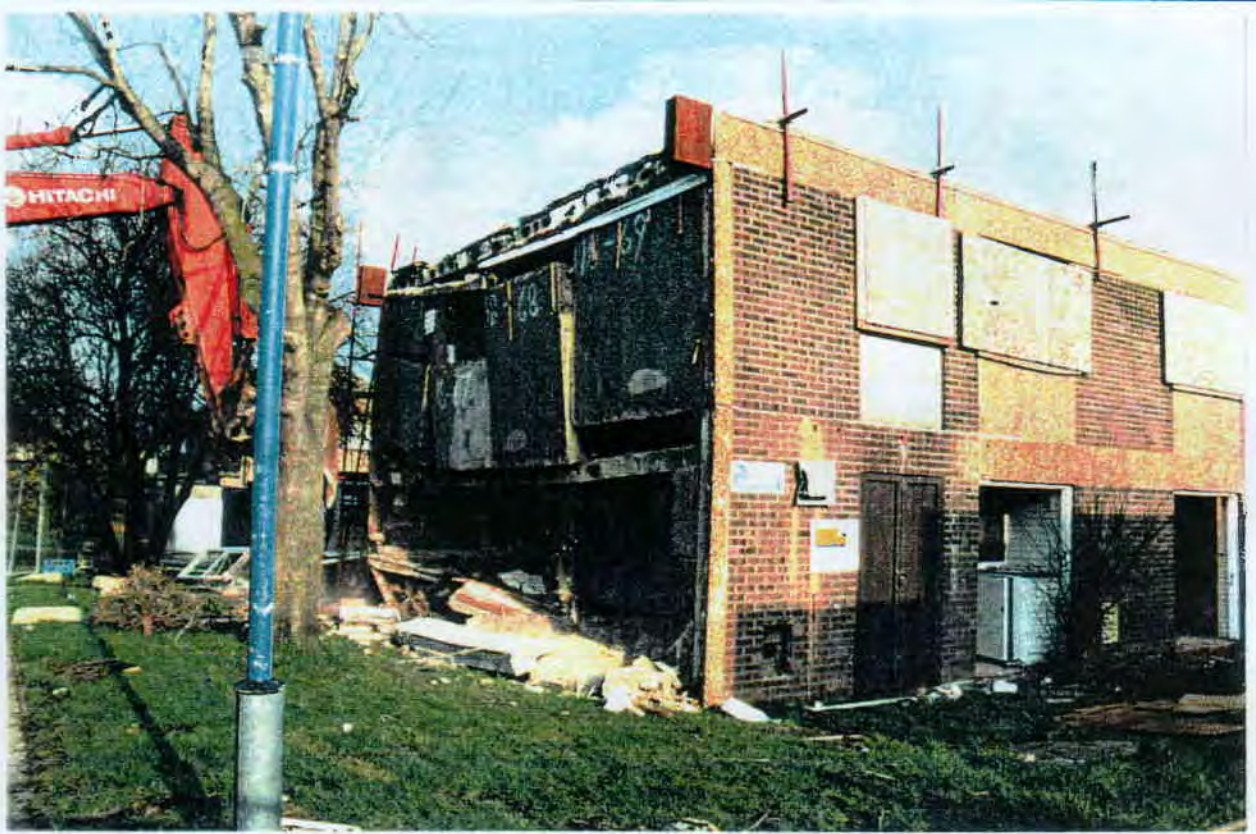
A8 The first floor continues to fail as a unit leaving behind the roof which is unsupported but still intact. The side walls start to buckle out at first floor level under rotational forces induced by the first floor wall panels.

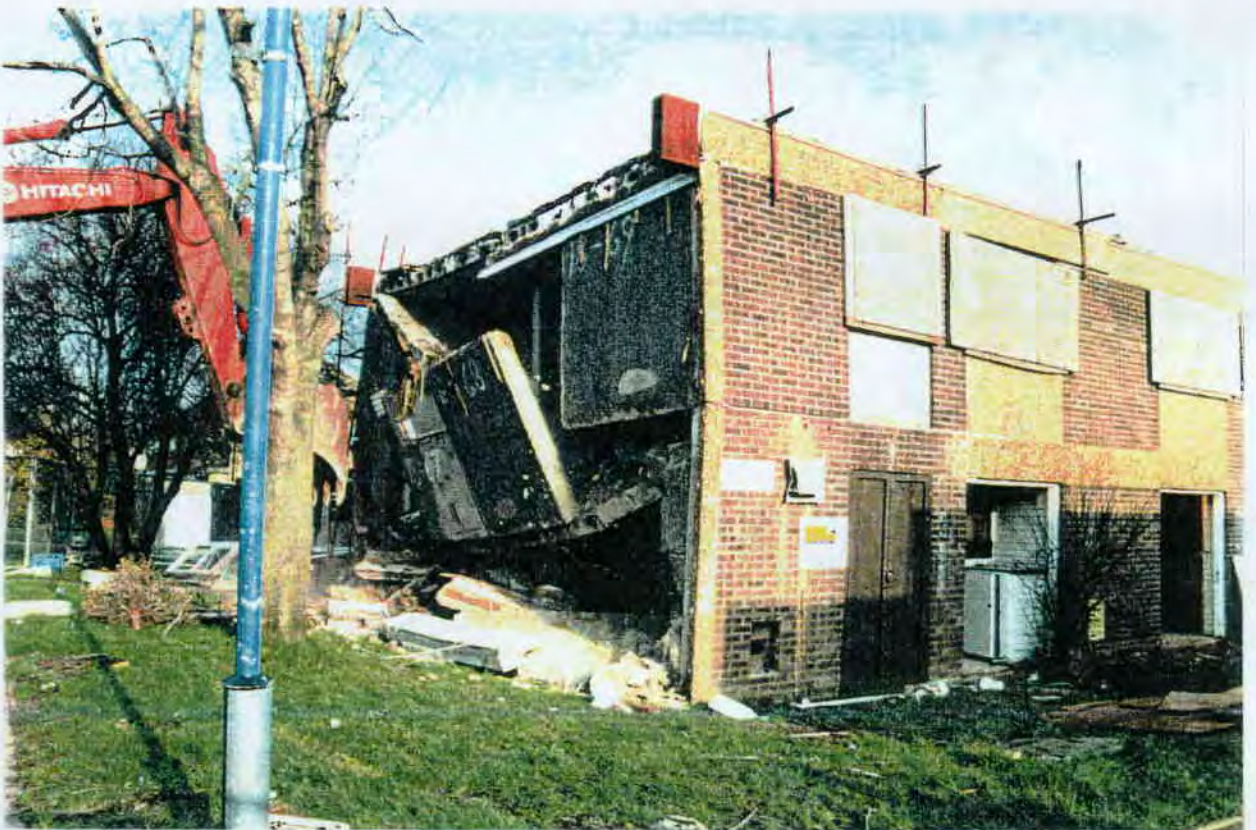
A10 The first floor collapse is complete, the side walls are now buckling badly but the unsupported roof remains in place and intact.

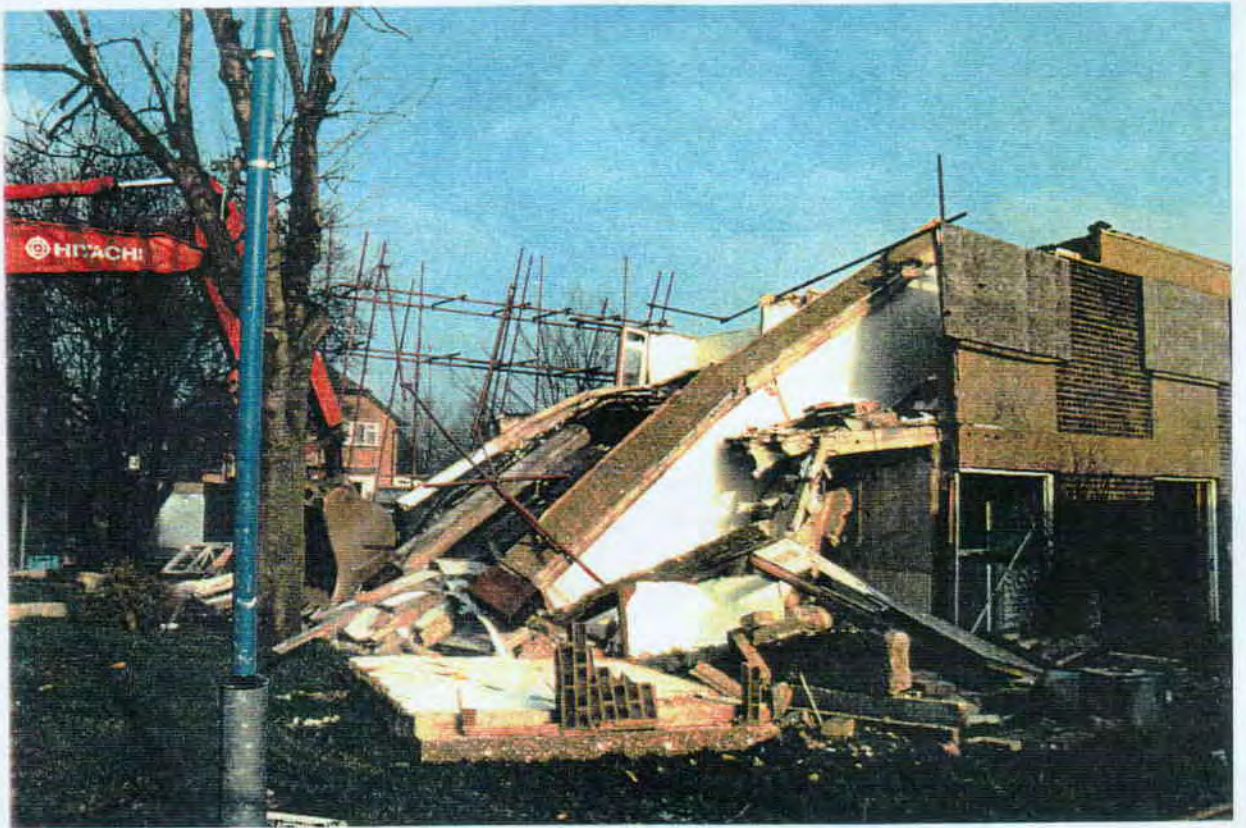
A35 Final condition of collapsed structure. Note most of the debris lies within the original dimensions of the building.

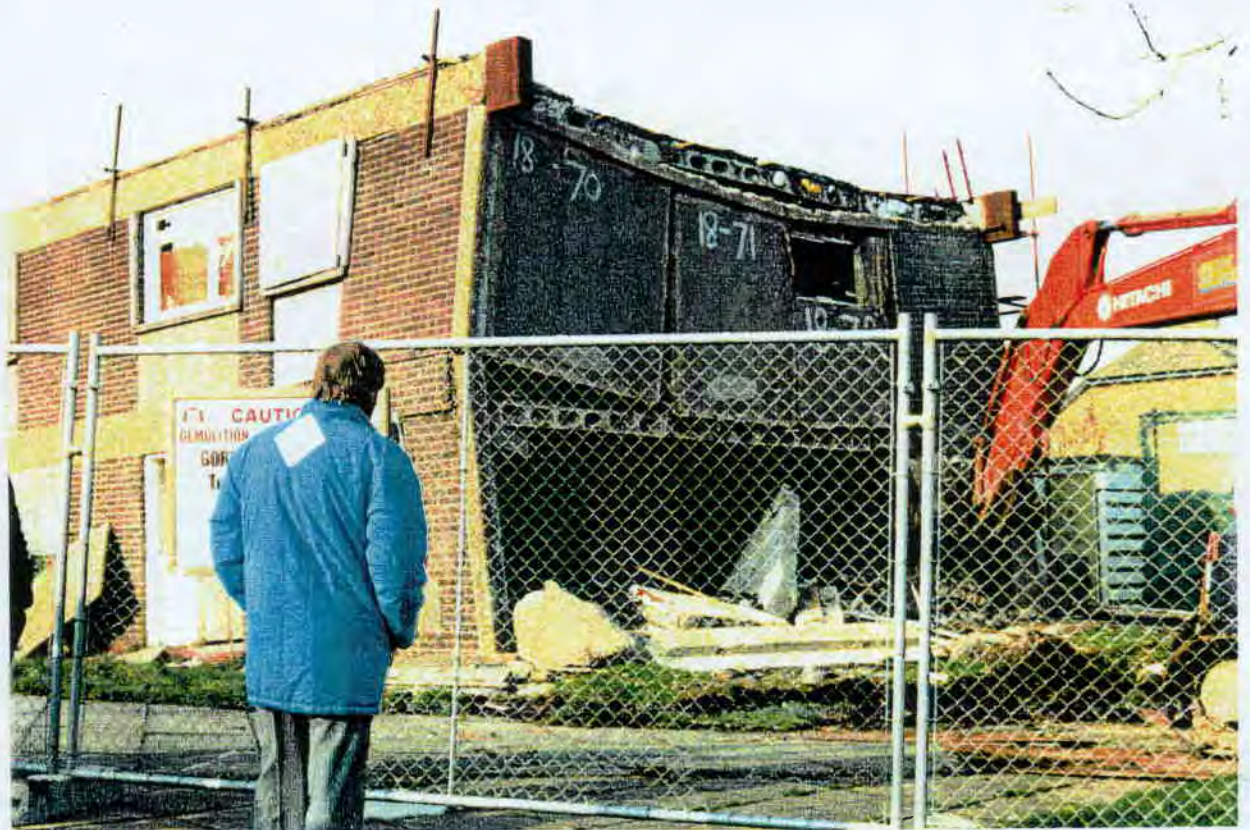
B6 The first floor is failing rapidly as the excavator bucket attempts to remove the remaining supports and the side walls have commenced buckling at first floor level.

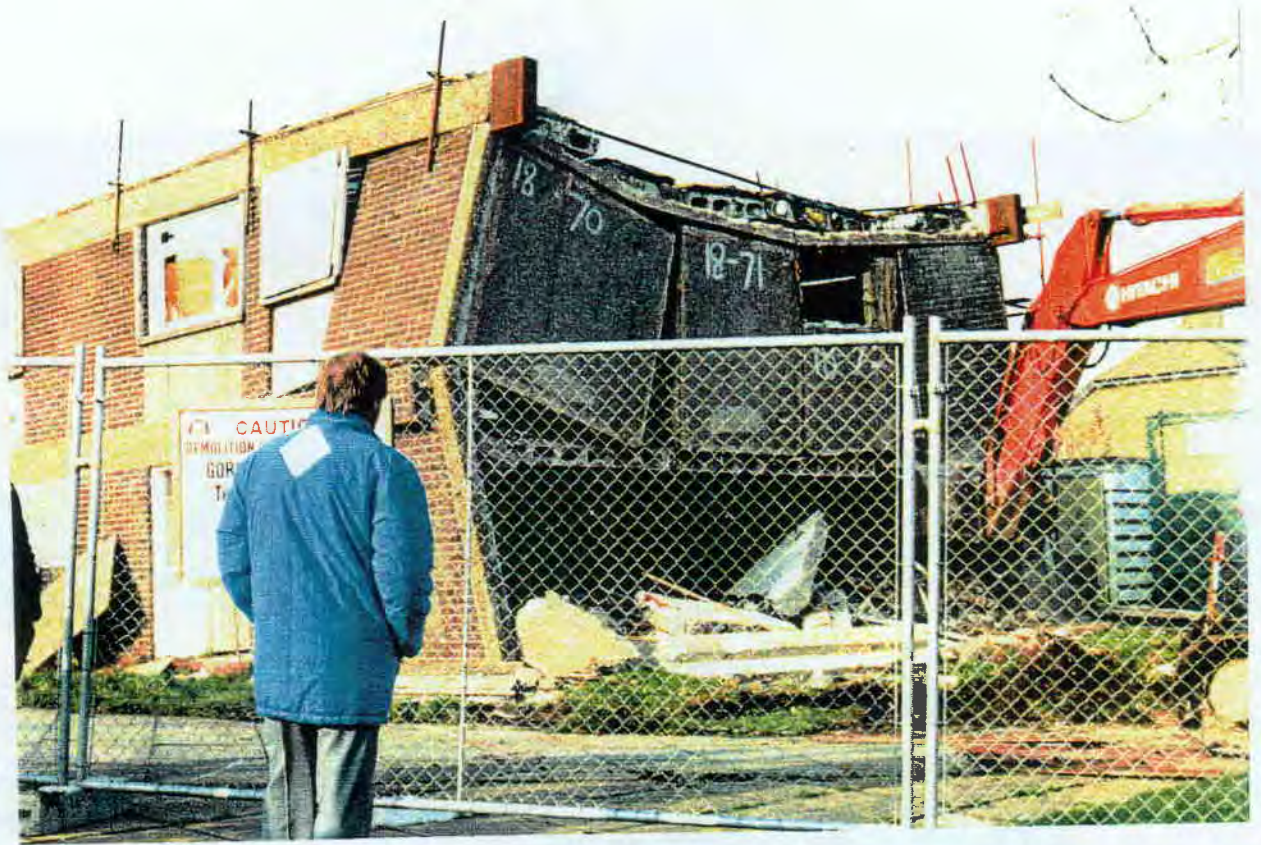
B7 As the failure progresses rapidly the roof breaks up and fails following the first floor down. Note the first floor centre wall panel is sandwiched between the roof and floor and the end is falling as a whole.

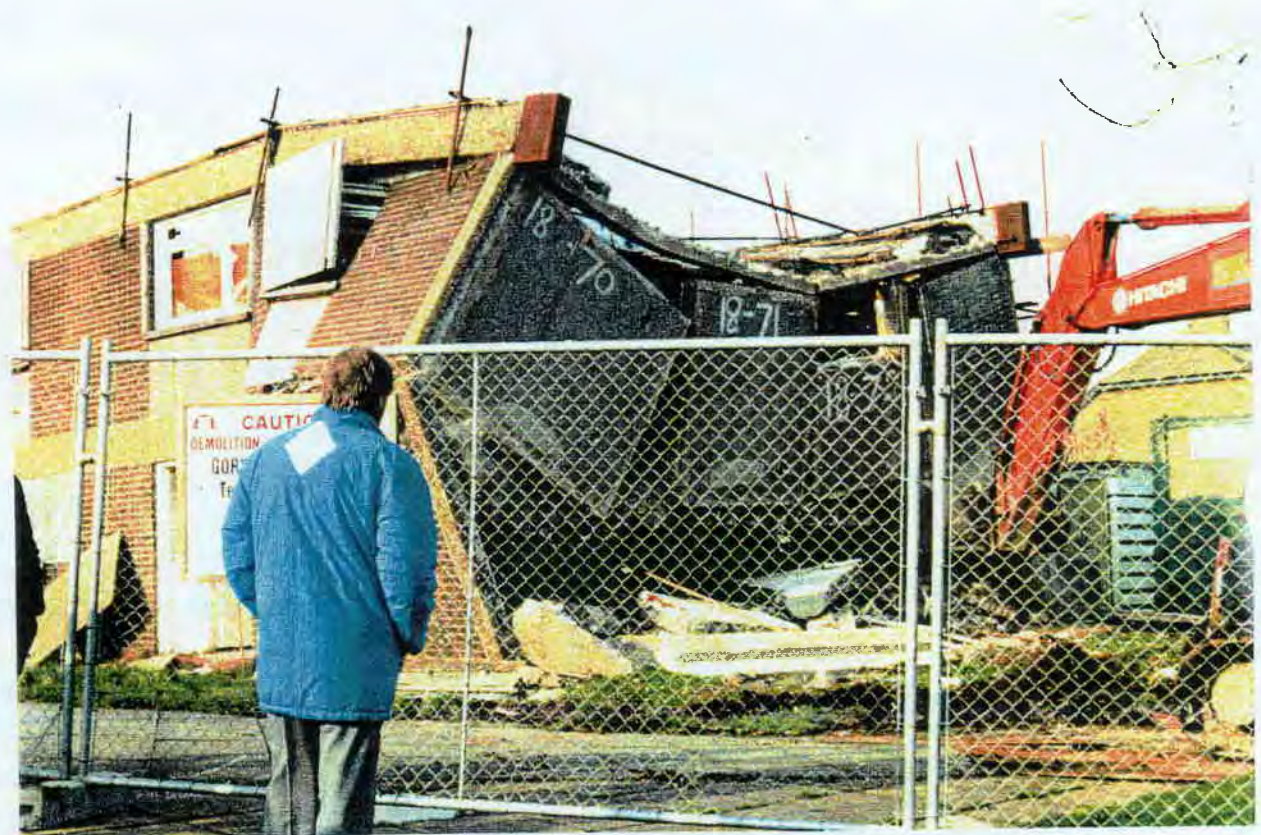
B8 The roof continues to follow the first floor in free fall.

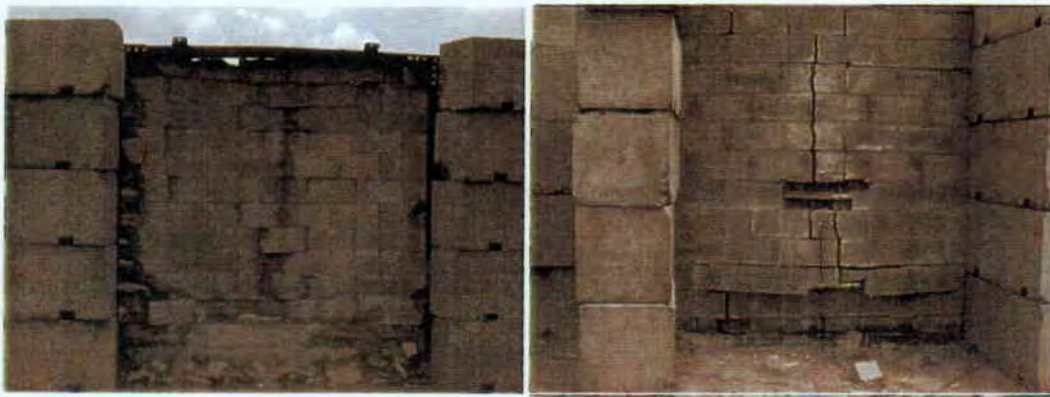
Figs 6 & 7 - Post-test photographs of the plain reinforced wall after the test: 200kg TNT NEQ @ 12.5m; 534kPa, 1274kPa-ms (440lbs TNT NEQ @ 41'; 77psi, 185psi-ms). The front view is on the left.

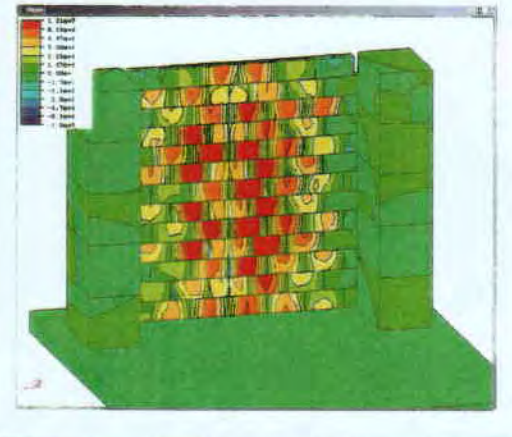
After 2ms, the bending zones move inwards and meet at the centre of the wall. Significant horizontal stresses on the back face exceed the tensile capacity of the bricks and initiate vertical cracking.
