CINTEC

TEST DATA

Moisture/Temperature cycling tests
On the Cintec remedial wall tie

Environmental investigation on the Behaviour of Cintec Anchors subjected to Ultimate Load Test – Ottawa Parliament West Block Rehabilitation Project

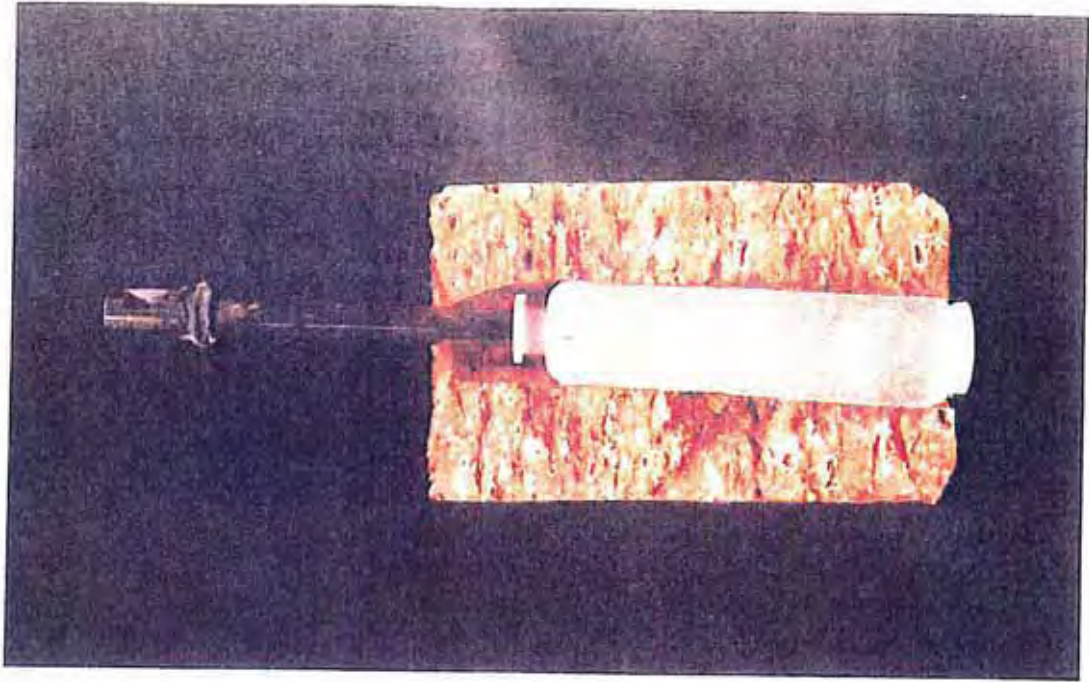
FIGURE 1 TYPICAL FAILURE MODE FOR THE STANDARD SPECIMEN

The failure of the system tested was typically by a pull-out of the steel tube from the anchor grout (Figure 1), sometimes accompanied by splitting of the brick in the plane of the anchor.

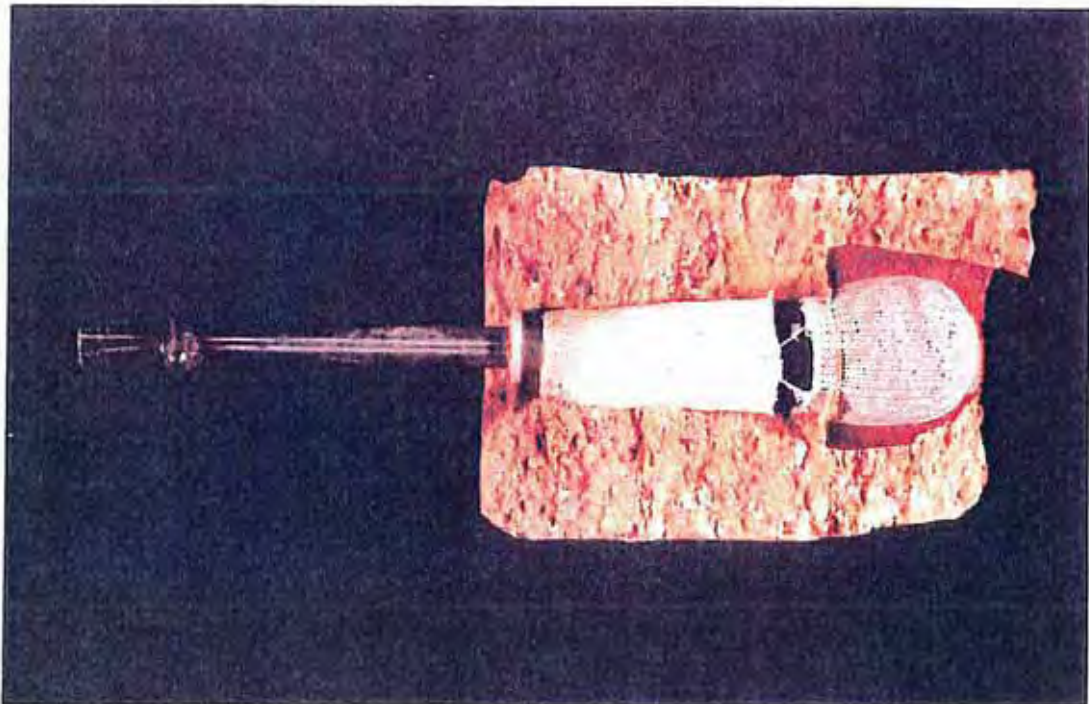
FIGURE 2 TYPICAL FAILURE MODE FOR THE EXTRA SPECIMEN

As to the three extra specimens, the mean pull-out value of 8.01 KN, when compared with the corresponding value given for the standard specimens, suggests that the apparent deterioration in performance was only due to the reduced length of embedment of the anchor. The failure here was typically by a rupture of the anchor grout at the interface between the embedded part to the bulging part, accompanied by a pull-out of the steel tube again (Figure 2).

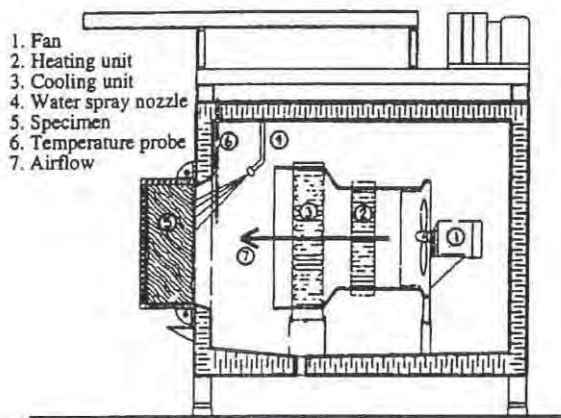
Figure 1 Schematic of Test Apparatus

The uni-directional freeze-thaw apparatus is capable of generating a cold stream of air within the chamber to lower the temperature of the face of the specimen to -15°C . This temperature is reached within one hour of the beginning of the test. The initial freeze cycle is six hours in duration to fully freeze the specimen. Thawing at the end of each cycle is achieved by blowing a stream of warm air against the face of the test panel for twenty minutes, followed by spraying a two minute flood-coat of 25°C water which re-saturates the face of the specimen and starts the next cycle. After the initial cycle each subsequent freeze period is 120 minutes in duration.

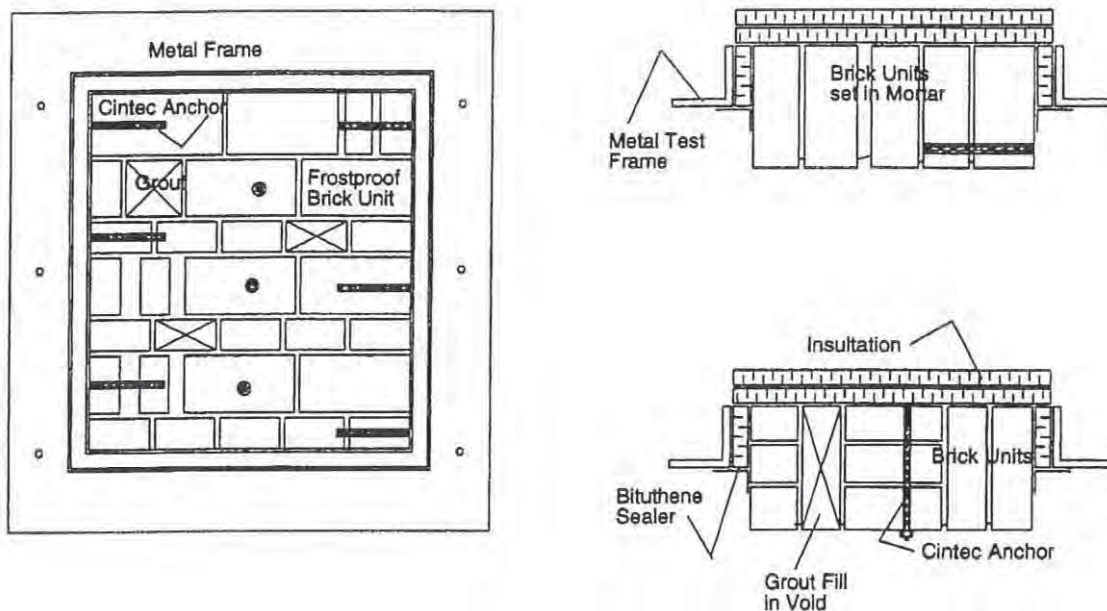
Figure 2 Schematic of Wallette with Cintec anchors

The two-brick thick wallette, which was constructed before anchor installation, was built within an insulated stainless steel frame using a relatively high initial strength cement-gauged bedding mortar known to be durable under freeze-thaw testing. The bedding mortar was formulated using 1-part white Portland cement, 1-part dolomitic lime putty and 6-parts of concrete sand. The back of the wallette was encased in 50mm thick rigid insulation. The perimeter of the wallette was insulated from the frame with 25mm rigid insulation. The gap between the wallette and frame was sealed with a strip of adhesive membrane to prevent water entry during testing. The wallette was damp-cured for seven days then allowed to dry at room temperature for 21-days before drilling and installation of anchors.

Nine test anchors were installed in the fully-cured masonry in accordance with standard Cintec installation methodology. Three anchors were installed within holes drilled through the mid-section of the face and six holes drilled through the sides of the wallette. All anchors consisted of a stainless steel rod and expandible fabric socklet that contains the proprietary grout injected under low pressure through a plastic feeder tube along and to the back of the anchor.

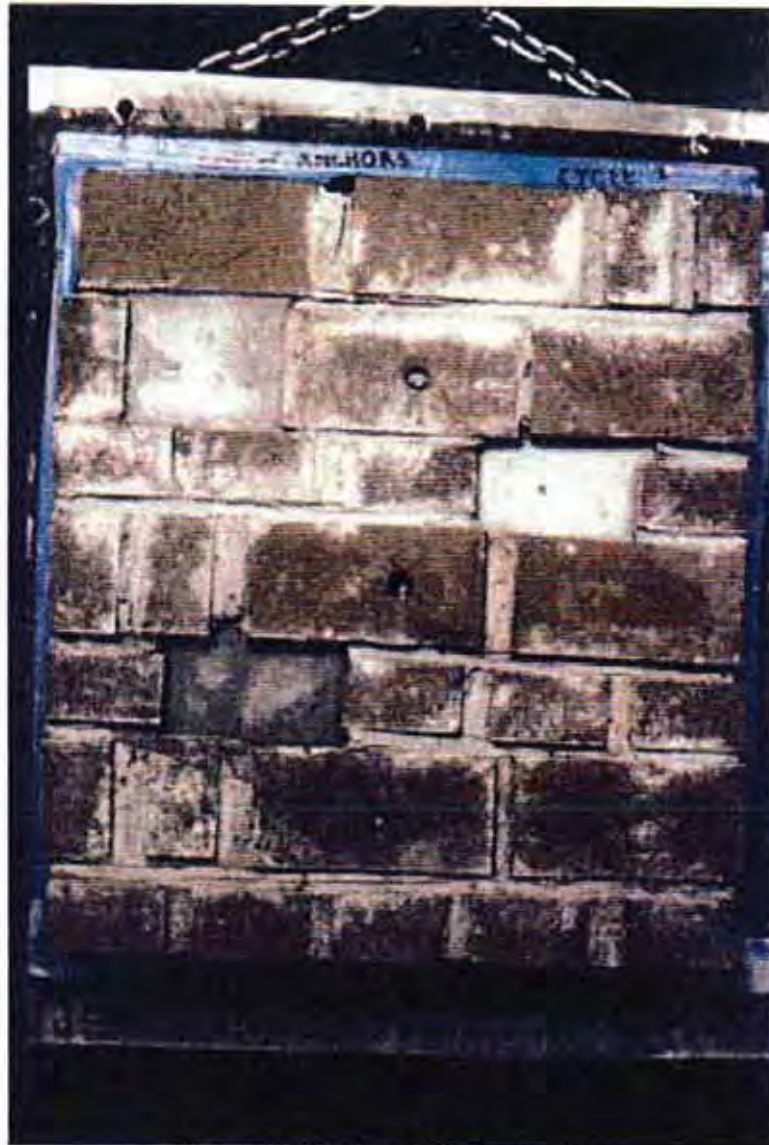
Figure 3 Wallette A before testing

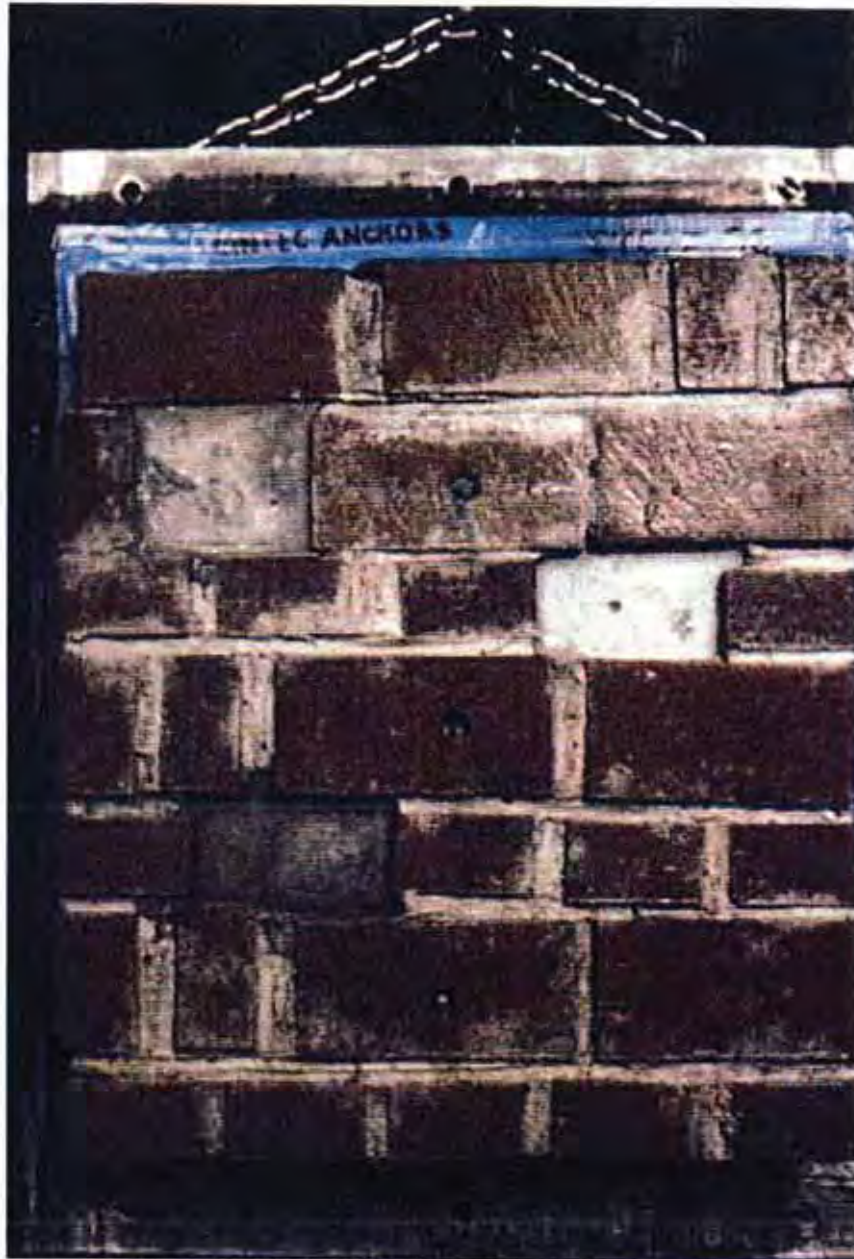
Figure 4 Wallette A after 100 freeze-thaw cycles

No appreciable loss of grout or encasing brickwork was observed after the full 100-cycle test. No grout degradation or delamination of the grout from the brickwork was noted after the test.

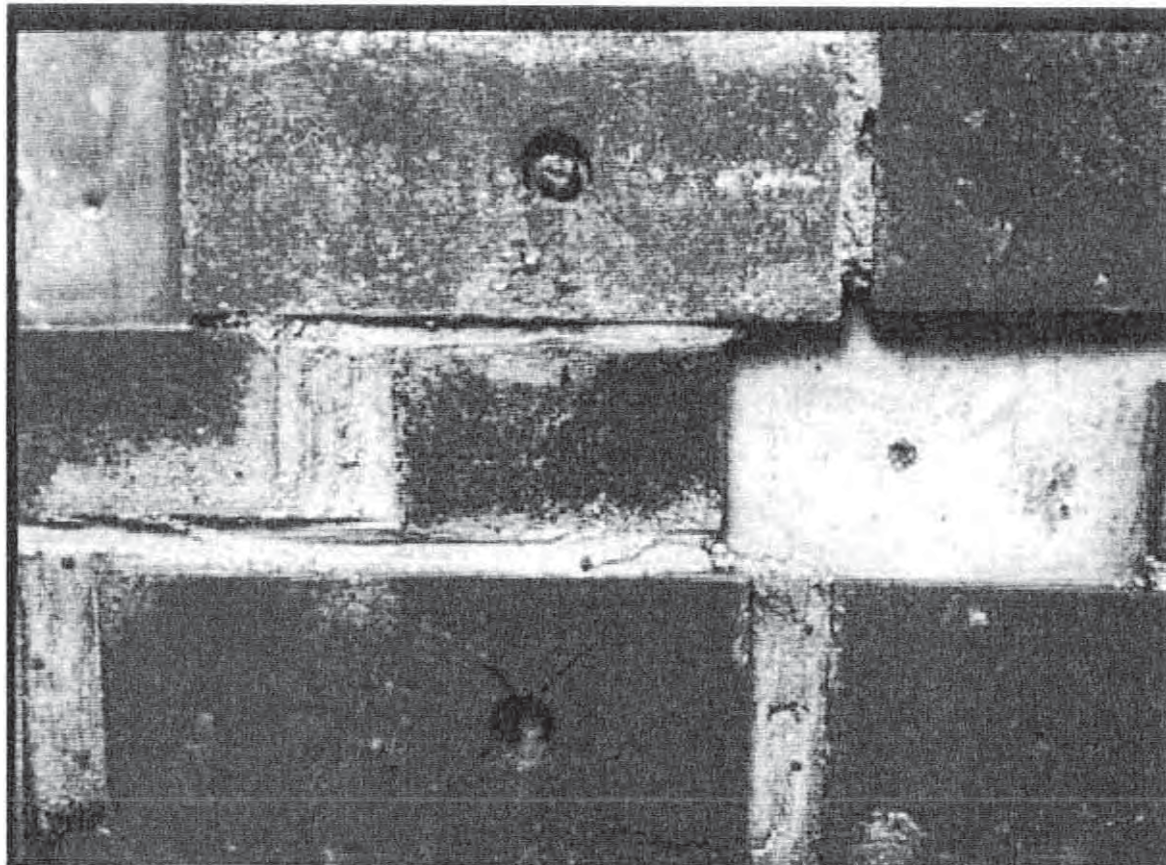
Figure 5 Wallette A after 100 freeze-thaw cycles, detail

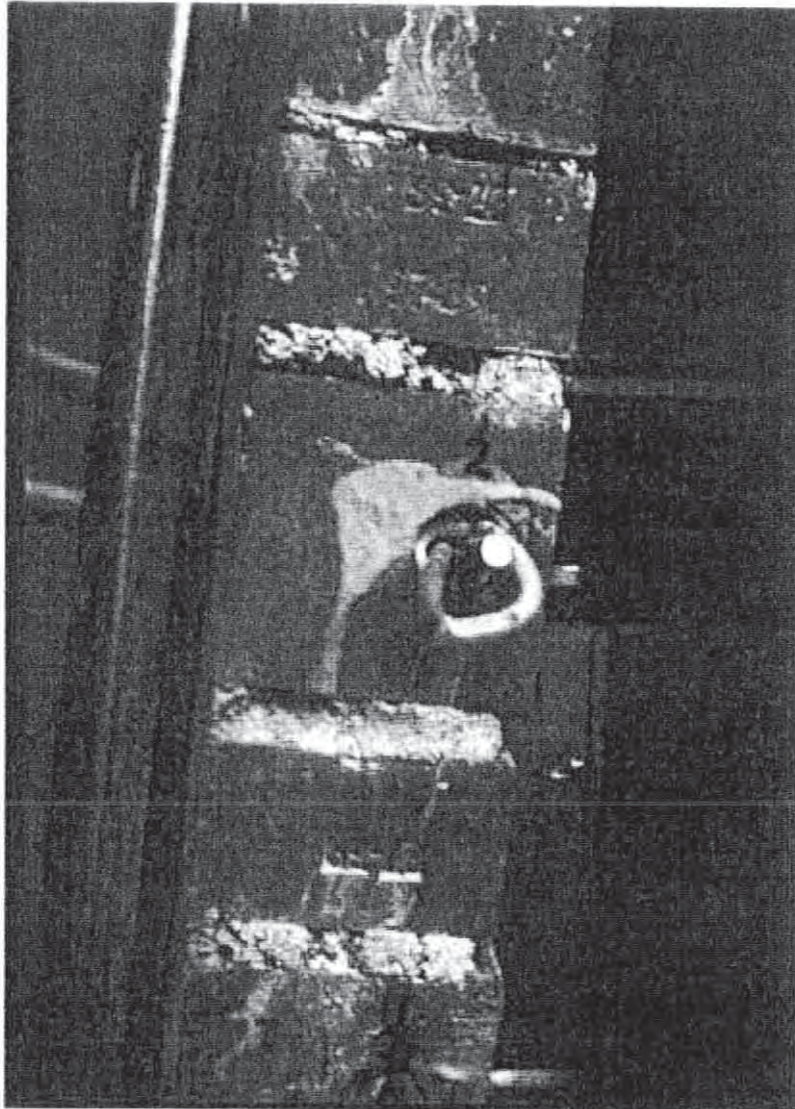
Figure 6 Side-mounted anchor before testing

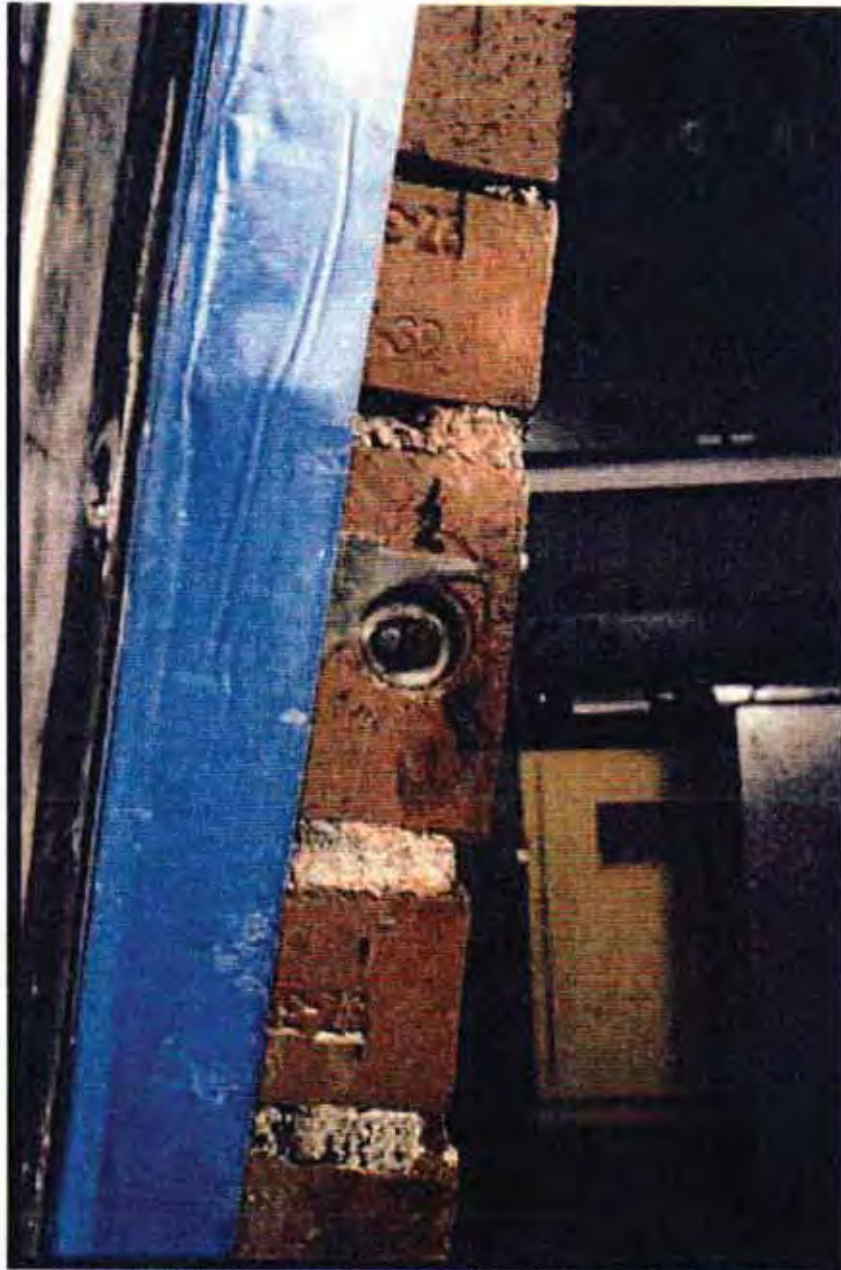
Figure 7 Side-mounted anchor after 100 freeze-thaw cycles

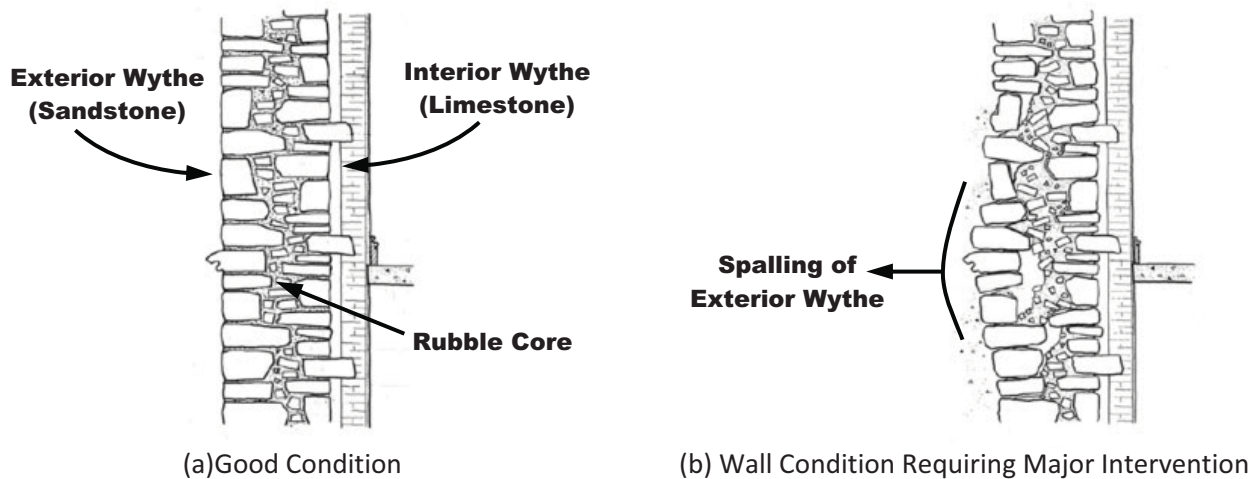
Figure 2 – West Block Structure Wall Details and Conditions

The West Block building, like many other historic stone masonry structures in Canada, was constructed with two-wythe stone walls. The walls, shown in Figure 2(a), include a rubble core separating an inner limestone wythe from an outer sandstone wythe. Masonry surveys performed by UMA Engineering Ltd. for PWGSC between 1994 and 1996 suggest that the long-term exposure

of the building to harsh Canadian weather has caused the outer wythe to separate from the rubble core at several locations on the structure. The separation is shown in Figure 2(b) and the severity of this deterioration was further evaluated by PWGSC with an additional survey in 2005. A summary of the results from this survey are shown in Figure 3.

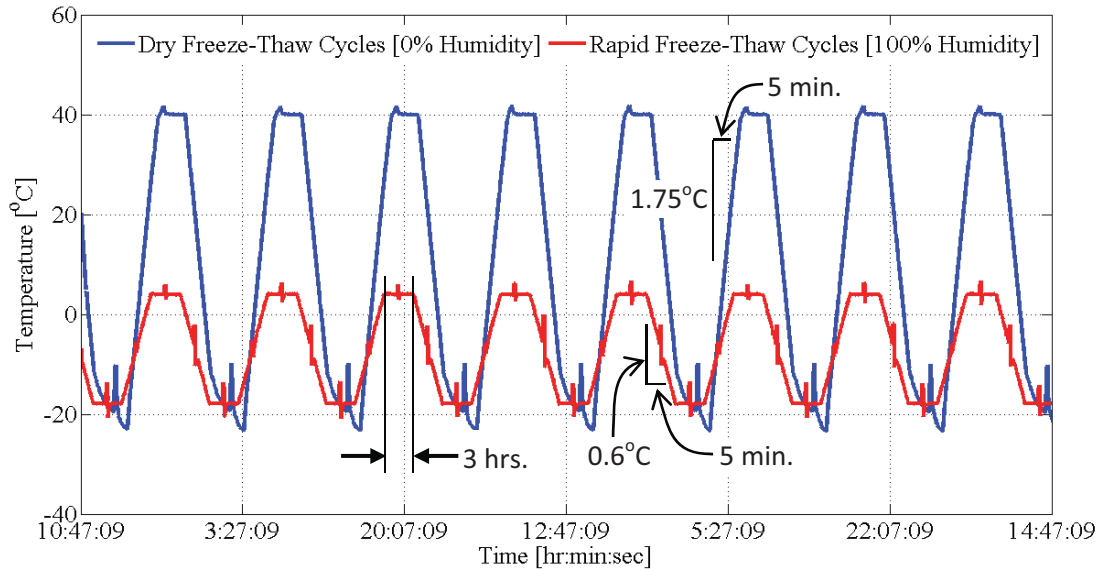
Figure 5 – Temperature Fluctuation during Conditioning: Chamber Records

during conditioning. The extremes of temperature were maintained for 3 hours with a ramping of 1.75°C every 5 minutes. The temperature variation for these dry freeze-thaw cycles is illustrated in Figure 5 over the course of approximately 4 days.

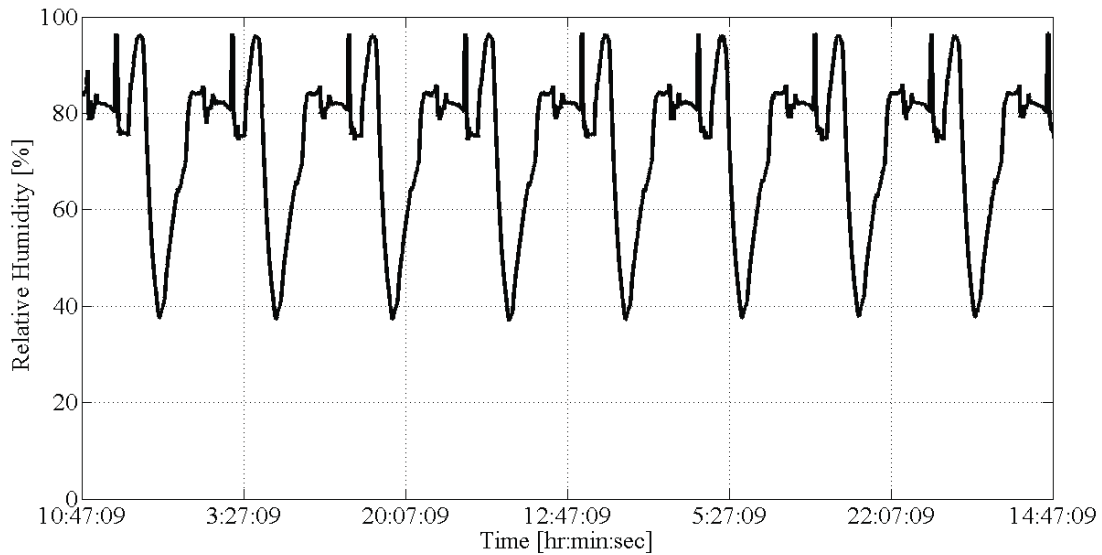
Figure 6 – Relative Humidity during Rapid Freeze-Thaw Cycles

The second conditioning scheme consisted of subjecting five of the samples for each of the 75mm, 150mm and 200mm sock lengths considered to a total of 150 thermal cycles ranging from -18°C to 4°C . The conditioning was performed in accordance with ASTM C666/C666M (2003), which required a relative humidity of 100% to be maintained during each cycle. As indicated in Figure 5, the extremes of temperature were also maintained during 3 hours with a ramping of 0.6°C every 5 minutes. The relative humidity for this conditioning scheme is shown in Figure 6 and indicates that it is difficult to maintain a level of 100% during each cycle. This slight discrepancy arises from the fact that temperature is generated by convection using large fans that circulate air from the back of the chamber. This flow of air creates a temporary state of drying during the ramping stages of the cycles when the temperature increases from -18°C to 4°C . There are also some fluctuations at -18°C that arise from the chamber defrosting stages. Nevertheless, the chamber was able to maintain an average relative humidity of 80% during most of the cycle durations.

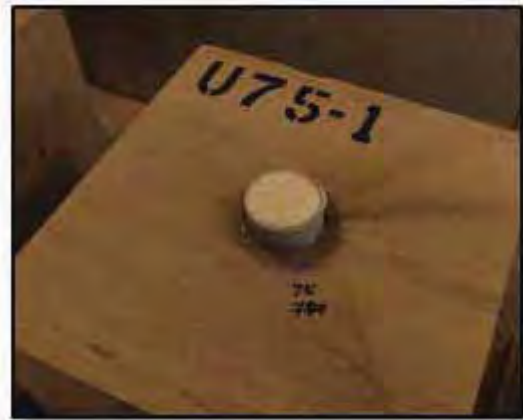
(h) Insulating Foam against Moisture Ingress
(Expansive Insulating Foam Used)

Figure 8 – Sectioning Procedure

Once the rod was sectioned, a segment of 1in diameter PVC conduit was inserted in the stonework hole and filled with R-20 FIBERGLASS PINK® insulation (Figure 8(e) to (f)). The use of a washer and nut to stabilize the anchor during the sectioning process provided a threaded rod stub of approximately 9.5mm (3/8in) that extruded from the stone. As a result, an external 2in PVC confinement was placed on the surface of the stone and expansive insulating foam was inserted to protect the top of the rod from temperature and moisture ingress (Figure 8(g) to (h)).

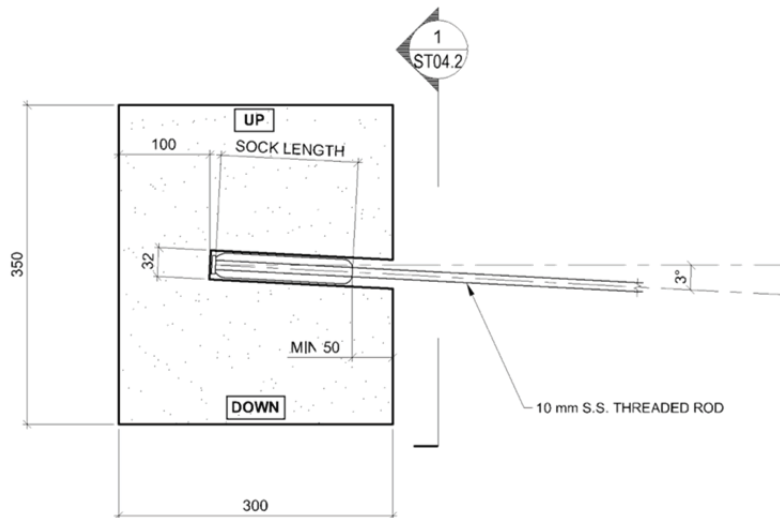
Figure 9 – Requirement for Sample Inclination: Shop Drawings (PWGSC)

The second observation that can be made from the layout shown in Figure 7 is the fact that all samples were placed sideways on wooden pallets to provide a 3° inclination with respect to the chamber floor. This inclination was provided in accordance with the fact that samples were shipped with anchors installed at a right angle from the surface of the stone. Original drawings provided by PWGSC suggest that anchors should have been installed at 3° with respect to the horizontal to prevent moisture ingress when using the repair technique in the field. A diagram of the shop drawings provided in the Request for Proposal document submitted by PWGSC can be found in Figure 9.

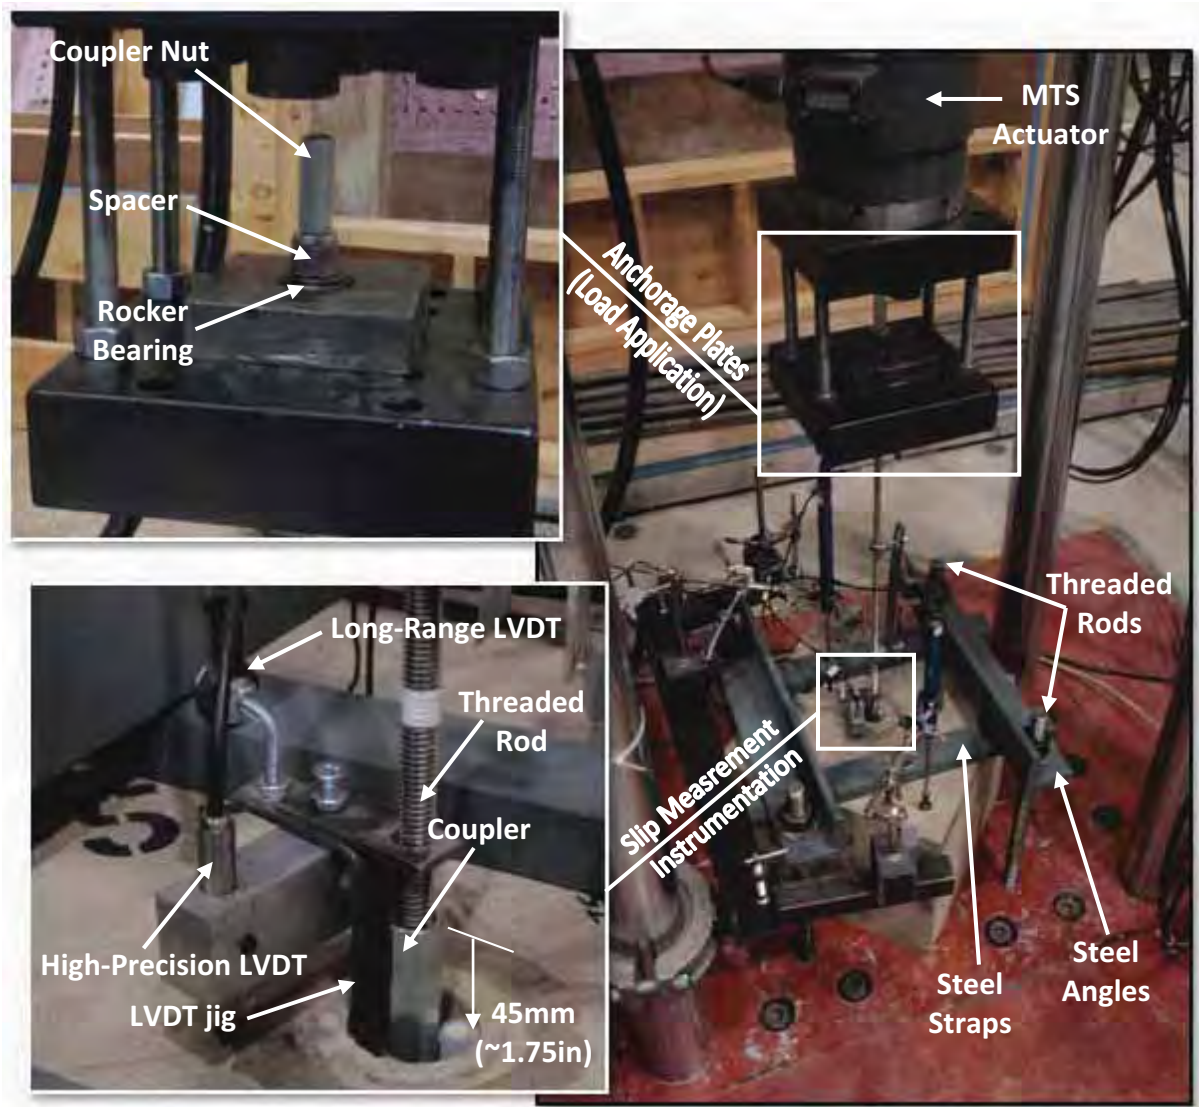
Figure 10 – Pullout Test Setup: 1000kN MTS Machine

firmly attached to the strong floor with four threaded bars, two steel angles as well as two steel straps. A picture outlining the details of the test setup can be found in Figure 10. The figure also shows that a 45mm (~1.75in) long coupler was used to extend the threaded rod stub extruding from the stonework to the anchorage plates for loading. The stub was extended using the same portion of the threaded rod that was removed during sectioning. The figure also shows that the jig supporting the LVDT sensors was secured below the coupler to minimize external sources of displacement. Finally, a rocker bearing was inserted for load application in order to accommodate the possibility of eccentric loading.

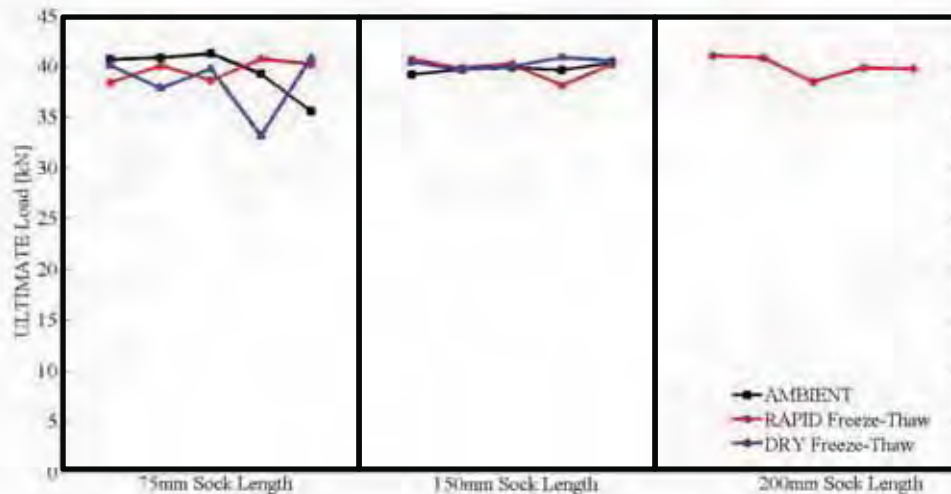
Figure 11 – Anchorage System Capacity in Ohio Sandstone (All Samples)

Results in this figure do not show sufficient evidence to conclude that rapid freeze-thaw or dry freeze-thaw conditions have any influence on the capacity of Cintec anchors embedded in Ohio sandstone masonry blocks using either 75mm or 150mm sock lengths. Figure 11 also shows that providing a

150mm sock length does not visibly improve the capacity of the repair technique from what can be achieved with a 75mm sock length. The result is also true when considering samples repaired with a 200mm sock length but more specimens need to be tested with this configuration. It should also be noted from the results of this figure that the capacity of anchors with 75mm sock length display more variability ($\pm 2.23\text{kN}$ standard deviation) than for anchors with 150mm sock length ($\pm 0.69\text{kN}$ standard deviation).

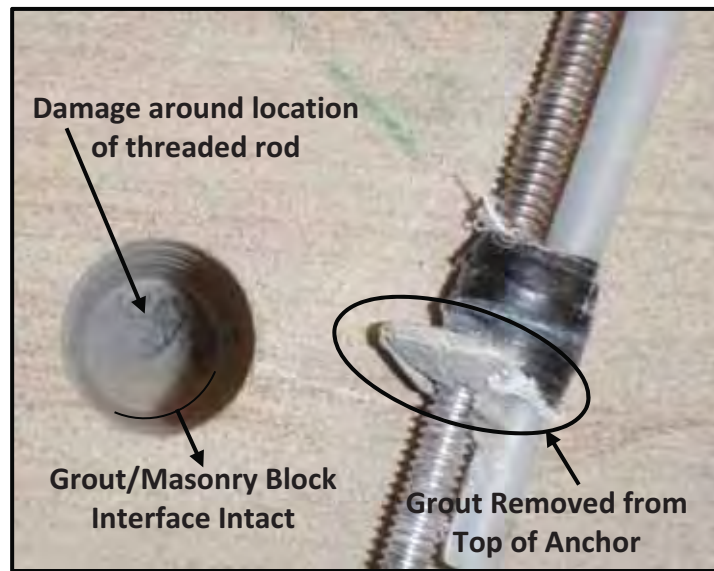
Figure 13 – Grouted Hole after Threaded Rod Pullout (Control Sample C75-1)

Another key observation made after testing relates to the quality of the grouted portion of the anchor, particularly at the interface with the stonework within the hole that was drilled for installation. Failure is initiated by yielding of the rod, after which considerable elongation causes damage to the grout surrounding the rod during testing. Figure 13 suggests that this damage is contained in the vicinity of the rod as well as at the top of the grouted hole. It does not extend towards the interface to affect the bond between the fabric sock and the stonework. The result underlines another advantage of the Cintec anchorage system for rehabilitating structures similar to the West Block building on Parliament Hill.

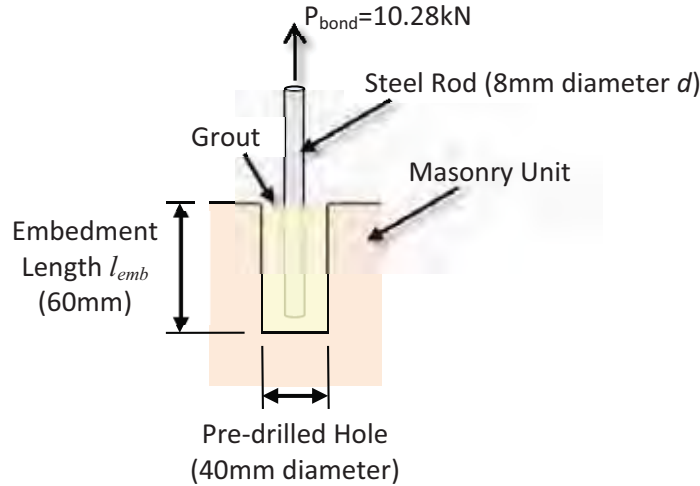
Figure 14 – Grouted Cintec Anchor Assembly (BRE Technical Consultancy Report, 1990)

As observed in Table 3 and mentioned in the previous section, there are two main failure modes observed for the Cintec anchors embedded in the Ohio Sandstone blocks provided by PWGSC. These include steel failure in the rod between the stonework and the machine fixtures. In order to evaluate the first of these failure modes, we refer to test data provided in the BRE Technical Consultancy Report (November 1990) for Cintec anchors. The data was obtained from tests conducted on masonry samples that were instrumented with 8mm diameter steel rods grouted in 40mm diameter holes that were 60mm in length. The sample geometry is shown in Figure 14 and, using force equilibrium, can be used to derive an expression (EQ.1) for the average bond strength between the steel rod and grout.

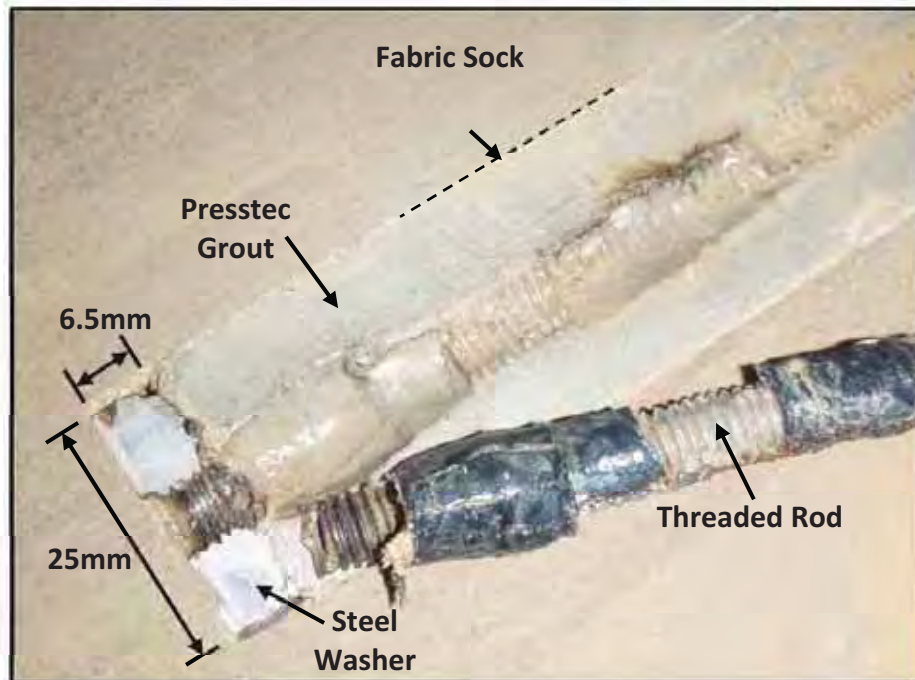
Figure 15 – Cintec Anchor Assembly with Bottom Threaded Washer

It should be noted at this stage that the strength values for bond of the threaded rods in the Presstec grout (P_{bond}) in Table 5 follow a linear trend with embedment length. Although this behavior is anticipated when considering the fundamentals of bond transfer, the ultimate loads observed during the pullout tests conducted on the stone blocks provided by PWGSC did not confirm this result. The ultimate loads for samples exhibiting slippage in the grout were found to be much higher and consistent with those describing steel failure in the threaded rod ($P_{\text{steel failure}}$). The outcome can be attributed to the fact that a 25mm diameter, 6.5mm thick steel washer was tapped and screwed to the tip of the threaded rod at the bottom of the grouted hole. This assembly, illustrated in Figure 15, provides additional strength and prevents the rods from slipping out of the grout at the loads shown in Table 5. It is believed that failures exhibiting slippage between the threaded rod and grout are initiated by steel

failure in the rod at the bottom of the grouted hole, immediately above the washer. This additional strength will increase the ultimate loads listed in Table 5 for bond failure to that which is equivalent to steel failure and thereby confirms the consistency obtained for pullout loads listed in Table 3 despite having used varying embedment (sock) lengths for the anchors.

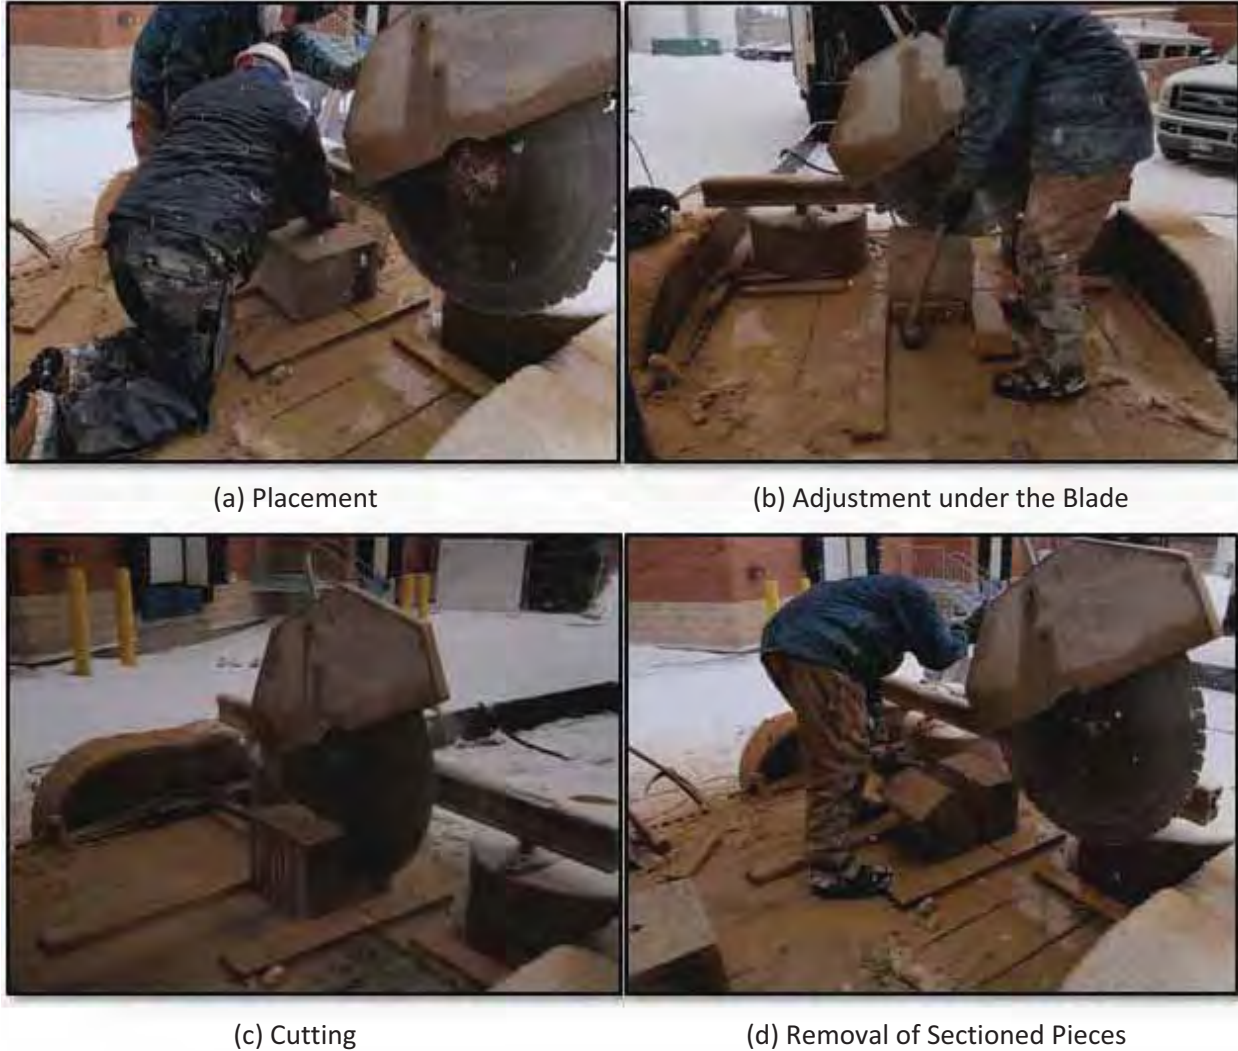
Figure 16 – Sectioning Procedure (DiTECH International Inc.)

A complete illustrative documentation of the failure planes similar to the one shown in Figure 15 after testing is provided in Appendix B of this report. The illustrations do not show evidence of damage in the grouted portion of the anchor for any of the failure modes, which indicates that the Cintec rehabilitation technique is resilient despite the consideration of thermal weathering. It should be noted that the failure planes in these illustrations were exposed by sectioning the samples down the center of the grouted hole. Sectioning was performed by DiTECH International Inc. and took place at the University of Manitoba. Several pictures of the sectioning procedure are shown in Figure 16.

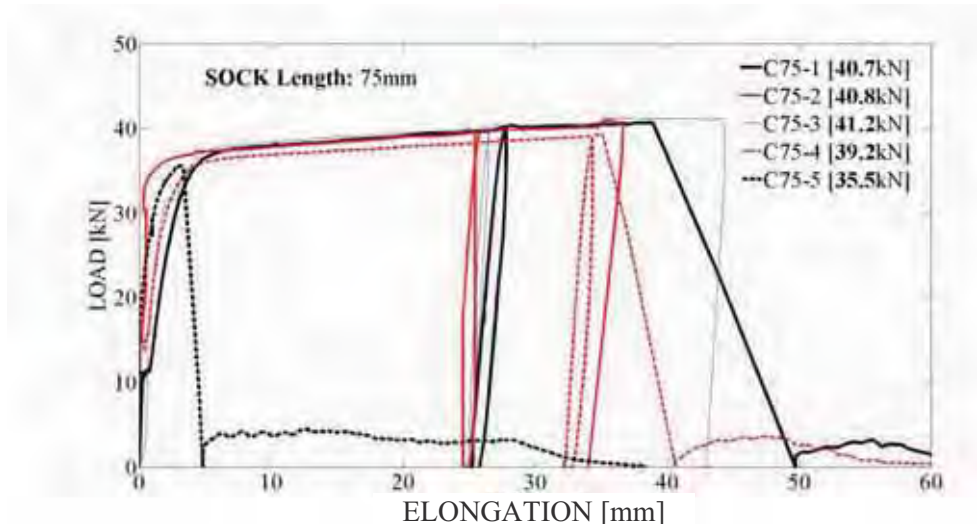
Figure A.1 - Load-Elongation Behaviour (Control Samples - 75mm Sock Length)

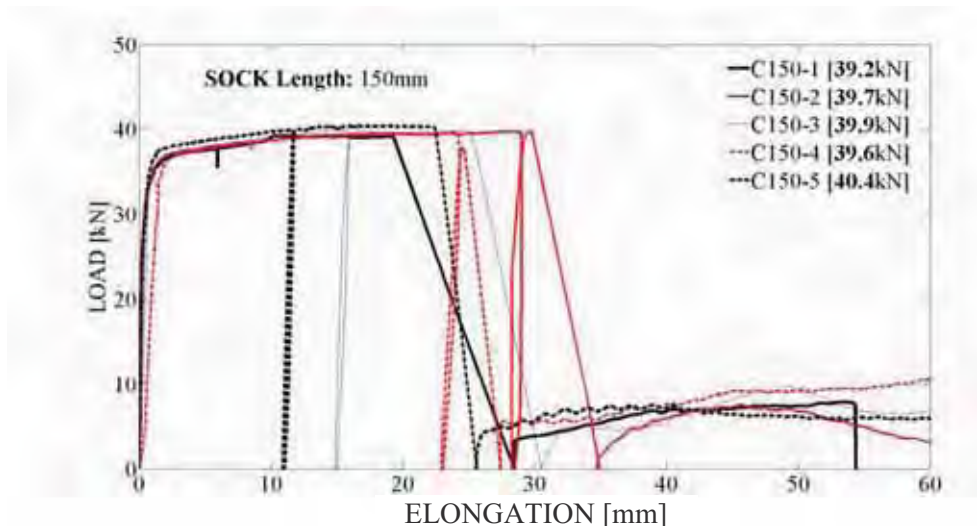
Figure A.2 - Load-Elongation Behaviour (Control Samples - 150mm Sock Length)

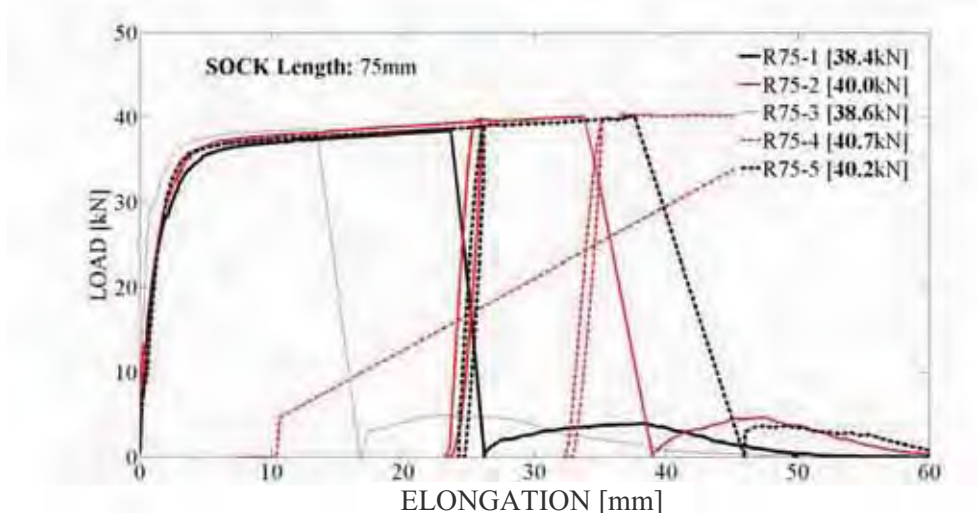
Figure A.3 - Load-Elongation Behaviour (Rapid Freeze-Thaw Samples - 75mm Sock Length)

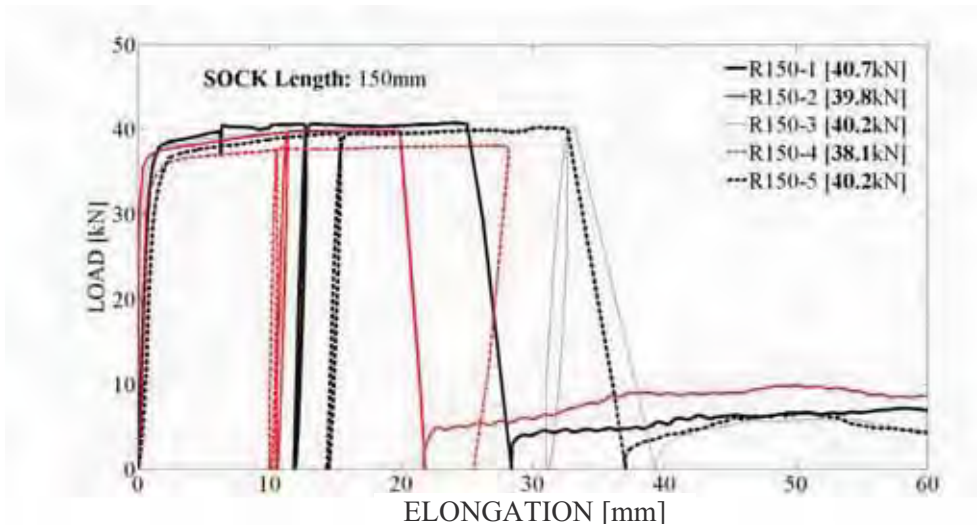
Figure A.4 - Load-Elongation Behaviour (Rapid Freeze-Thaw Samples - 150mm Sock Length)

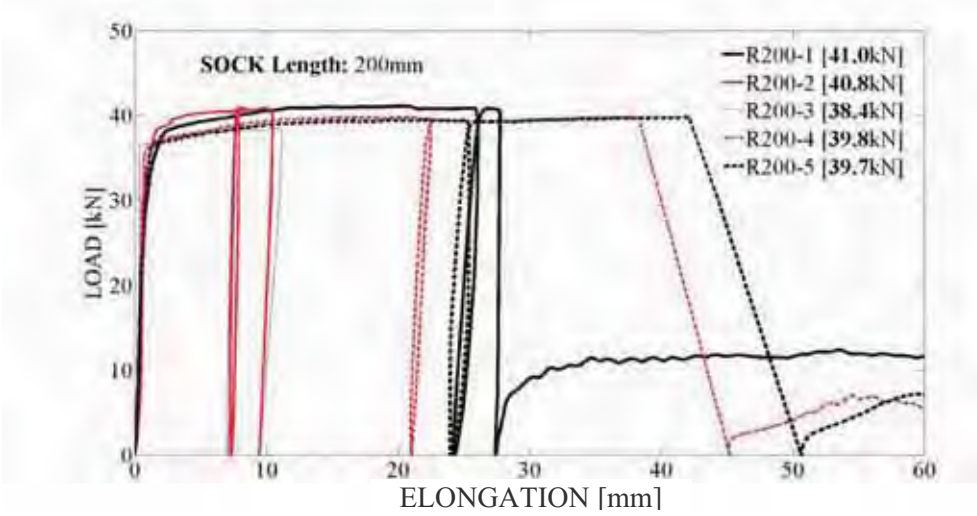
Figure A.5 - Load-Elongation Behaviour (Rapid Freeze-Thaw Samples - 200mm Sock Length)

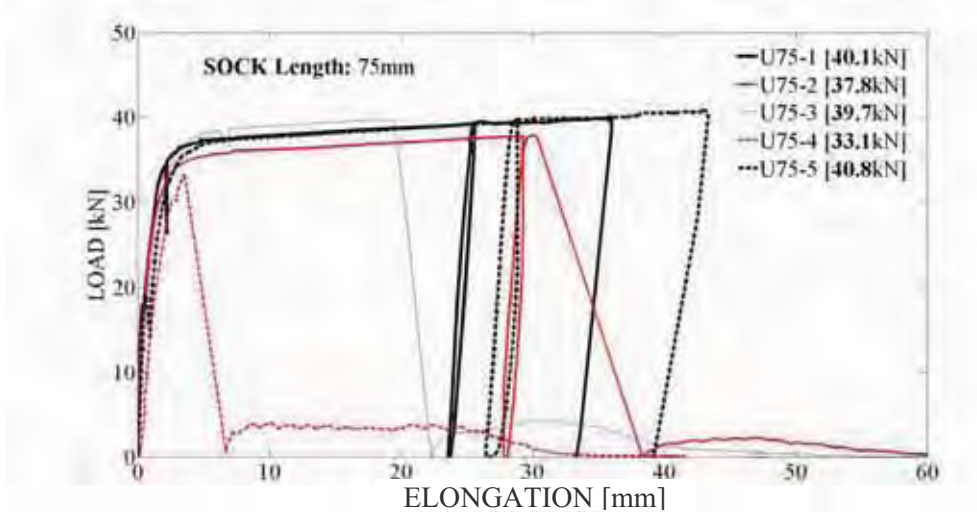
Figure A.6 - Load-Elongation Behaviour (Dry Freeze-Thaw Samples - 75mm Sock Length)

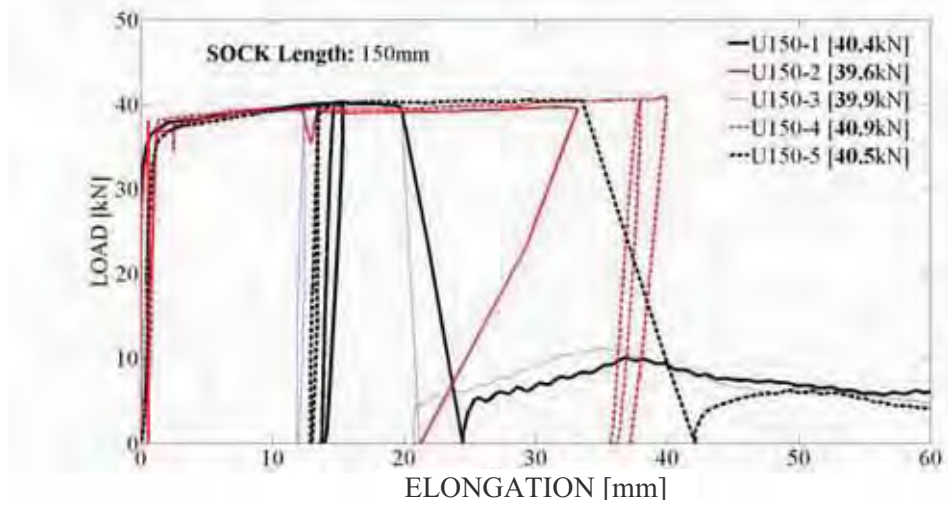
Figure A.7 - Load-Elongation Behaviour (Dry Freeze-Thaw Samples - 150mm Sock Length)

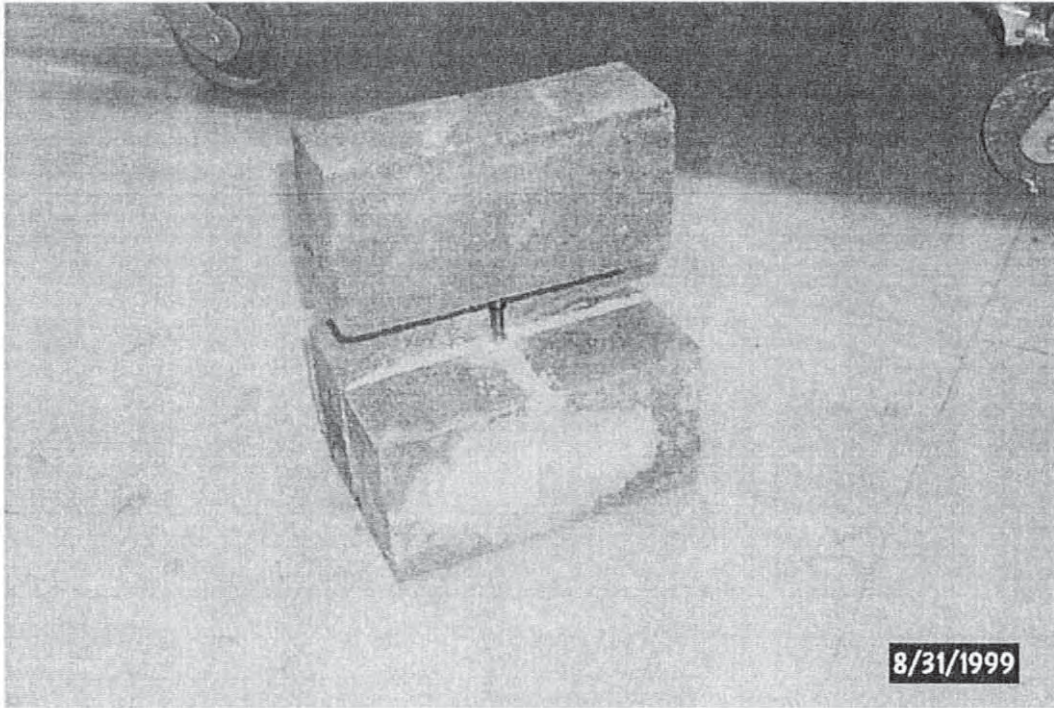
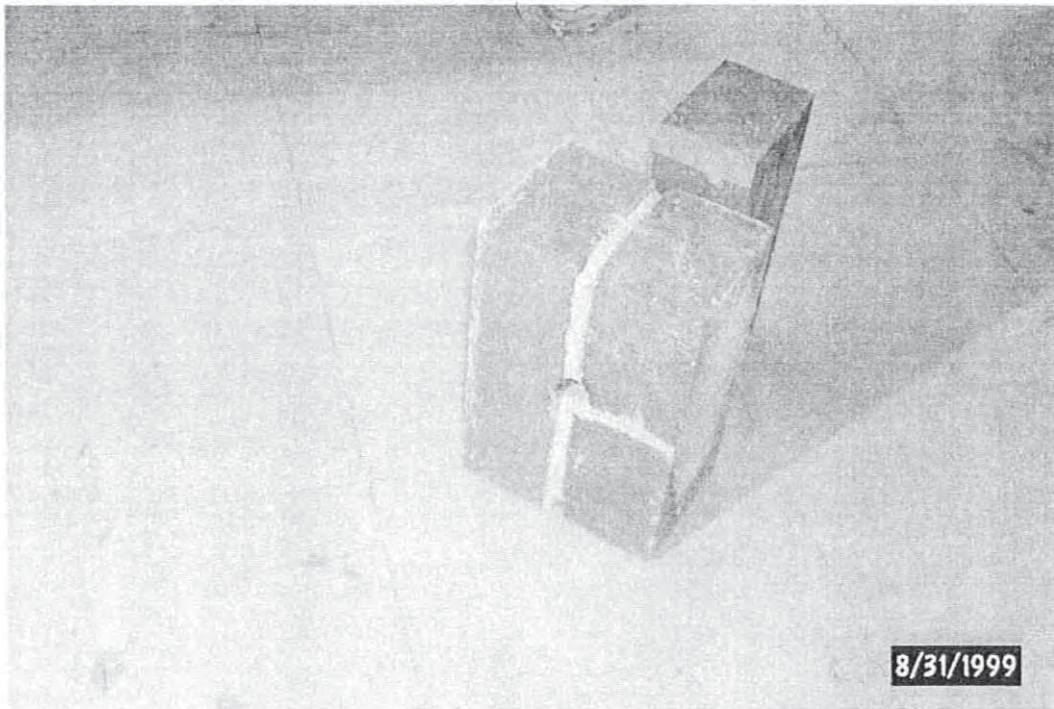
FIGURE 1. Test Specimen
