CINTEC

TEST DATA

Moisture/Temperature cycling tests
On the Cintec remedial wall tie

Environmental investigation on the Behaviour of Cintec Anchors subjected to Ultimate Load Test – Ottawa Parliament West Block Rehabilitation Project

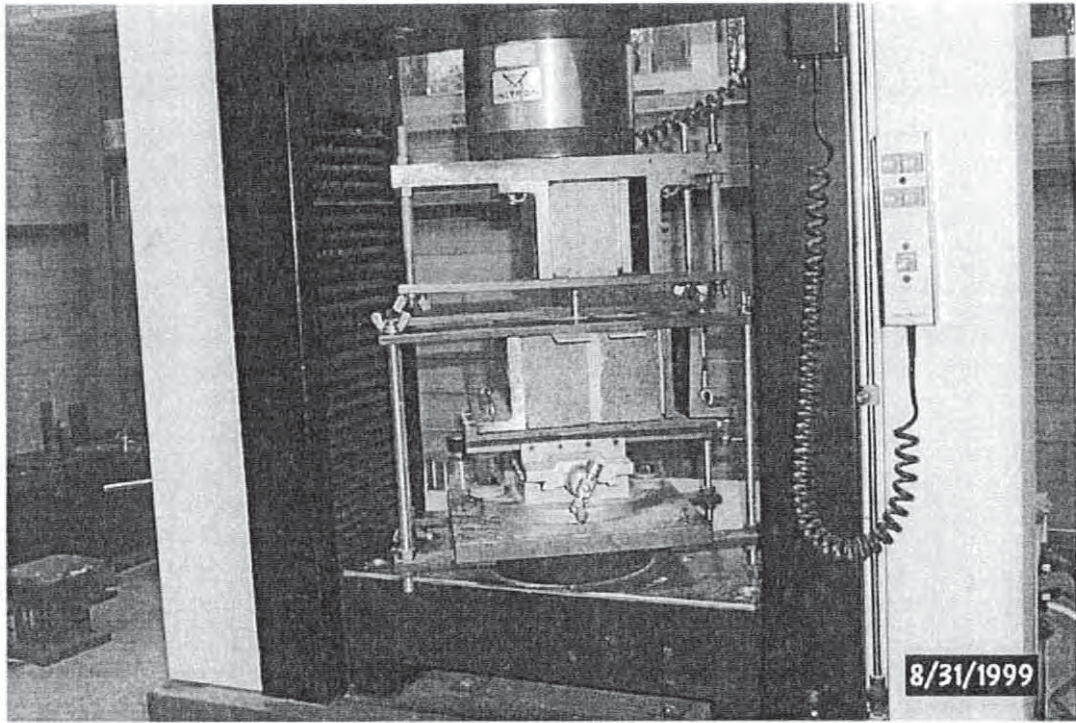
FIGURE 2. Testing Arrangement
