Case History

Arthur Cottage - Ballymena, Northern Ireland

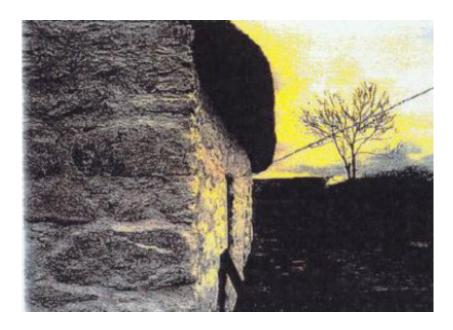
Before this, a survey had indicated that two external walls showed signs of moving outwards. (see photograph)

Before the cottage could be opened to the public it was necessary to reinforce these external walls to prevent further movement.

This suggestion was accepted by the Architect and two 30mm x 30mm x 450 long WSA anchors were installed tied together with 16mm rod, tensioned using two bottle screws. (See diagram below).

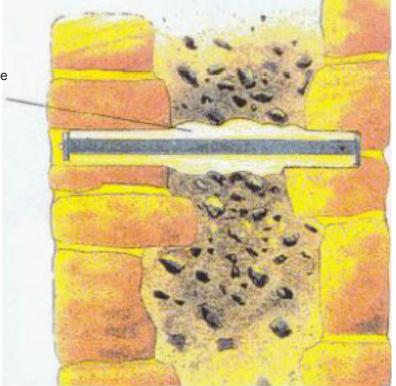
Socks expansions into the soft friable core

Anchor body design dependent on lead but normally -

15x15 20x20 or 30x30 Square Hollow Section

Number and position dependent on structural condition

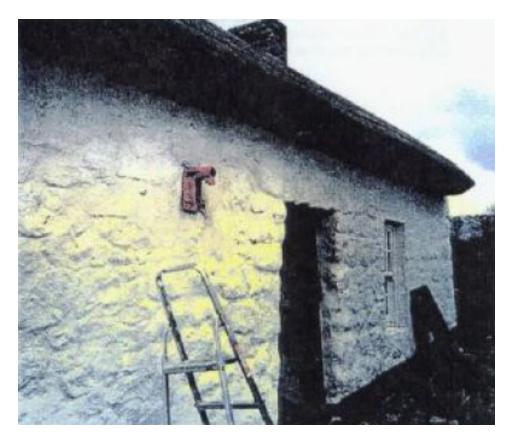
(a) Drilling Rig Base Plate fixed to wall.

The anchor is installed into a 60mm diameter hole drilled with a Diamond Drilling Rig.

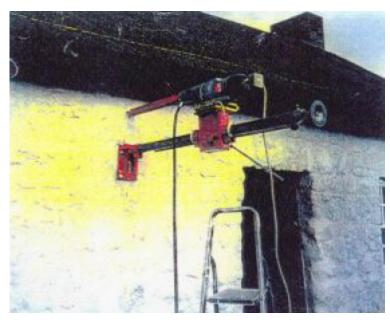
(b) Drilling Rig in place.

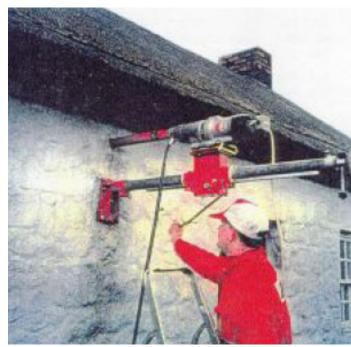
(d) Installing the anchor.

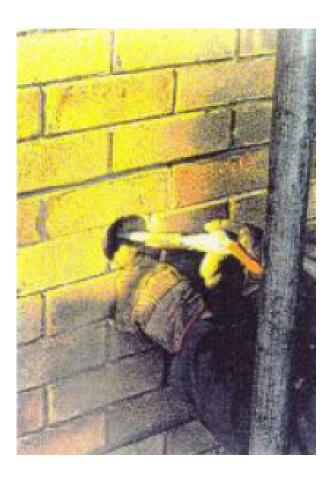
(d) Inflating the anchor with grout. (Note the photograph taken of the actual operation did not come out.)

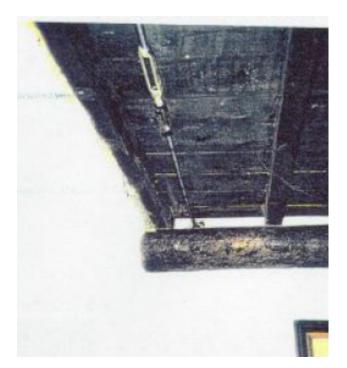
(e) Internal view of one installed anchor with the bar (connecting to the other anchor) and showing the bottle screws.
